FIELD INSPECTION

Project Name:	Mountain Valley Pipeline	Inspector:	Matthew Grant
Inspection Date:	Tuesday, November 19, 2019	Project Contact:	Brian Clauto
Spread: Franklin Co. MP 264.9-.8 AR-FR306.02 MP 263-.5 ATWS 697 MP 269.4-.7 MLV 32 ATWS 693 ATWS 350	Spread I	Weather (Wet/Dry/Rain):	Dry

FIELD INSPECTION PHOTO LOG

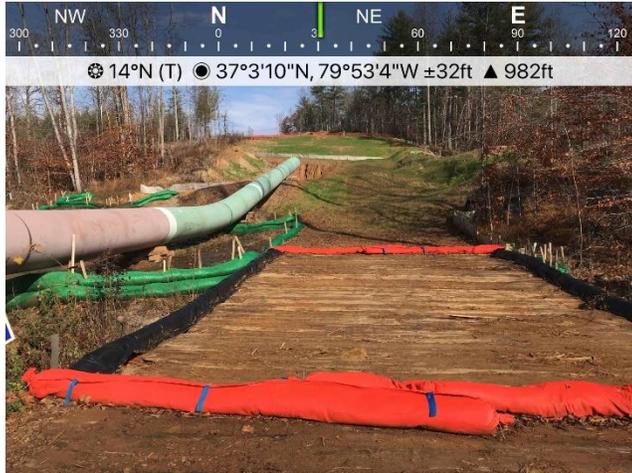
Fig. 1. At designated stream crossing S-KL36, ECD's were in place and functioning.

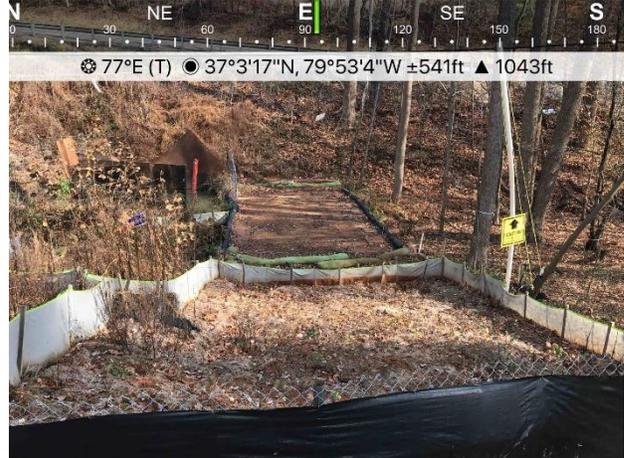
Fig. 2. At designated stream crossing S-KL38, ECD's were in place and functioning.

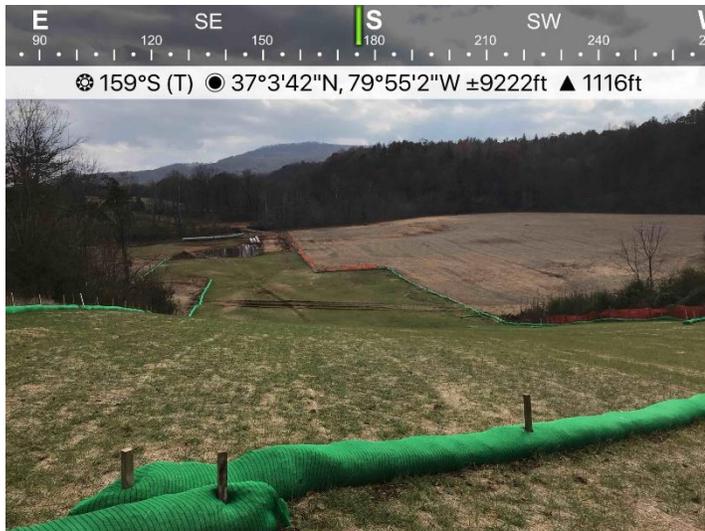
Fig. 3 Near MP263.2 ECD's and stabilization were affective.

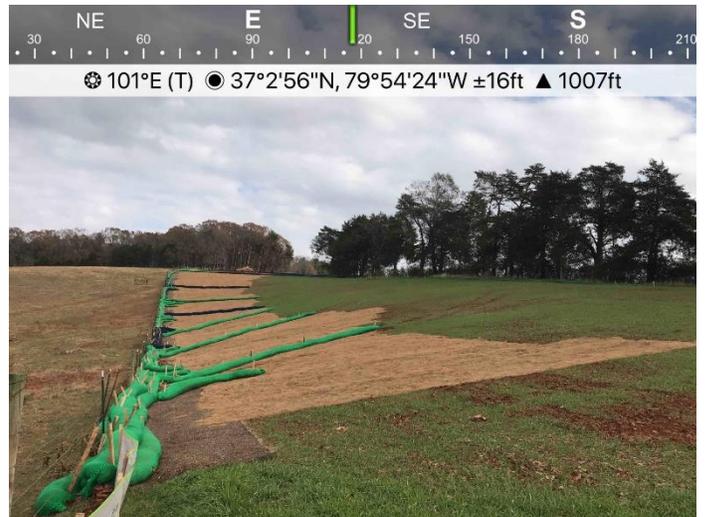
Fig. 4 Near MP 263.5 slope has been repaired and stabilization and ECD's were in place and functioning.
