FIELD INSPECTION

Project Name:	Mountain Valley Pipeline	Inspector:	Matthew Grant
Inspection Date:	Wednesday, November 28, 2018	Project Contact:	Brian Clauto
Spread: Franklin County MP 261 St#13814-13808	Spread I	Weather (Wet/Dry/Rain):	Wet

FIELD INSPECTION PHOTO LOG

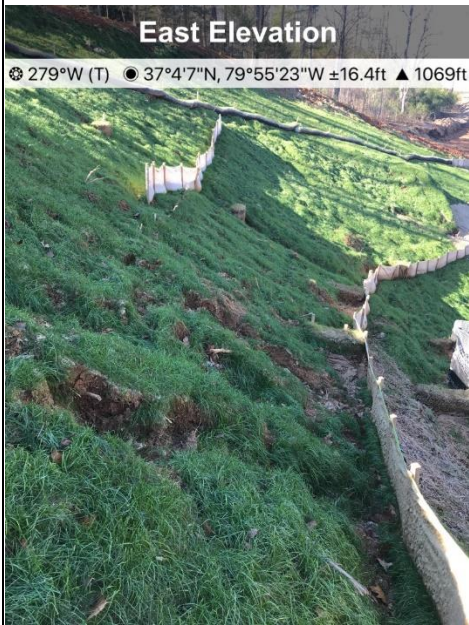
Fig. 1 St#13819+01 slope is showing signs of erosion

Recommended Corrective Action: repair and maintain all controls per the approved plan.

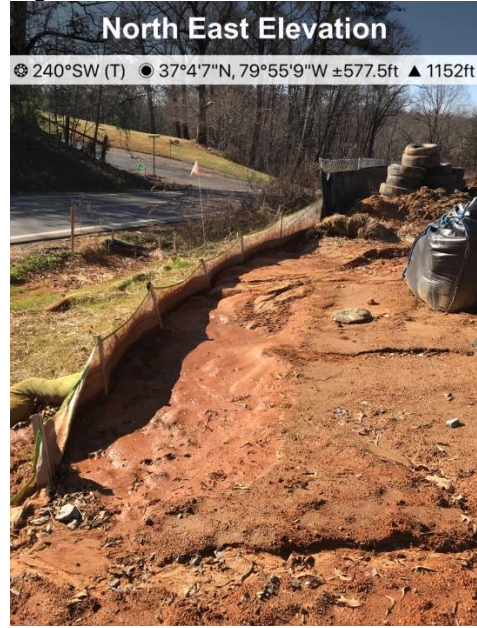
Fig. 2 St#13811 Silt fence is filled with sediment

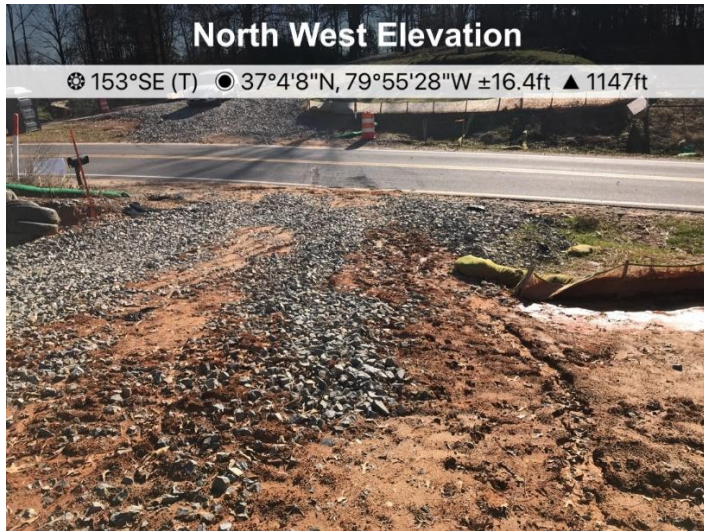
Fig. 3 Brick Church Rd construction entrance has signs of sediment in stone

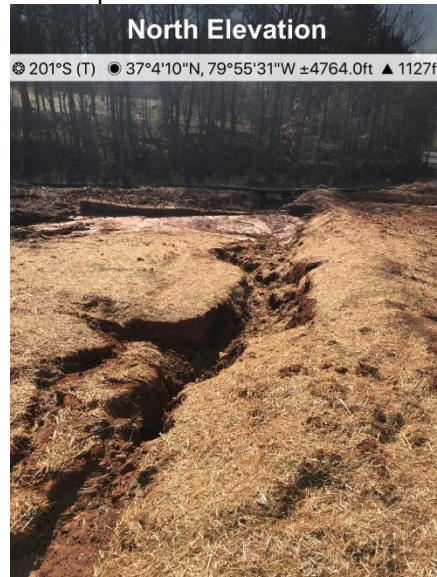
Fig. 4 St#13808+74 waterbar flow path has eroded and sump is filled with sediment
