FIELD INSPECTION

Project Name:	Mountain Valley Pipeline	Inspector:	Marshall Willis
Inspection Date:	Thursday, December 12, 2019	Project Contact:	Brian Clauto, Cory Chalmers
Spread I: Pittsylvania County Franklin County	STA 15113+00 – 15142+66 STA 13853+45 – 13876+00 MVP-FR-303.01	Weather (Wet/Dry/Rain):	Wet

FIELD INSPECTION PHOTO LOG

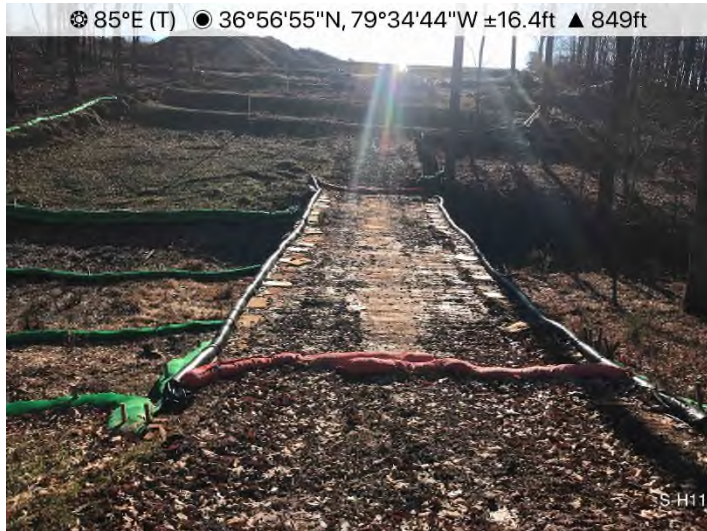
Fig. 1: **Stream S-H11** – Controls in place and properly functioning. Area stabilized with Earth Guard.

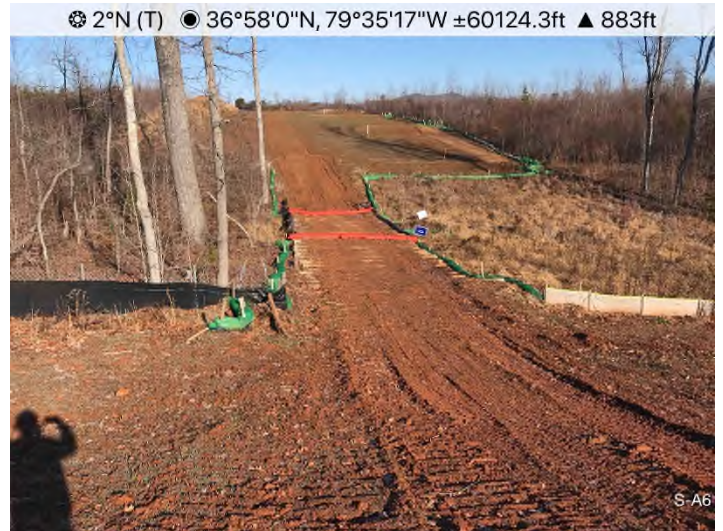
Fig. 2: **Stream S-A6** – Controls in place and properly functioning. Area stabilized with Earth Guard.

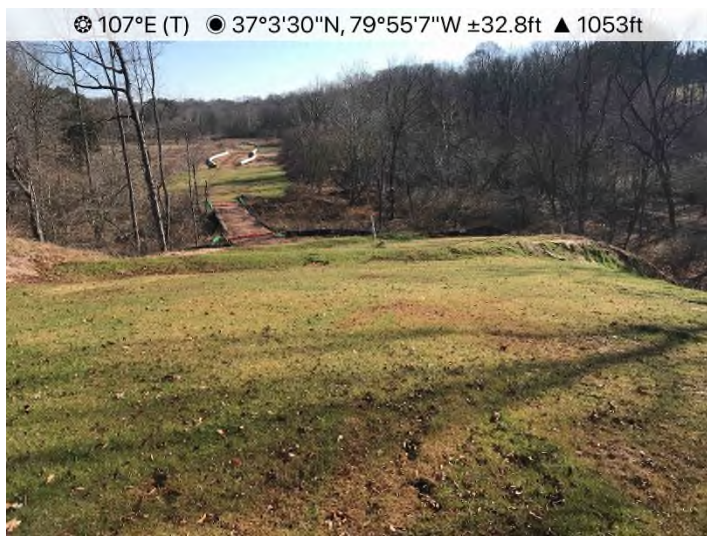
Fig. 3: **STA 13860+00** – Controls in place and functioning above Stream S-C17. Area stabilized with vegetation.

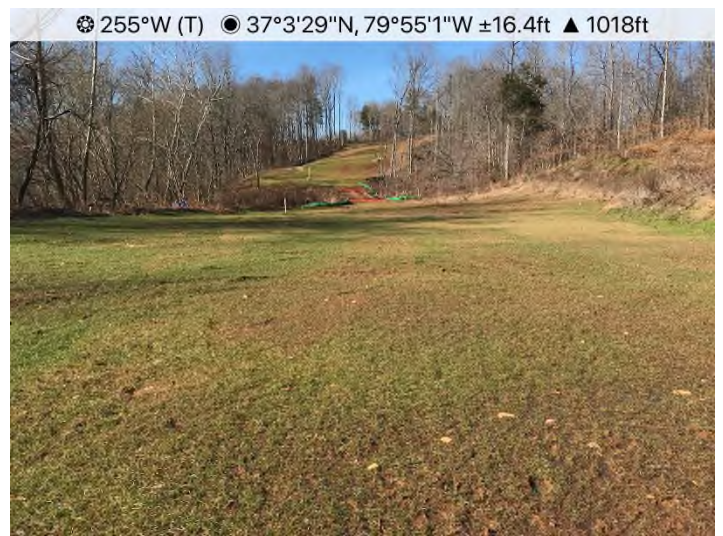
Fig. 4: **STA 13867+57** – Controls in place and properly functioning. Area stabilized with vegetation.
