FIELD INSPECTION

Project Name:	Mountain Valley Pipeline	Inspector:	Marshall Willis
Inspection Date:	Friday, December 20, 2019	Project Contact:	Brian Clauto, Cory Chalmers
Spread I: Pittsylvania County	STA 15693+89 – 15826+77 MVP-PI-337/338 ATWS 399/399A/631/499	Weather (Wet/Dry/Rain):	Wet

FIELD INSPECTION PHOTO LOG

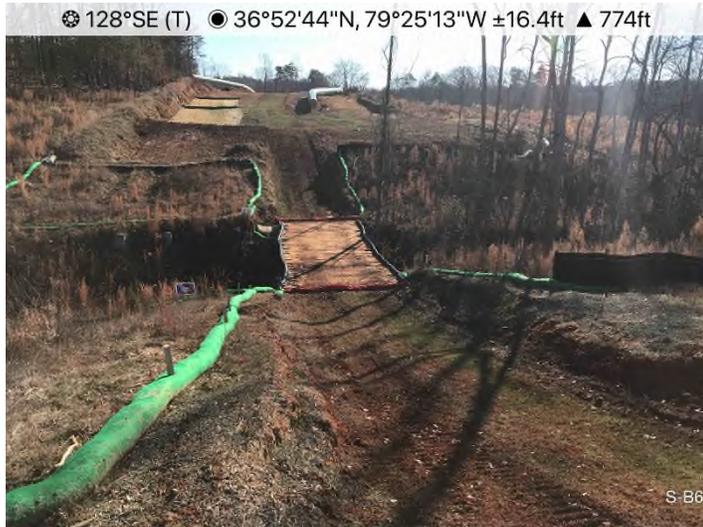
Fig. 1: **Stream S-B6** – Controls in place and properly functioning. Area stabilized with Earth-Guard.

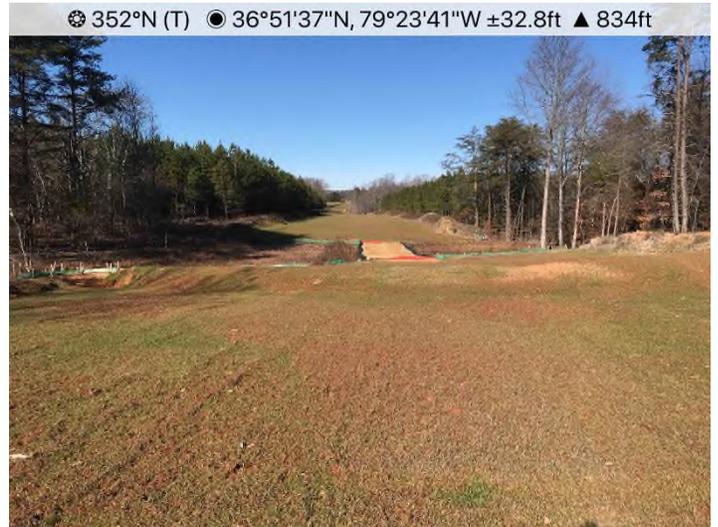
Fig. 2: **STA 15810+00** – Controls in place and properly functioning. Area stabilized.

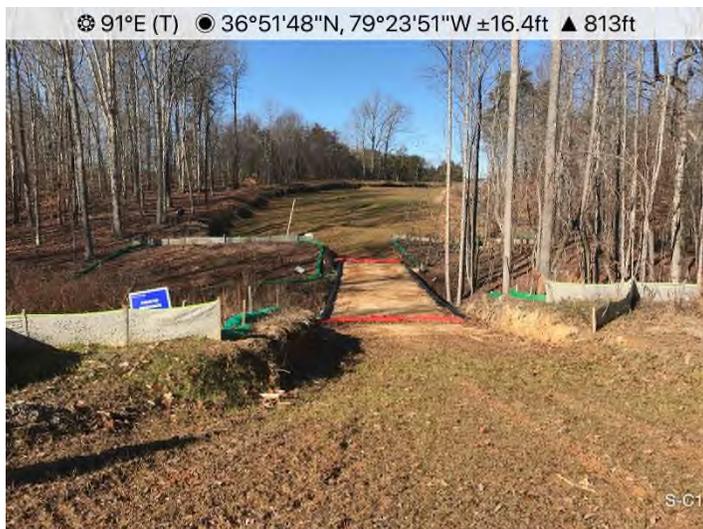
Fig. 3: **STA 15795+00** – Controls in place and properly functioning at Stream S-C1. Area stabilized.

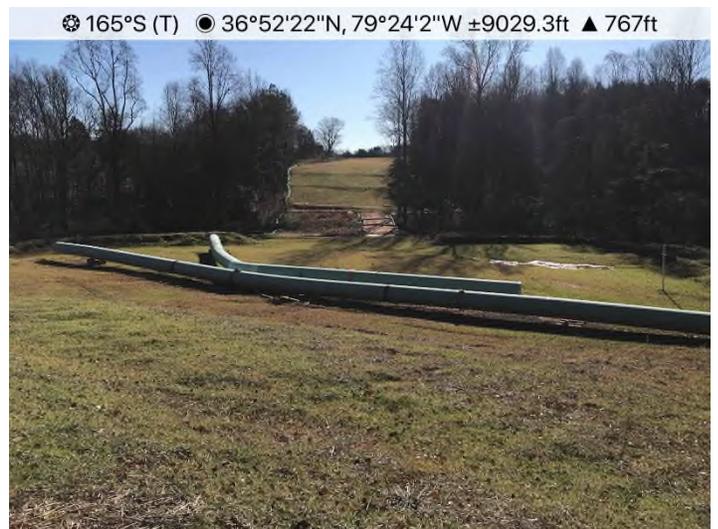
Fig. 4: **STA 15762+00** – Controls in place and properly functioning. Area stabilized with vegetation.
