## FIELD INSPECTION

<b>Project Name:</b>	Mountain Valley Pipeline	<b>Inspector:</b>	Marshall Willis
<b>Inspection Date:</b>	Monday, December 9, 2019	<b>Project Contact:</b>	Brian Clauto, Cory Chalmers
<b>Spread I: Franklin County</b>	STA 13415+51 – 13440+00 STA 13539+14 – 13542+58 STA 13562+63 – 13575+21 STA 13996+56 – 14001+97	<b>Weather (Wet/Dry/Rain):</b>	Rainy

# FIELD INSPECTION PHOTO LOG

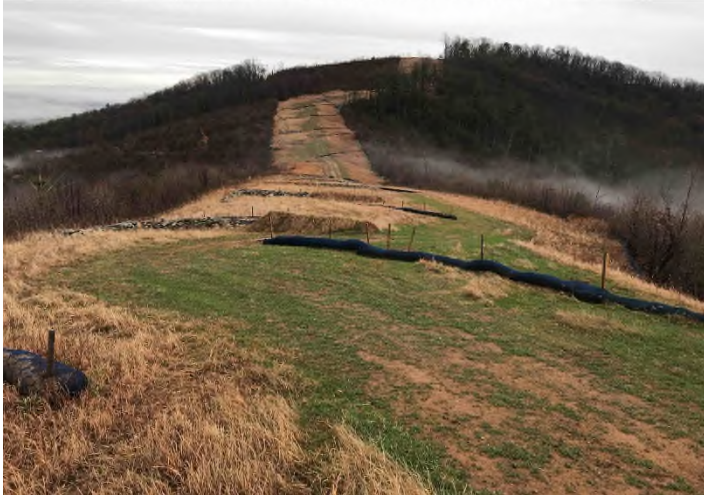
Fig. 1: **STA 13438+31** – Controls in place and properly functioning. Area stabilized with vegetation.

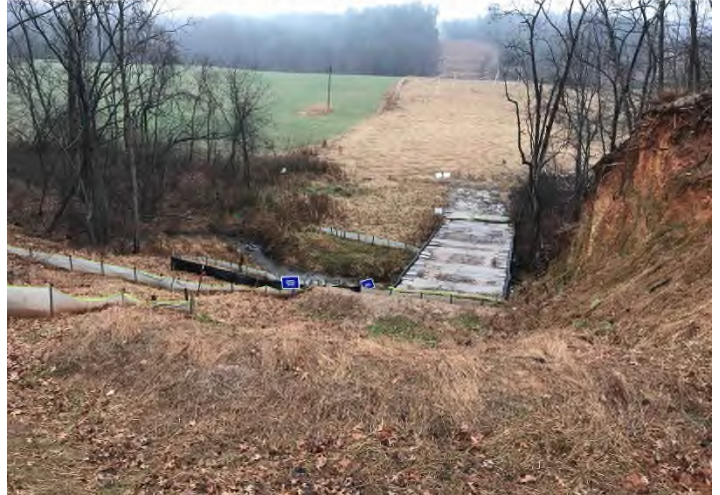
Fig. 2: **STA 13542+58** – Controls in place and functioning properly. Area stabilized with vegetation.

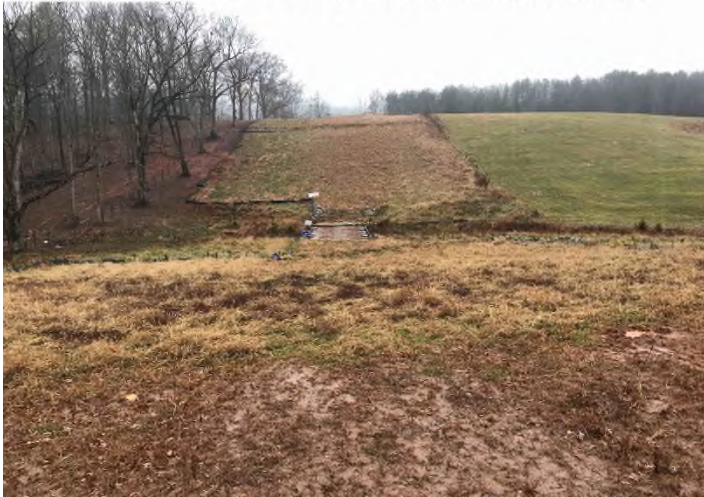
Fig. 3: **Stream S-II7** – Controls in place and functioning above Stream S-II7. Area stabilized with vegetation.

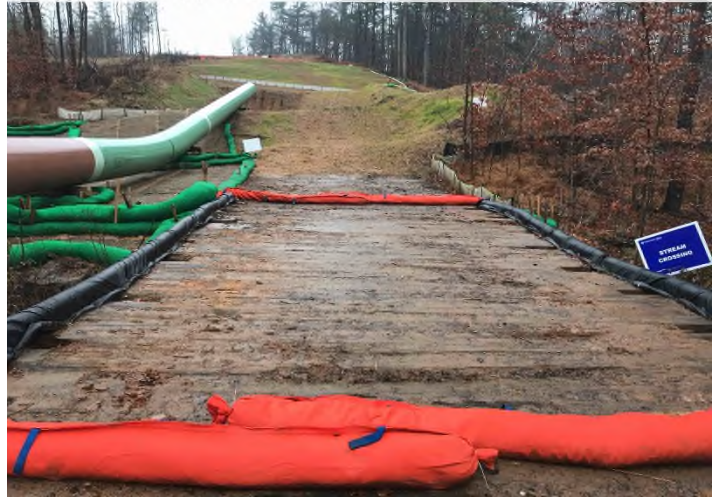
Fig. 4: **Stream S-KL36** – Controls in place and properly functioning along Stream S-KL36 crossing.
