## FIELD INSPECTION REPORT

<b>Project Name:</b>	Mountain Valley Pipeline	<b>Inspector:</b>	Marshall Willis
<b>Inspection Date:</b>	Monday, February 10, 2020	<b>Project Contact:</b>	Brian Clauto, Cory Chalmers
<b>Spread I: Franklin County</b>	STA 13690+91 – 13748+30 ATWS 562/1362	<b>Weather:</b>	Rainy

## FIELD INSPECTION PHOTO LOG

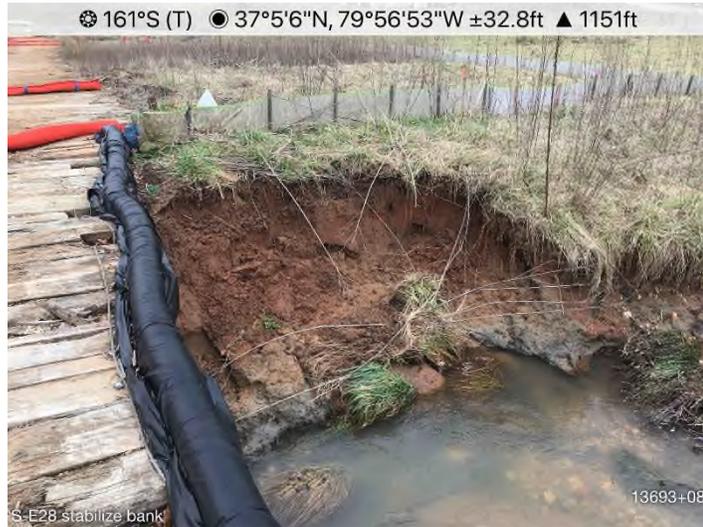
- STA 13693+08: Bank scour at S-E28 crossing from high flow conditions. Bank stabilization needed.
- STA 13704+90: Bank scour at S-E28 crossing from high flow conditions. Bank stabilization needed.

**Figure 1: STA 13693+08** – Bank scour along S-E28 crossing from high flow conditions. Bank stabilization needed.

**Recommended Corrective Action:** Stabilize bank scour.

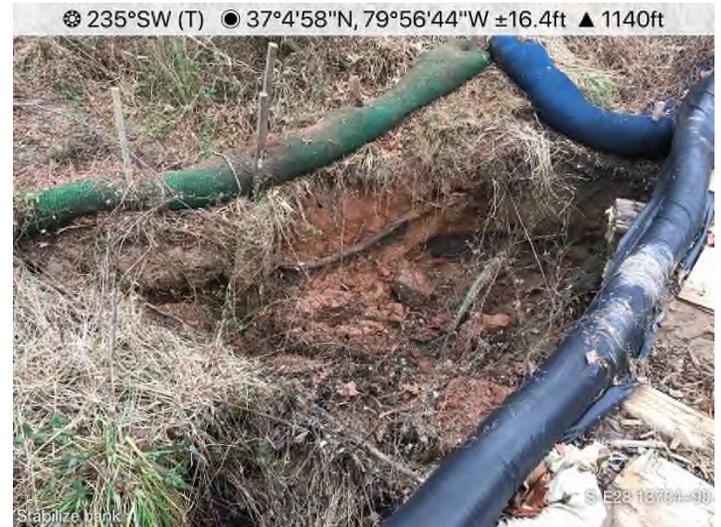
**Figure 2: STA 13704+90** – Bank scour along S-E28 crossing from high flow conditions. Bank stabilization needed.

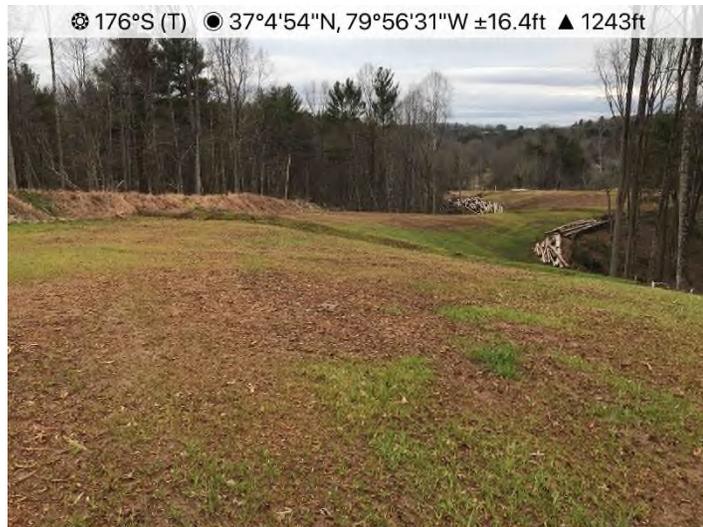
**Figure 3: STA 13721+00** – Controls in place and functioning properly.

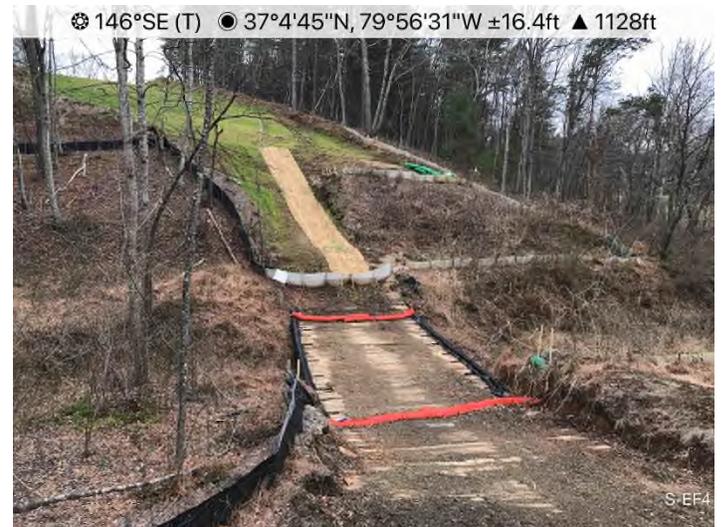
**Figure 4: Stream S-EF4** – Controls in place and functioning properly at stream S-EF4.
