FIELD INSPECTION REPORT

Project Name:	Mountain Valley Pipeline	Inspector:	Marshall Willis
Inspection Date:	Tuesday, February 11, 2020	Project Contact:	Brian Clauto, Cory Chalmers
Spread I: Franklin County	STA 14049+00 – 14062+17	Weather:	Rainy

FIELD INSPECTION PHOTO LOG

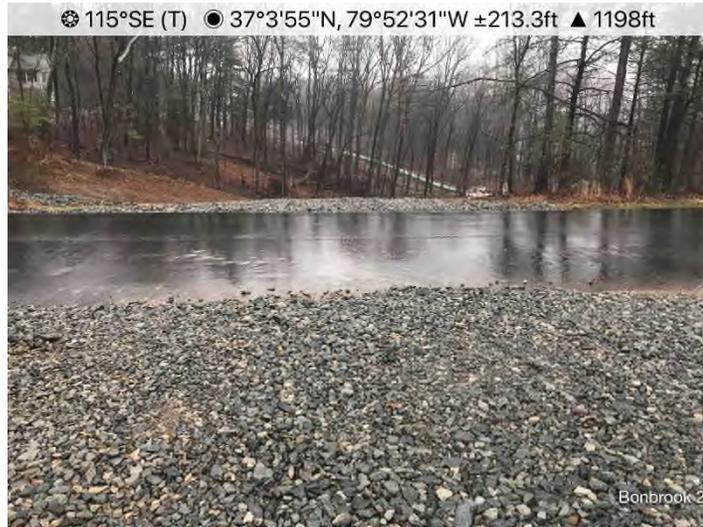
Figure 1: Bonbrook Mill Road – Controls in place and functioning properly.

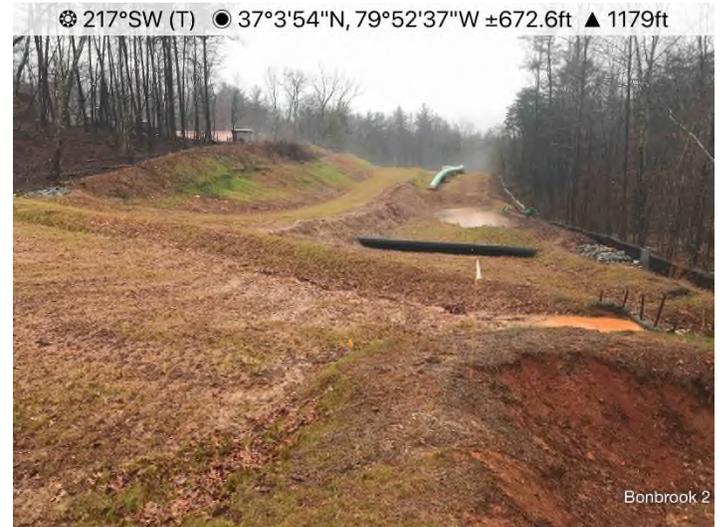
Figure 2: STA 14057+25 – Controls in place and functioning properly. No sediment discharge off ROW observed.

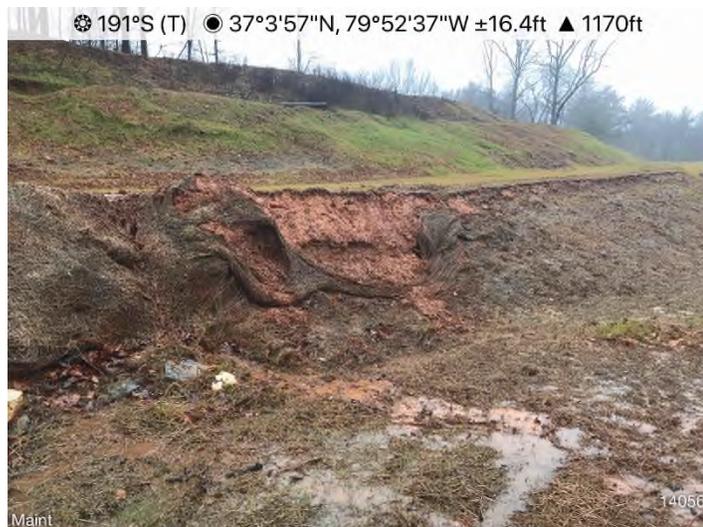
- STA 14056+00: Erosion matting maintenance needed.

Figure 3: STA 14056+00 – Erosion matting repair needed.

Recommended Corrective Action: Maintain and install all controls per the approved PSS&S.

Deadline: Within 72-Hour of Notification

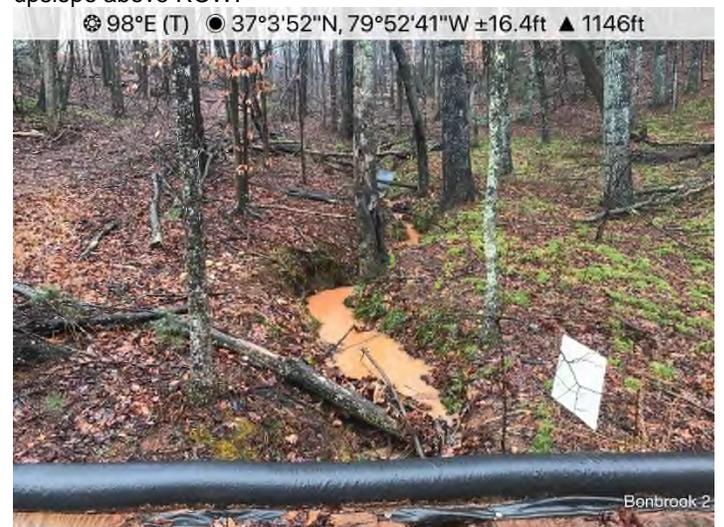
Figure 4: Stream S-YZ4 – Looking upstream from S-YZ4 crossing. Turbid water observed flowing down S-YZ4 from upslope above ROW.
