FIELD INSPECTION REPORT

| Project Name: | Mountain Valley Pipeline | Inspector: | Marshall Willis |
| Inspection Date: | Wednesday, February 12, 2020 | Project Contact: | Brian Clauto, Cory Chalmers |
| Spread I: Franklin County | STA 14018+47 – 14171+36 MVP-FR-309.05/309.06/309 ATWS 1470/1471/1472/1473/1478 | Weather: | Rainy |

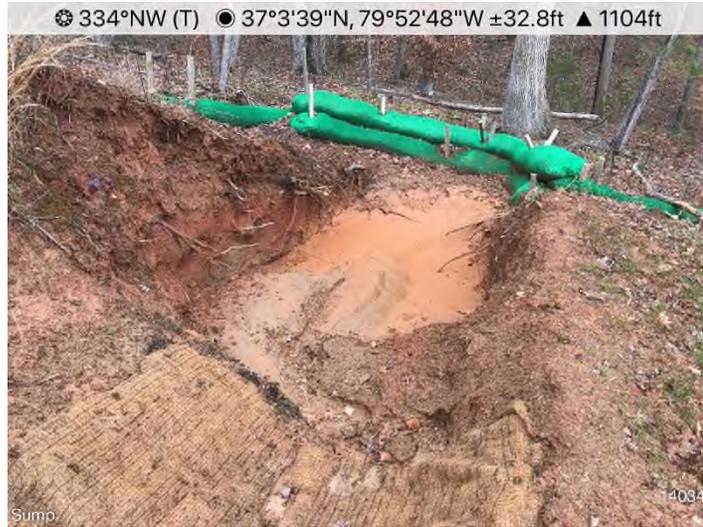
Figure 1: STA 14034+00 – Sump maintenance needed.

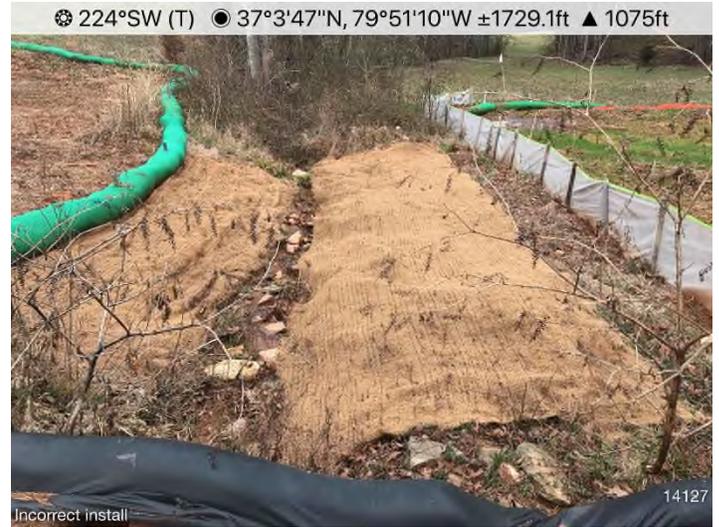
Figure 2: STA 14127+00 – Erosion matting improperly installed.

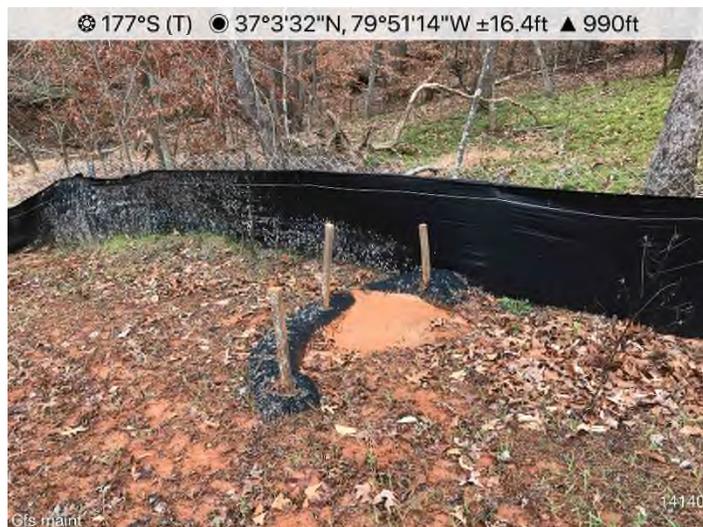
Figure 3: STA 14140+00 – CFS maintenance needed.

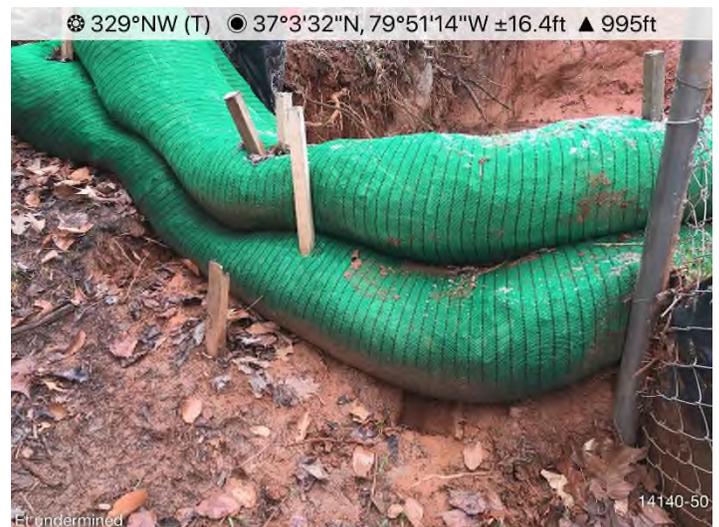
Figure 4: STA 14140+50 – End Treatment undermined. Maintenance needed.

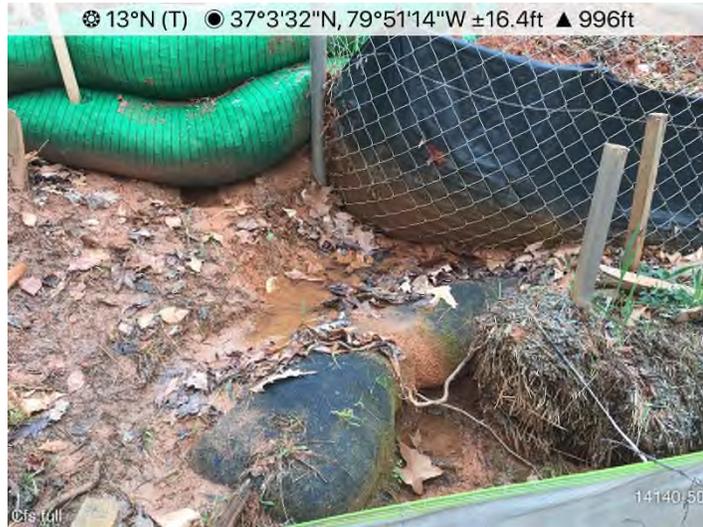
Figure 5: STA 14140+50 – CFS maintenance needed.

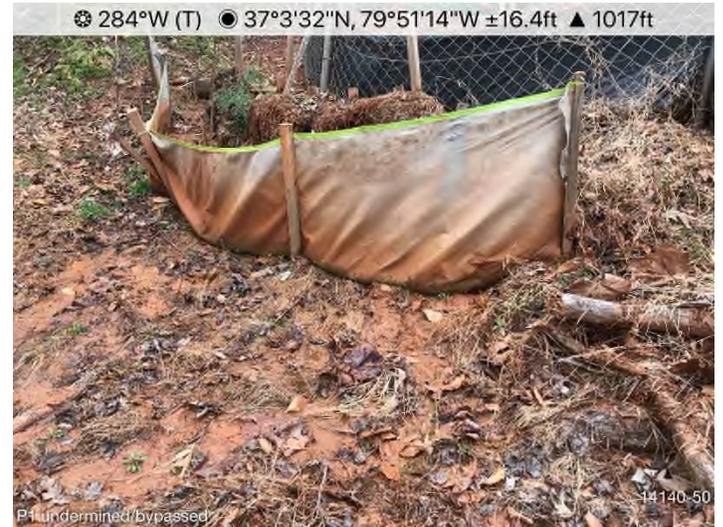
Figure 6: STA 14140+50 – P1 undermined and bypassed. Maintenance needed.

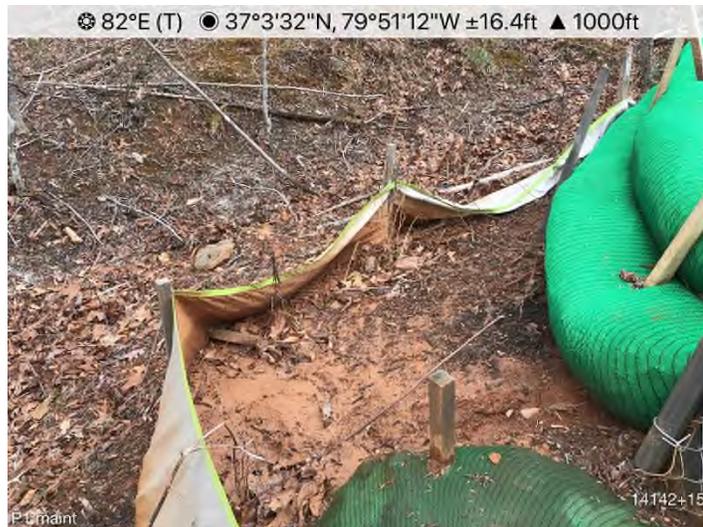
Figure 7: STA 14142+15 – P1 maintenance needed.

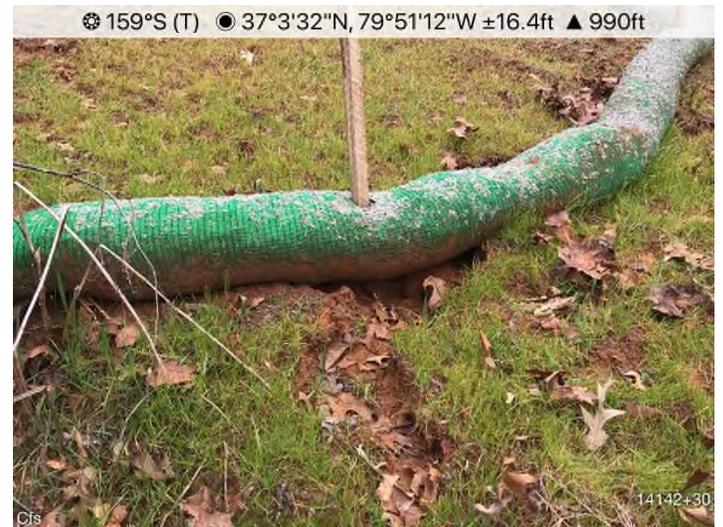
Figure 8: STA 14142+30 – CFS undermined. Maintenance needed.

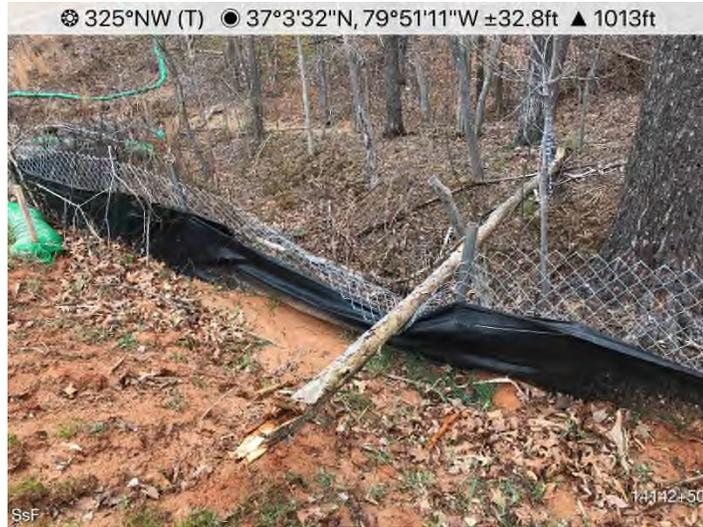
- STA 14142+50: SSF damaged by tree. Maintenance needed.

Figure 9: STA 14142+50 – SSF maintenance needed.

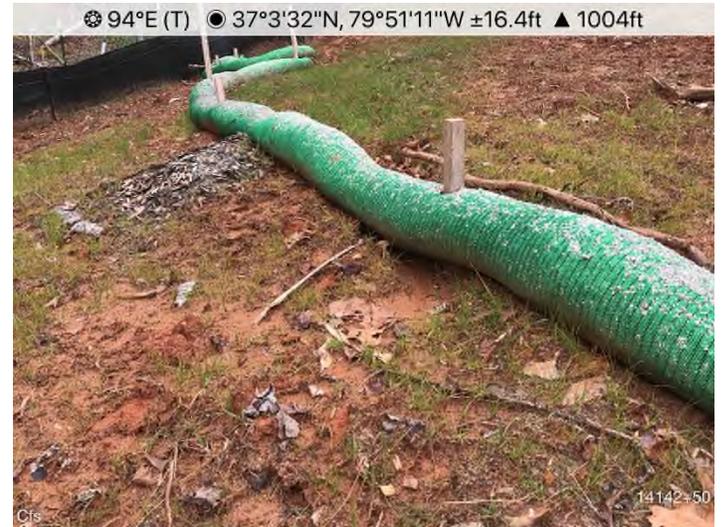
Figure 10: STA 14142+50 – CFS undermined. Maintenance needed.

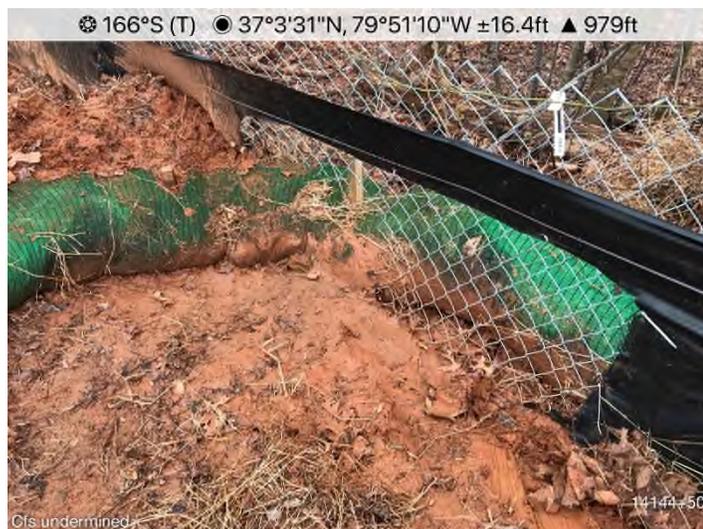
Figure 11: STA 14144+50 – CFS undermined. Maintenance needed.

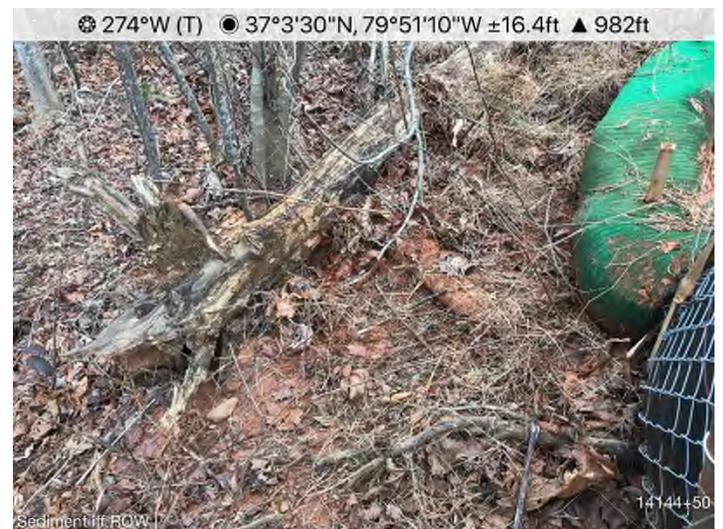
Figure 12: STA 14144+50 – Sediment off ROW. Retrieve and stabilize sediment.

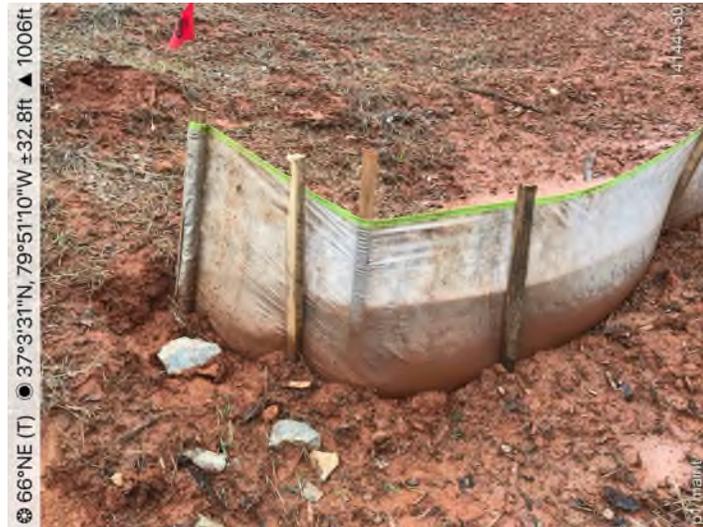
Figure 13: STA 14144+50 – P1 bypassed. Maintenance needed.

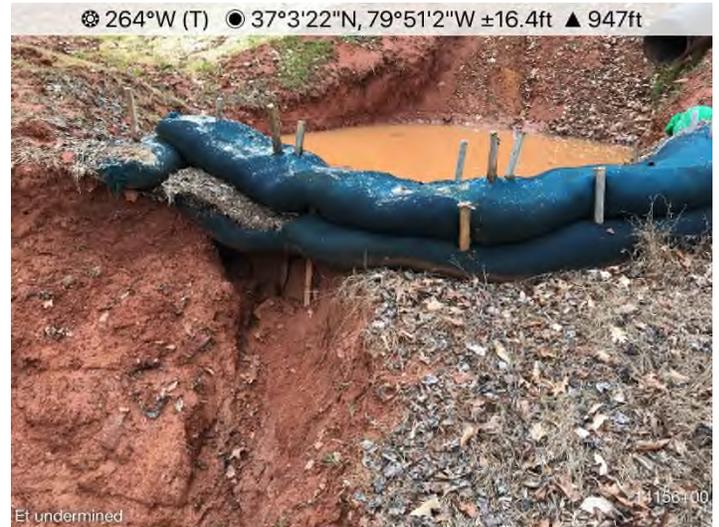
Figure 14: STA 14156+00 – End Treatment undermined. Maintenance needed.

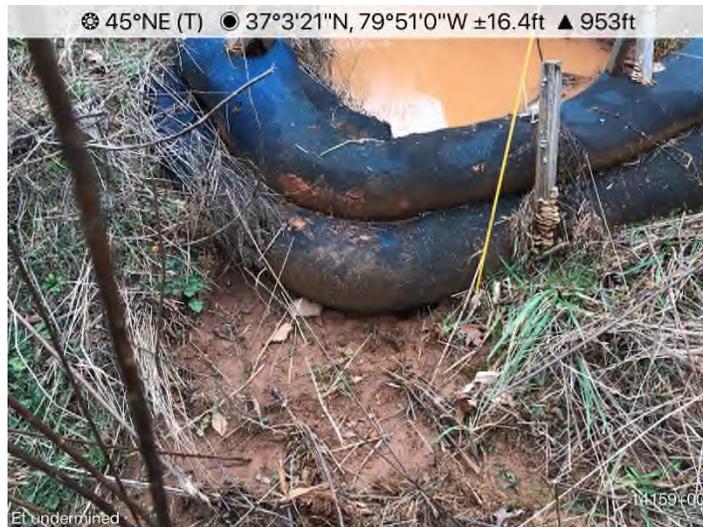
Figure 15: STA 14150+00 – End Treatment undermined. Maintenance needed.
