FIELD INSPECTION REPORT

Project Name:	Mountain Valley Pipeline	Inspector:	Marshall Willis
Inspection Date:	Thursday, February 13, 2020	Project Contact:	Brian Clauto, Cory Chalmers
Spread I: Franklin County	STA 14171+36 – 14209+75 ATWS 1481/521/521A	Weather:	Rainy

FIELD INSPECTION PHOTO LOG

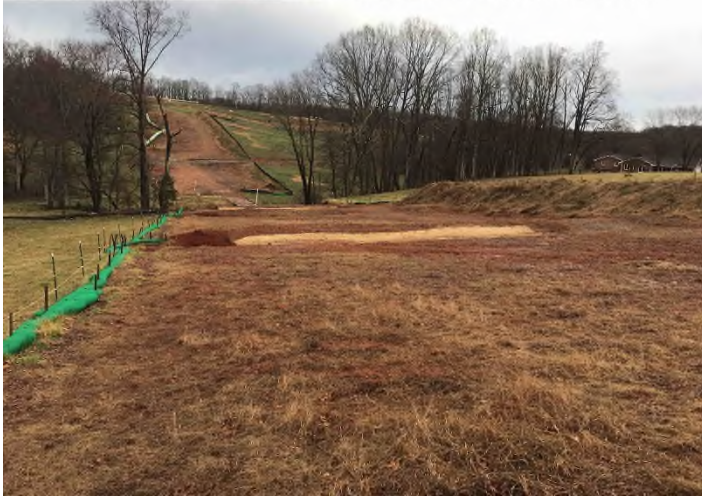
Figure 1: STA 14185+00 – Controls in place and functioning properly.

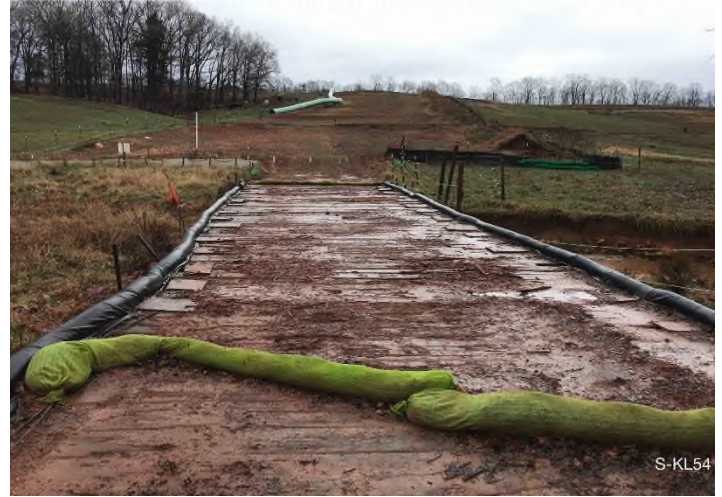
Figure 2: Stream S-KL54 – Controls in place and functioning properly at stream S-KL54.

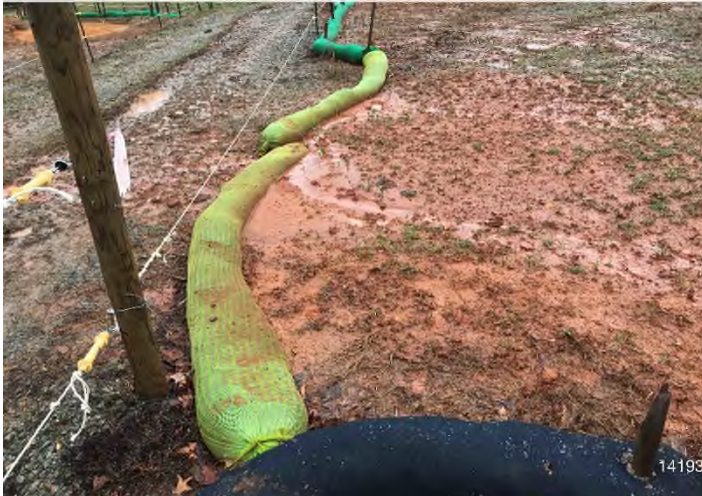
- STA 14193+00: CFS wattle maintenance needed.

Figure 3: STA 14193+00 – CFS wattle in need of maintenance.

Recommended Corrective Action: Maintain and install all controls per the approved PSS&S.

Deadline: Within 72-Hour of Notification

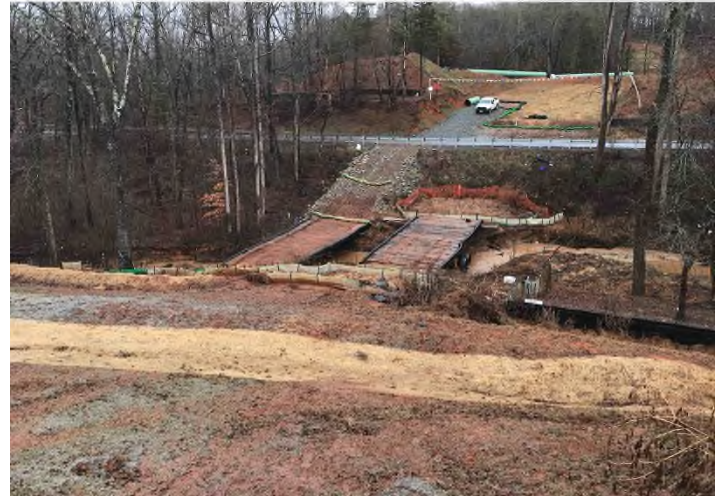
Figure 4: STA 14206+00 – Controls in place and functioning properly around stream S-F8.
