## FIELD INSPECTION REPORT

<b>Project Name:</b>	Mountain Valley Pipeline	<b>Inspector:</b>	Marshall Willis
<b>Inspection Date:</b>	Friday, February 14, 2020	<b>Project Contact:</b>	Brian Clauto, Cory Chalmers
<b>Spread I: Franklin County</b>	STA 14272+62 – 14333+27 ATWS MVP-FR-313 ATWS 353/354	<b>Weather:</b>	Wet

# FIELD INSPECTION PHOTO LOG

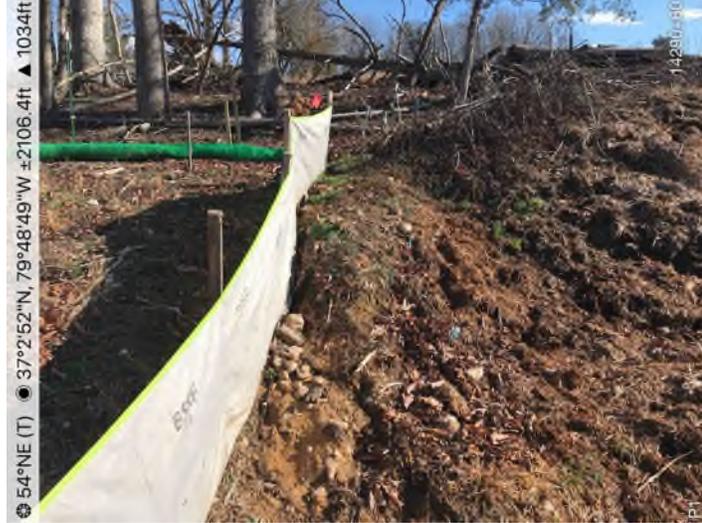
**Figure 1: STA 14290+60** – P1 undermined from offsite run-on. Repair needed.

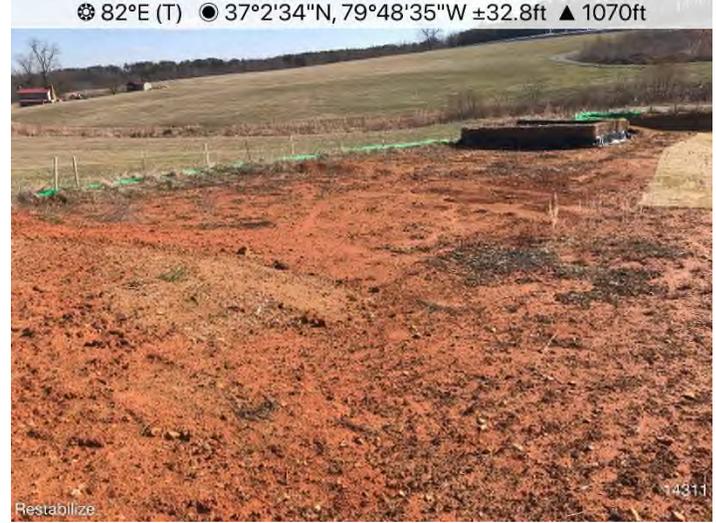
**Figure 2: STA 14311+00 to 14314+00** – Re-stabilization needed.

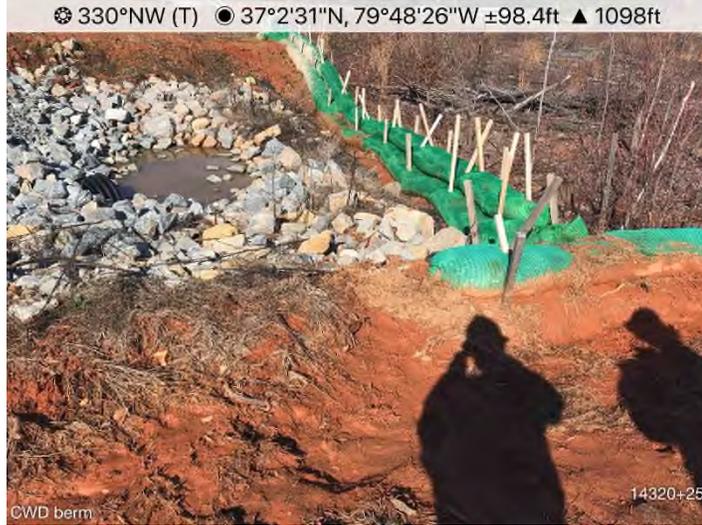
**Figure 3: STA 14320+25** – Plunge pool diversion berm repair needed.

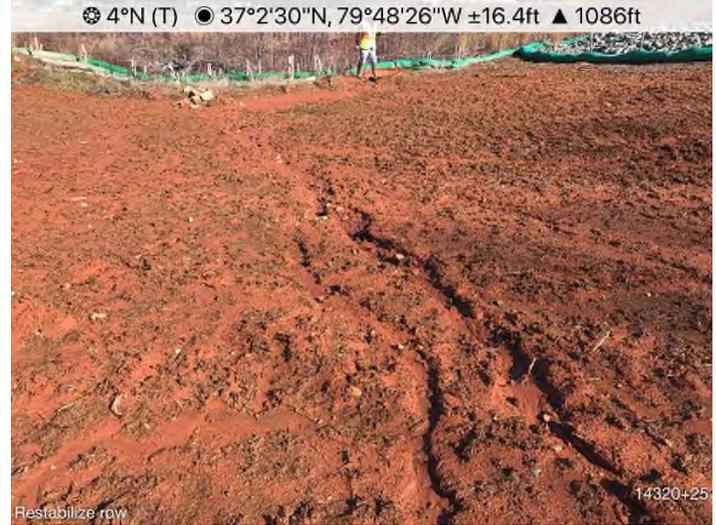
**Figure 4: STA 14320+25** – Re-stabilization needed.

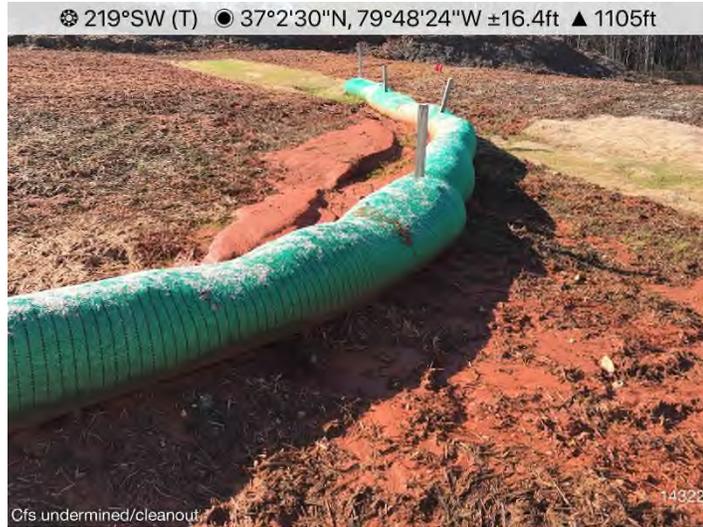
Figure 5: STA 14322+00 – CFS undermined. Repair needed.

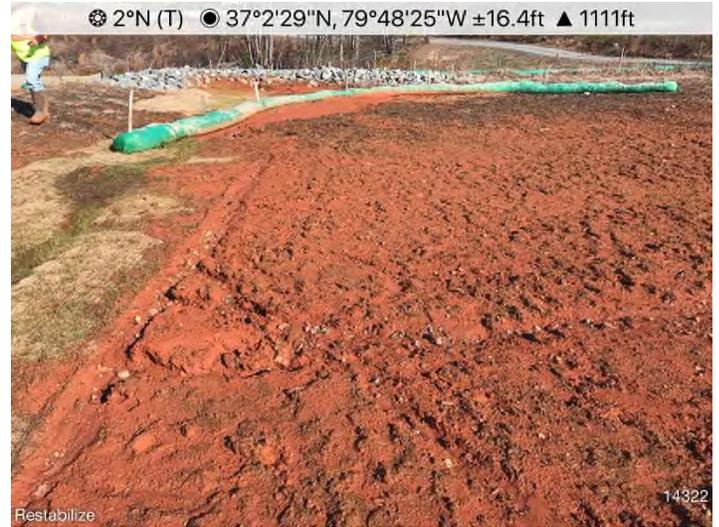
Figure 6: STA 14322+00 – Re-stabilization needed.
