FIELD INSPECTION

Project Name:	Mountain Valley Pipeline	Inspector:	Marshall Willis
Inspection Date:	Tuesday, February 19, 2019	Project Contact:	Brian Clauto
Spread I: Franklin County	STA 14062+17 – 14042+83 STA 14272+24 – 14274+00 STA 14129+00 – 14171+75	Weather (Wet/Dry/Rain):	Dry

FIELD INSPECTION PHOTO LOG

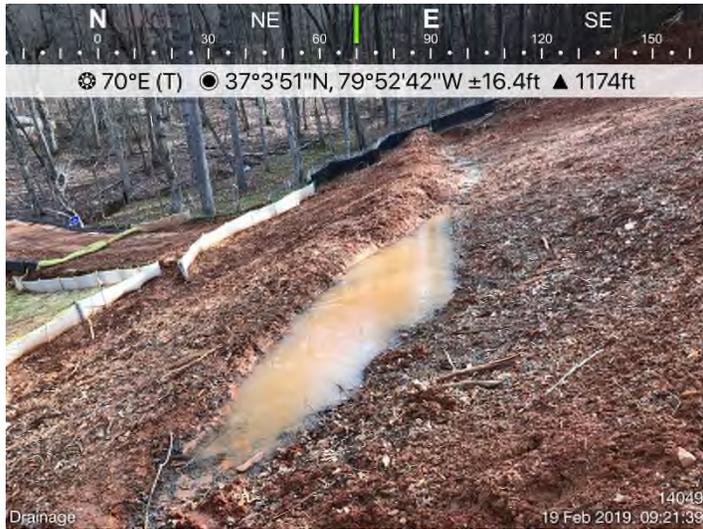
Fig. 1: STA 14049+30 – Waterbar does not have positive drainage.

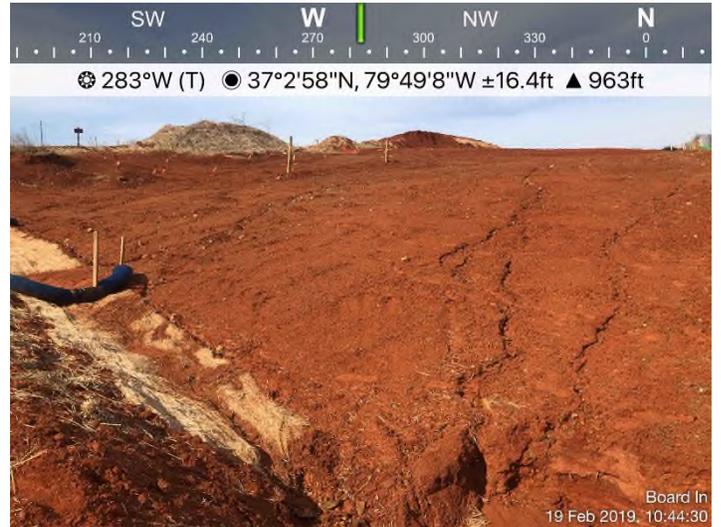
Fig. 2: STA 14272+24 – Stabilization needed.

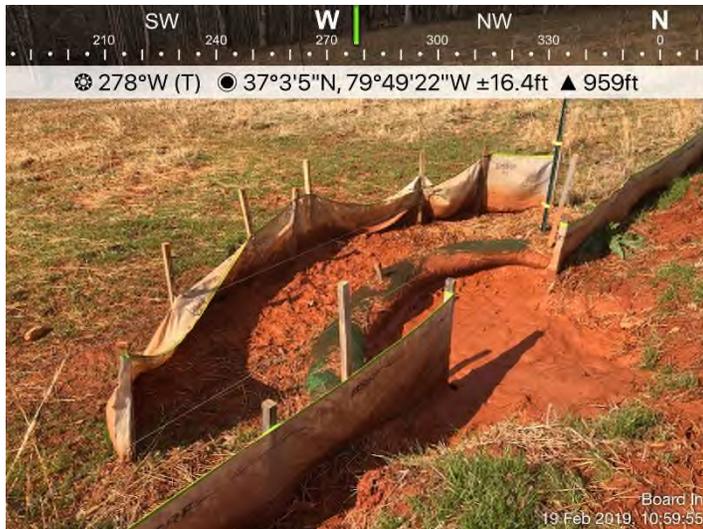
Fig. 3: STA 14273+25 – Maintain P1.

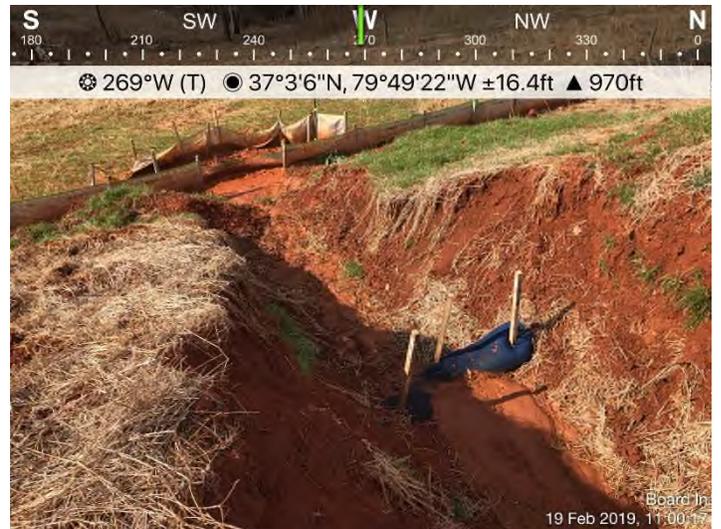
Fig. 4: STA 14273+25 – Clean out CFS.

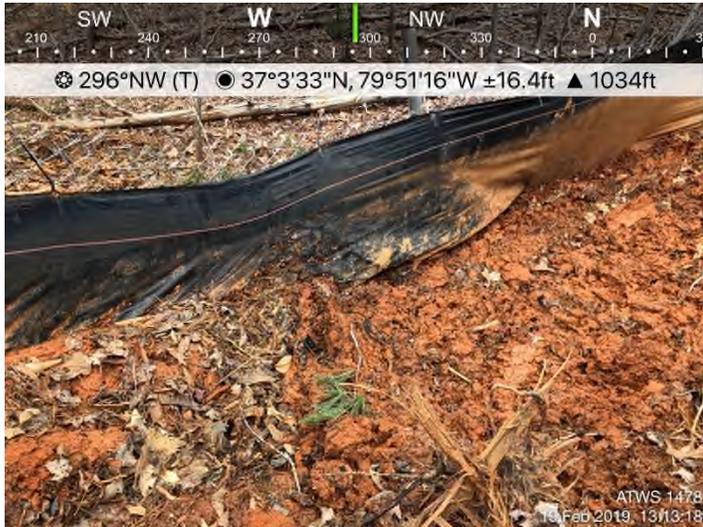
Fig. 5: ATWS 1478 – Repair SSF.

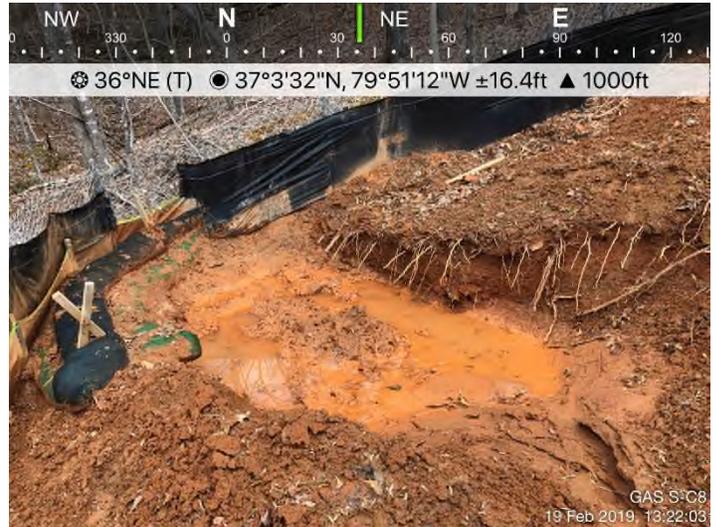
Fig. 6: GAS S-C8 – Sump full.

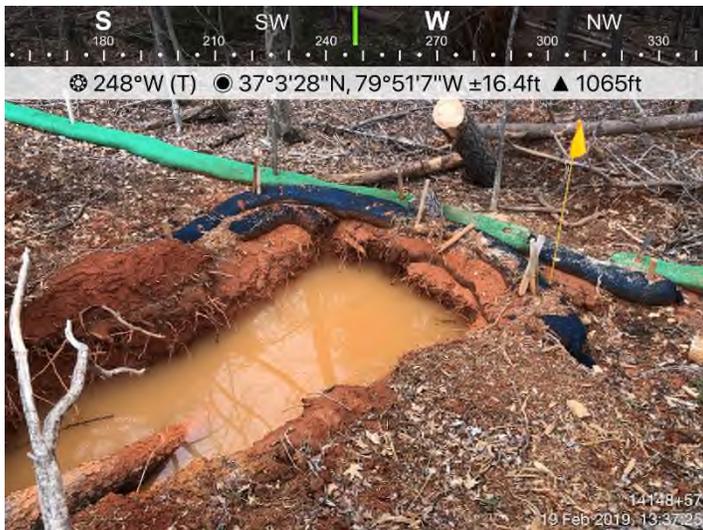
Fig. 7: STA 14148+57 – Maintain CFS.

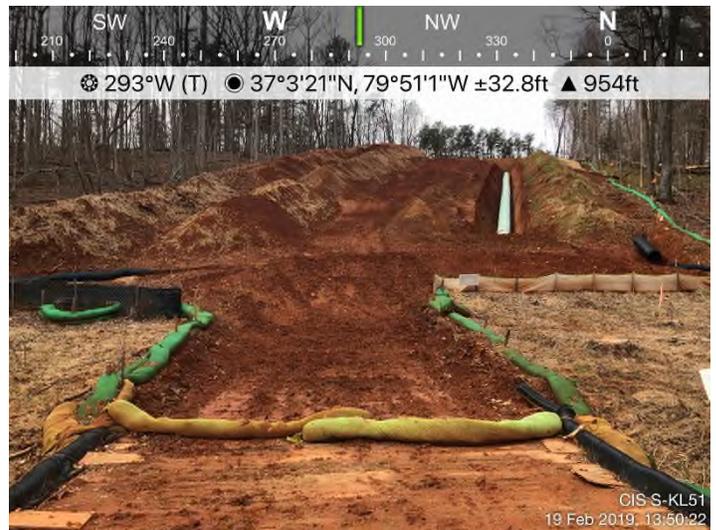
Fig. 8: CIS S-KL51 – Stabilize areas adjacent to resource.
