FIELD INSPECTION REPORT

Project Name:	Mountain Valley Pipeline	Inspector:	Marshall Willis
Inspection Date:	Wednesday, February 19, 2020	Project Contact:	Brian Clauto, Cory Chalmers
Spread I: Franklin County	STA 14649+67 – 14758+16 ATWS 367/533/534/368/536/536A ATWS 370/1279/371/372	Weather:	Wet

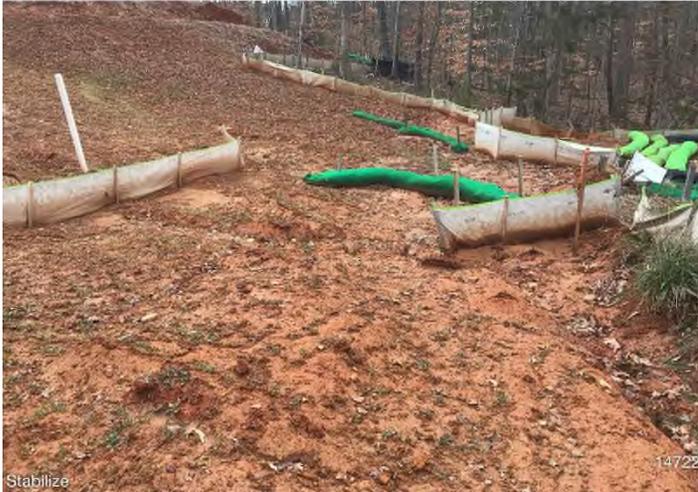
Figure 1: STA 14717+50 – Re-stabilize denuded ROW and repair erosion.

Recommended Corrective Action: Maintain and install all controls per the approved PSS&S.

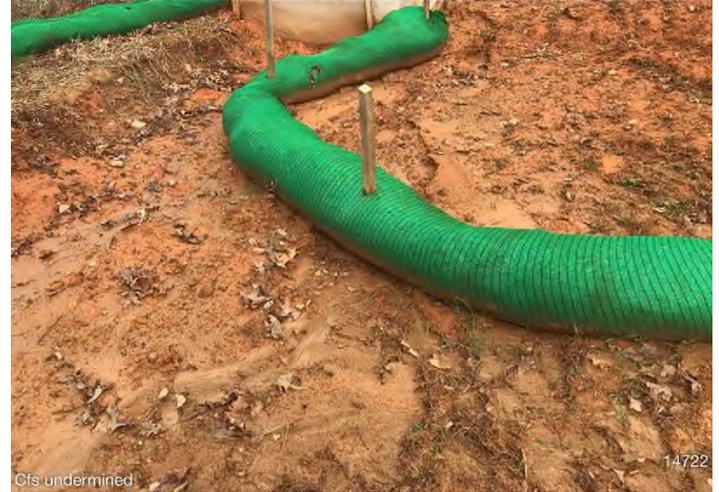
Figure 2: STA 14717+50 – CFS undermined. Repair needed.

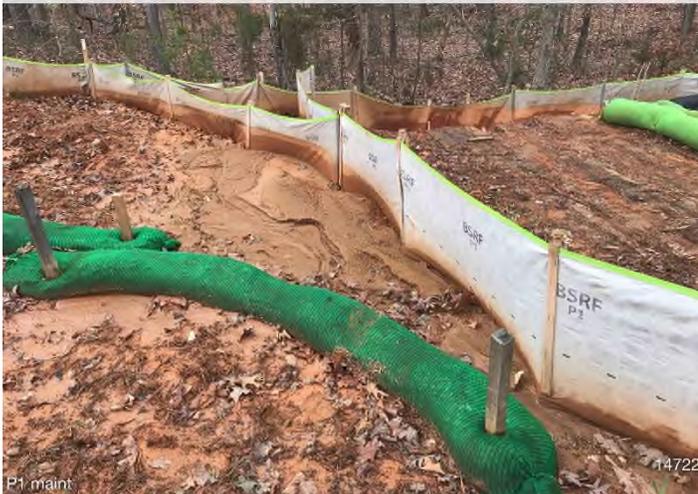
Figure 3: STA 14717+50 – P1 maintenance needed.

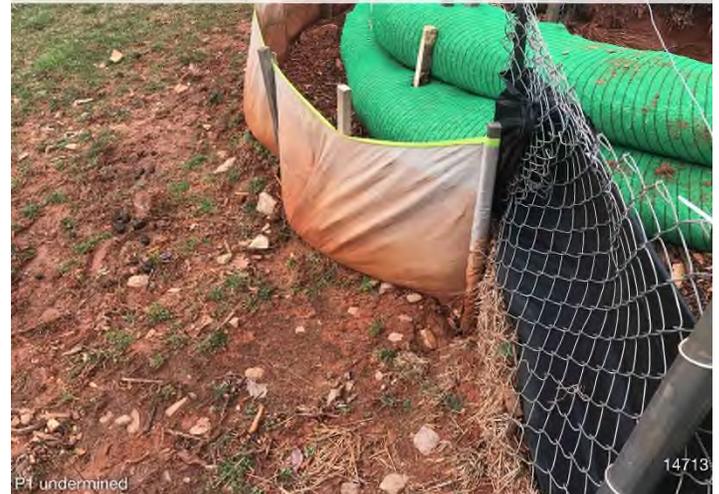
Figure 4: STA 14713+00 – P1 undermined. Repair needed.

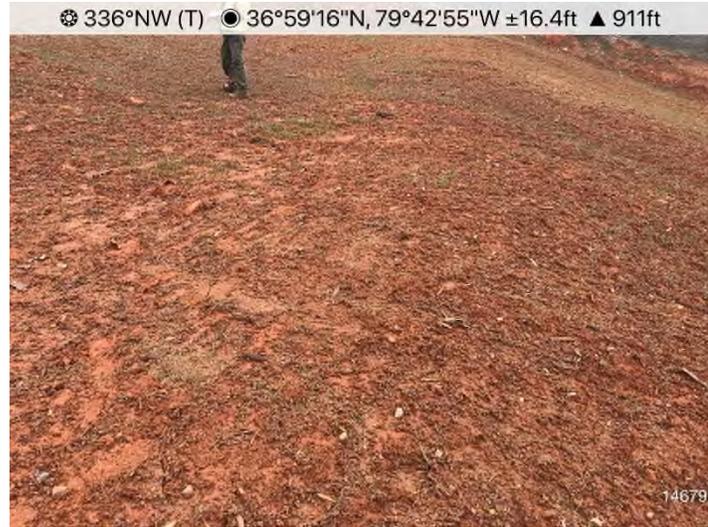
- STA 14717+50: P1 maintenance needed.
- STA 14679+00: Waterbar maintenance needed. Does not meet height requirement.

Figure 5: STA 14679+00 – Watebar maintenance needed.
