FIELD INSPECTION

Project Name:	Mountain Valley Pipeline	Inspector:	Marshall Willis
Inspection Date:	Tuesday, February 26, 2019	Project Contact:	Brian Clauto
Spread I: Franklin County	STA 13848+50 – 13942+00	Weather (Wet/Dry/Rain):	Dry

FIELD INSPECTION PHOTO LOG

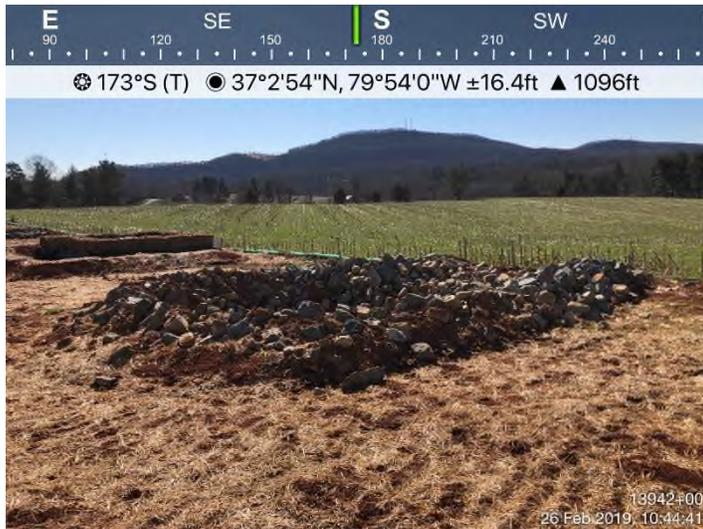
Fig. 1: **STA 13942+00** – No diversion for CWD.

Recommended Corrective Action: Maintain and install all controls per the approved plan and specs.

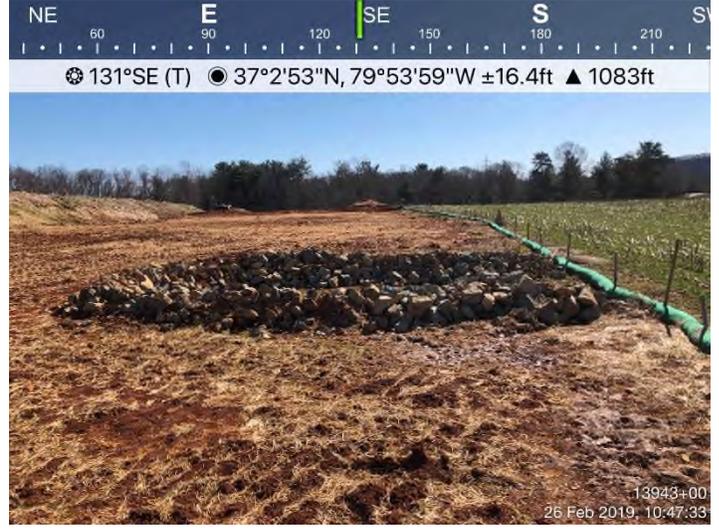
Fig. 2: **STA 13943+00** – No diversion for CWD.

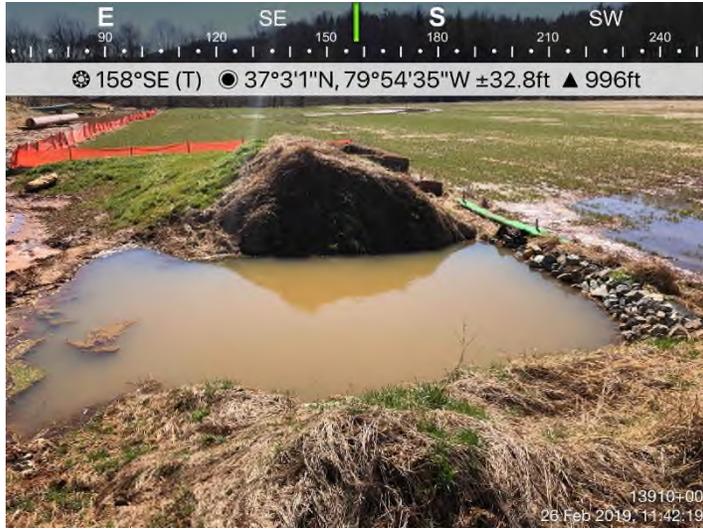
Fig. 3: **STA 13910+00** – CWD unable to drain.

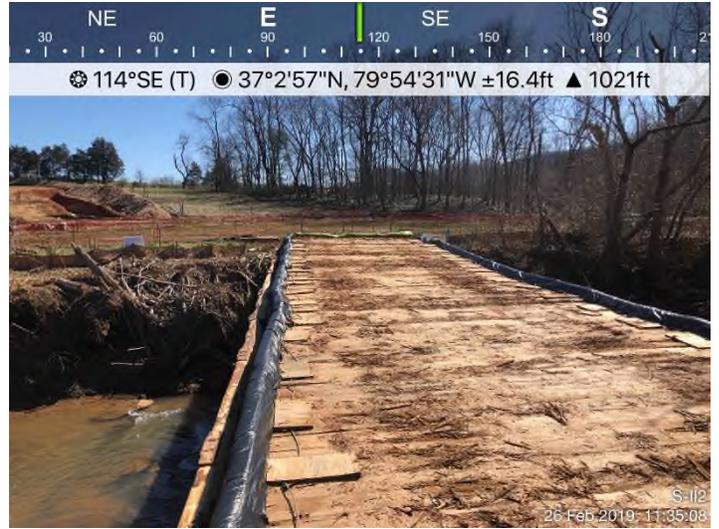
Fig. 4: **S-II2** – Controls in place.

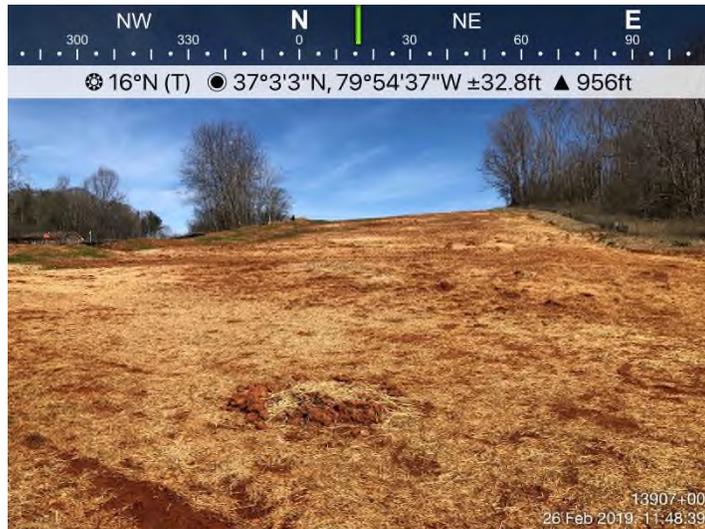
Fig. 5: STA 13907+00 – Area stabilized. Controls in place.

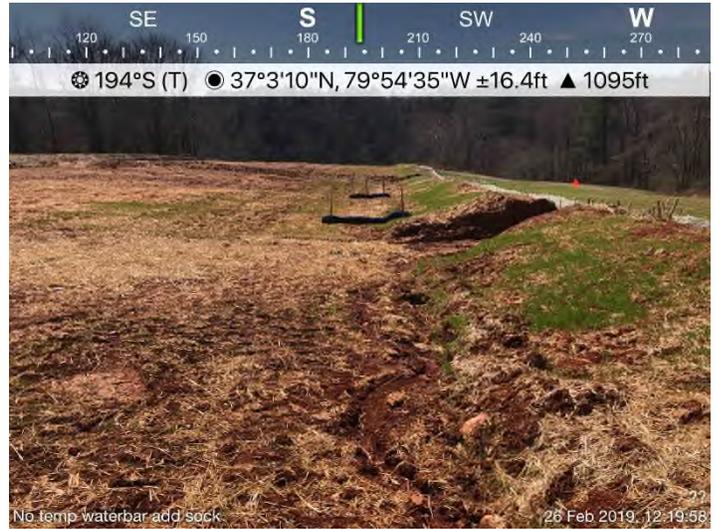
Fig. 6: STA 13901+00 – CFS waterbar needed.

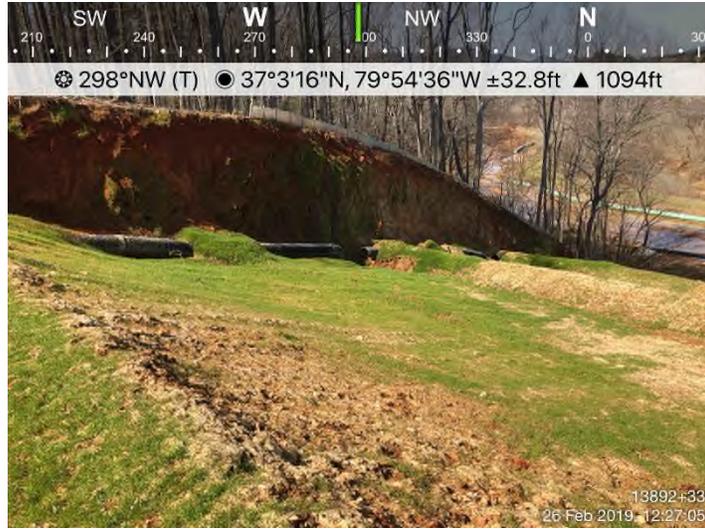
Fig. 7: STA 13892+33 – Area stabilized. Controls in place.

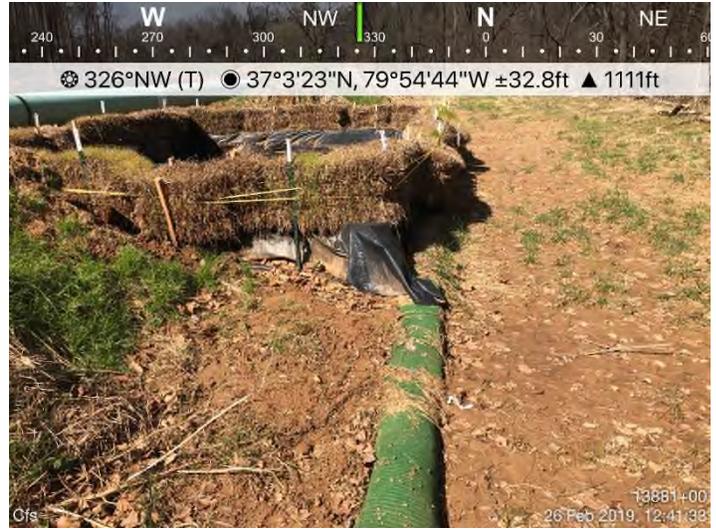
Fig. 8: STA 13881+00 – CFS needs maintenance.

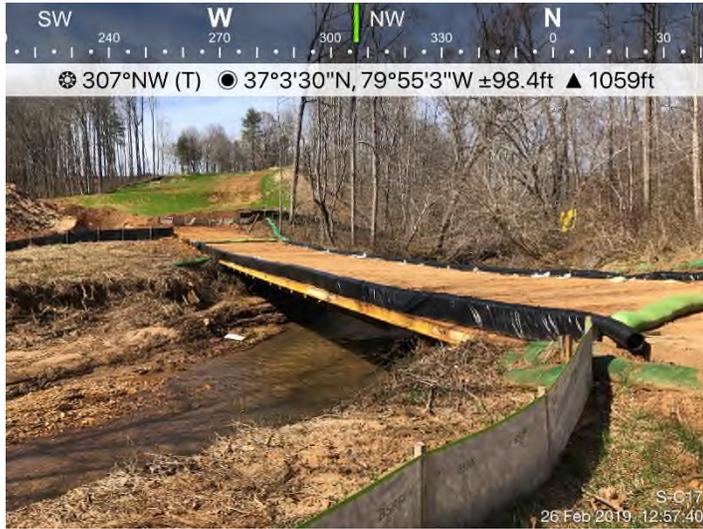
Fig. 9: **S-C17** – Controls in place.

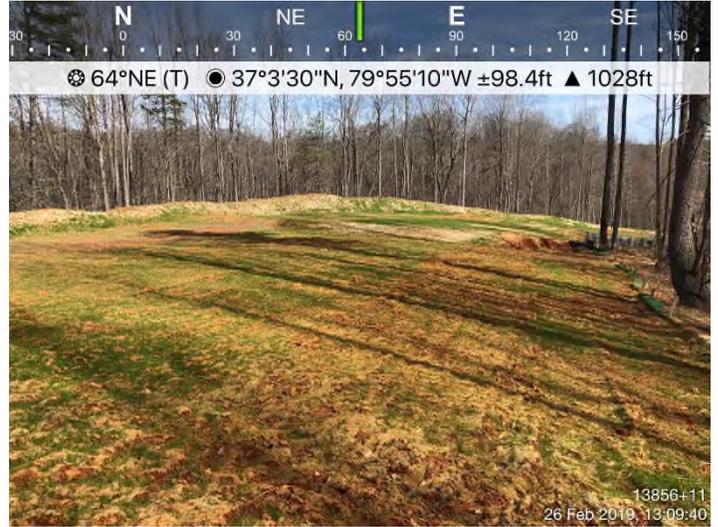
Fig. 10: **STA 13856+11** – Area stabilized. Controls in place.
