FIELD INSPECTION REPORT

Project Name:	Mountain Valley Pipeline	Inspector:	Matthew Grant
Inspection Date:	Wednesday, February 26, 2020	Project Contact:	Brian Clauto,
Spread I: Franklin	MP 275.3-277.2 MP 285.1-286 ATWS 362	Weather:	Wet

FIELD INSPECTION PHOTO LOG

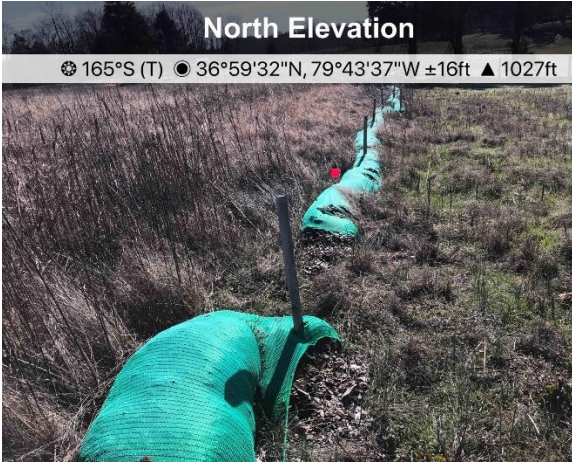
- St14639+85 CFS is torn and requires repair.
- St15092+00 P1 ECD has holes and requires repair.

<p>▪ Figure 1: St14639+85 CFS has been torn and requires repair, the area is well stabilized.</p> <div style="text-align: center;"> <p>North Elevation</p> <p>☉ 165°S (T) ● 36°59'32"N, 79°43'37"W ±16ft ▲ 1027ft</p>

Recommended Corrective Action: Maintain and install all controls per the approved PSS&S.

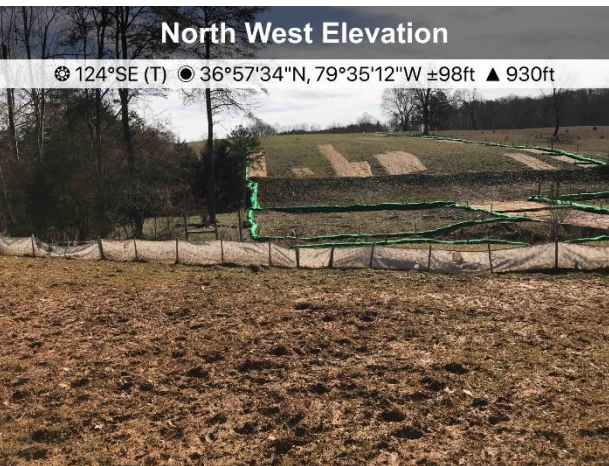
</div>	<p>▪ Figure 2: St15092+00 P1 has holes and requires maintenance.</p> <div style="text-align: center;"> <p>North West Elevation</p> <p>☉ 124°SE (T) ● 36°57'34"N, 79°35'12"W ±98ft ▲ 930ft</p>

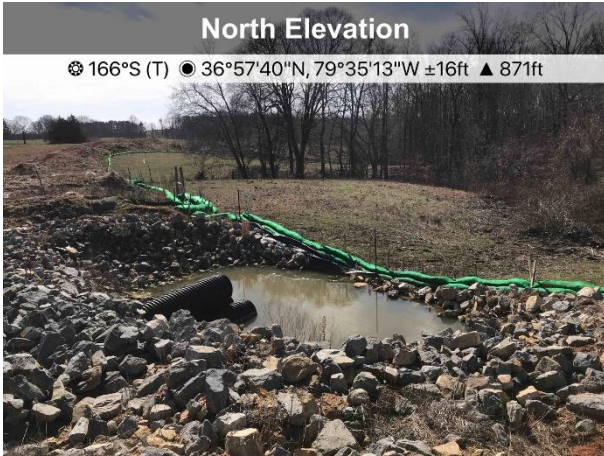
</div>
<p>▪ Figure 3: Near St 14537 CWD is in place.</p> <div style="text-align: center;"> <p>North Elevation</p> <p>☉ 166°S (T) ● 36°57'40"N, 79°35'13"W ±16ft ▲ 871ft</p>

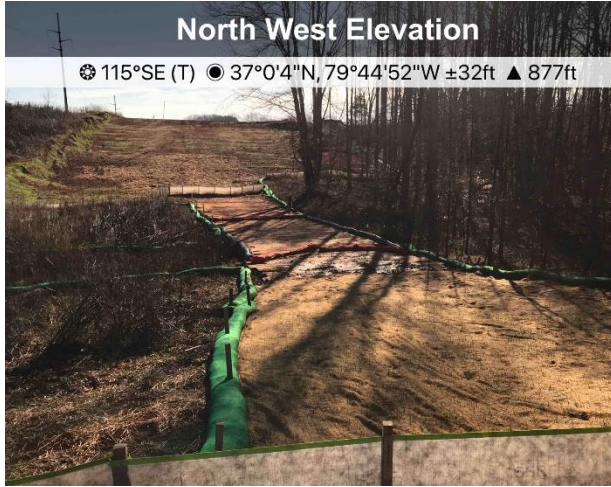
</div>	<p>- Figure 4: Designated crossing S-E18, ECD's are in place.</p> <div style="text-align: center;"> <p>North West Elevation</p> <p>☉ 115°SE (T) ● 37°0'4"N, 79°44'52"W ±32ft ▲ 877ft</p>
