FIELD INSPECTION

Project Name:	Mountain Valley Pipeline	Inspector:	Marshall Willis
Inspection Date:	Wednesday, February 27, 2019	Project Contact:	Brian Clauto
Spread I: Franklin County	STA 14209+75 – 14233+12	Weather (Wet/Dry/Rain):	Dry

FIELD INSPECTION PHOTO LOG

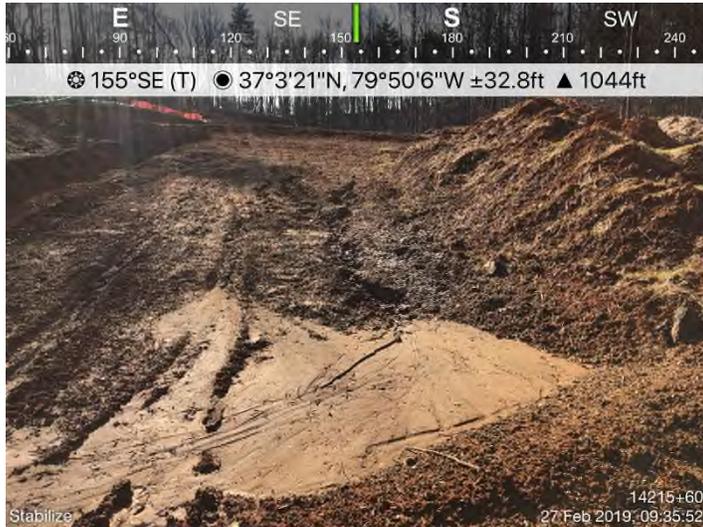
Fig. 1: **STA 14215+60** – Inadequate stabilization.

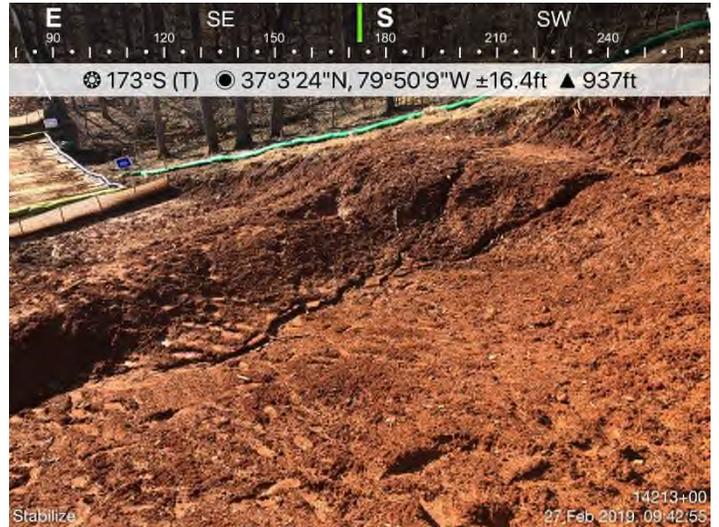
Fig. 2: **STA 14213+00** – Inadequate stabilization.

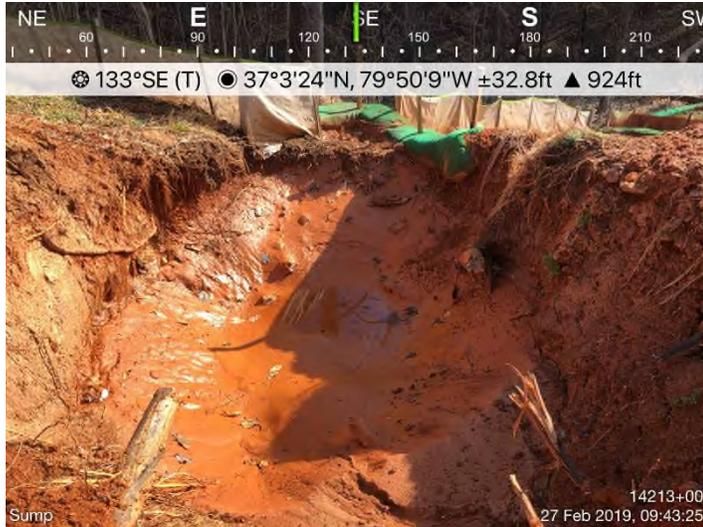
Fig. 3: **STA 14213+00** – Maintain sump.

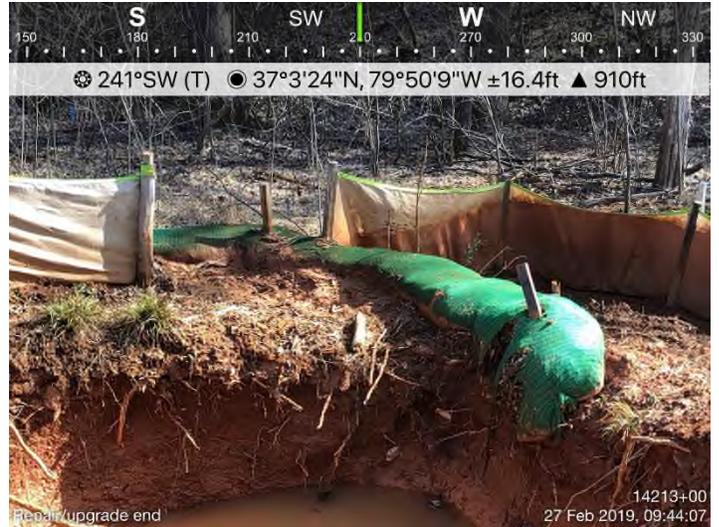
Fig. 4: **STA 14213+00** – Maintain CFS/upgrade end-treatment.

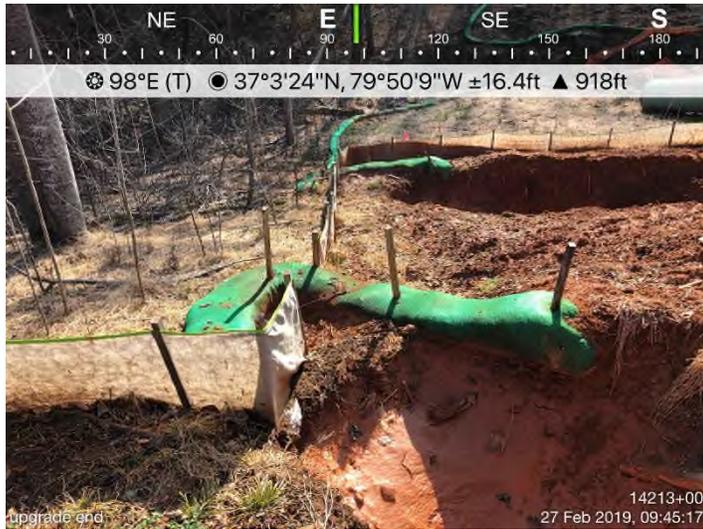
Fig. 5: **STA 14213+00** – Upgrade end-treatment. Discharge unable to exit ROW.

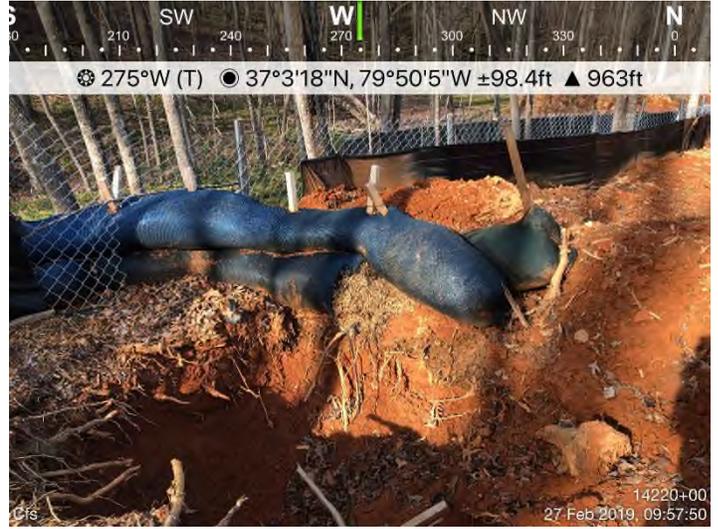
Fig. 6: **STA 14220+00** – Maintain CFS.

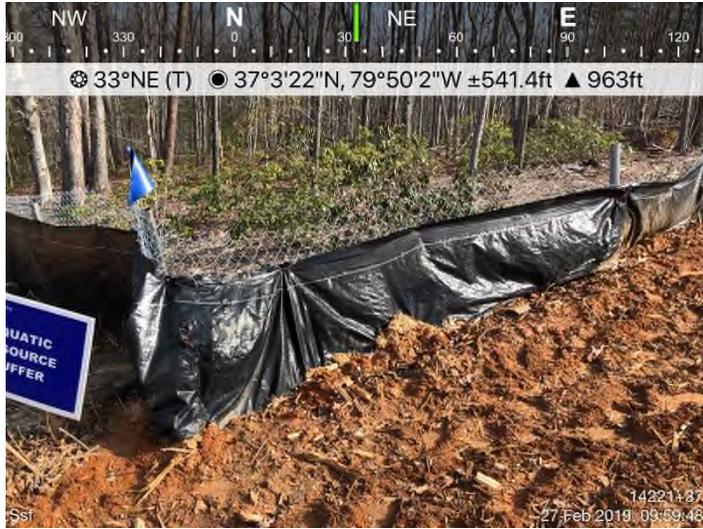
Fig. 7: **STA 14221+37** – Maintain SSF.

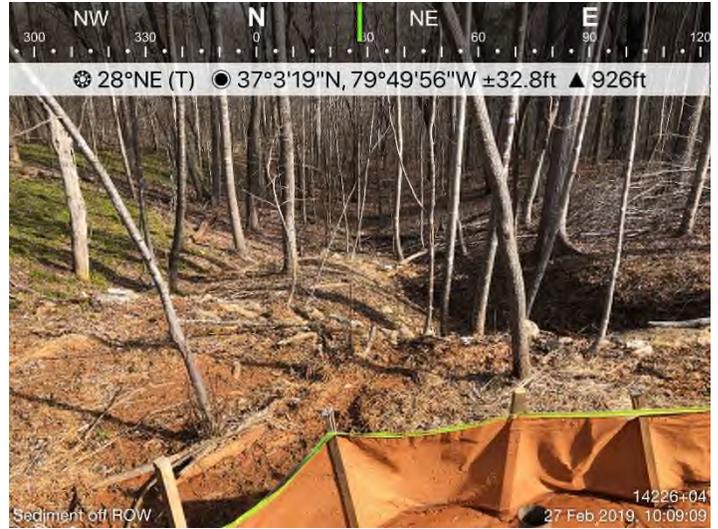
Fig. 8: **STA 14226+04** – Sediment off ROW.

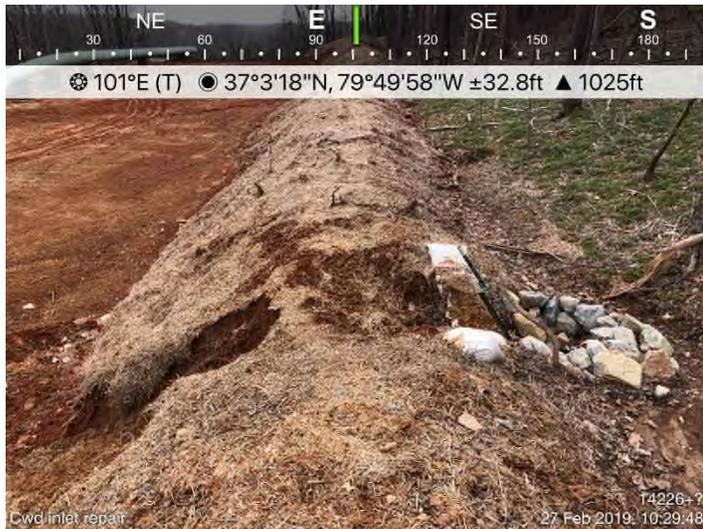
Fig. 9: STA 14226+25 – Repair CWD inlet.

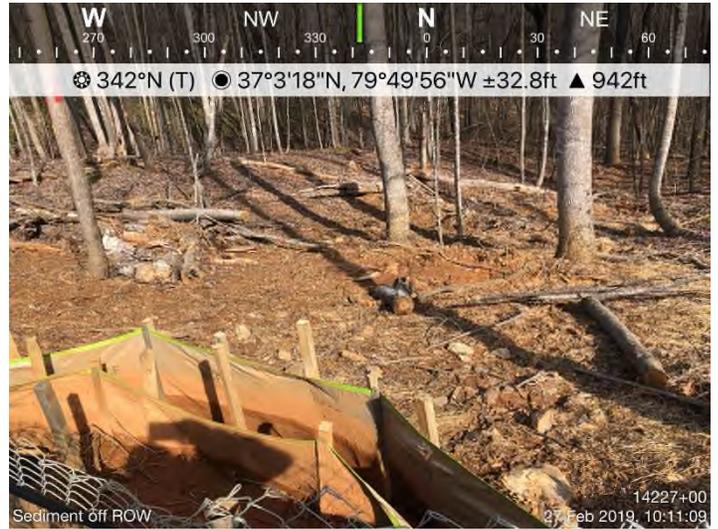
Fig. 10: STA 14227+00 – Sediment off ROW.

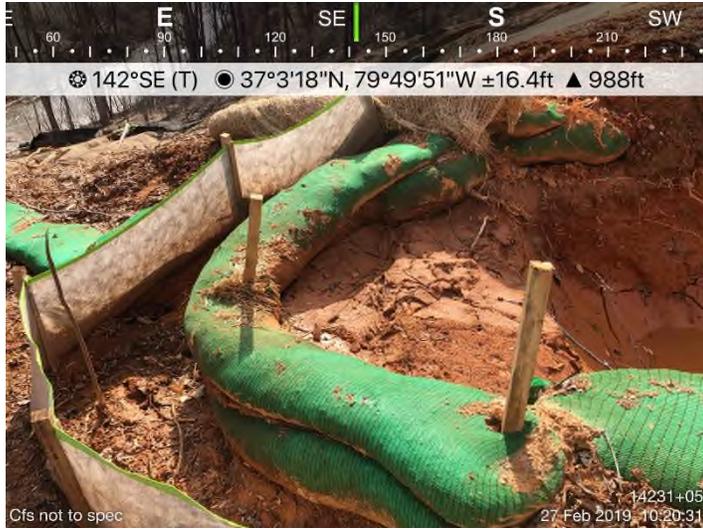
Fig. 11: STA 14331+05 – P1 undermined, CFS not installed per spec., sump full.

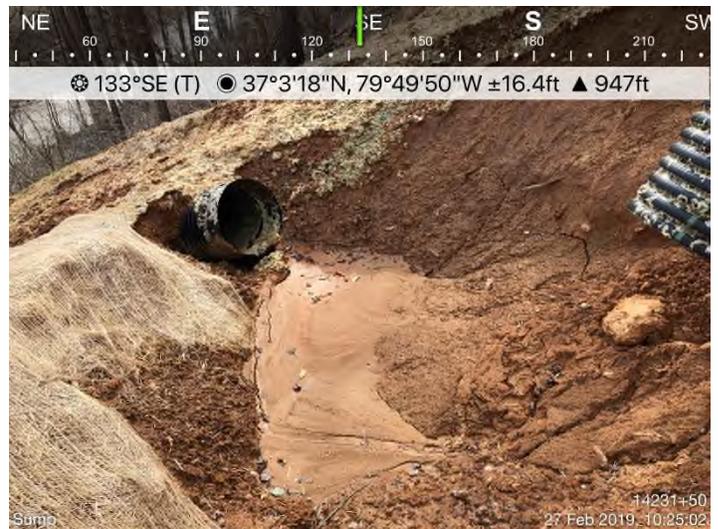
Fig. 12: STA 14231+50 – Sumps need maintenance.
