## FIELD INSPECTION REPORT

<b>Project Name:</b>	Mountain Valley Pipeline	<b>Inspector:</b>	Marshall Willis
<b>Inspection Date:</b>	Thursday, February 6, 2020	<b>Project Contact:</b>	Brian Clauto, Cory Chalmers
<b>Spread I: Franklin County</b>	STA 13996+56 – 14000+00 STA 14062+51 – 14066+77 STA 14171+36 – 14176+09 STA 14222+09 – 14224+45 STA 14233+12 – 14240+00 MVP-FR-306.02/311/300/302 MVP-MLV-AR-32	<b>Weather:</b>	Rainy

## FIELD INSPECTION PHOTO LOG

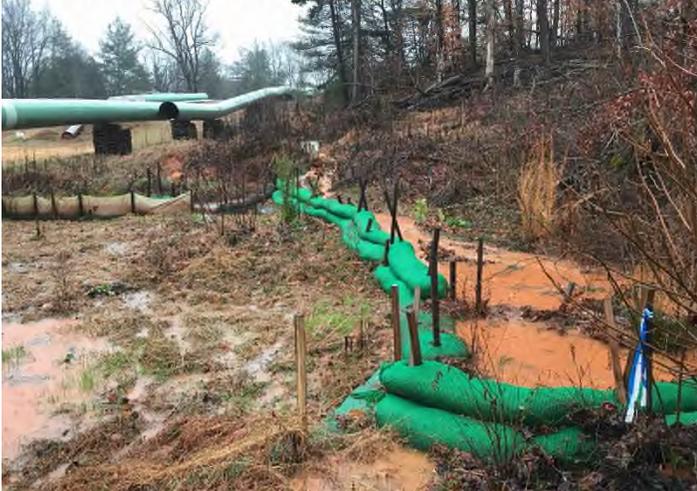
- Turbid stormwater run-on was documented entering the ROW at approx. STA 13996+00. Source of turbid discharge appears to be a logging operation located on private property above the ROW. Turbid water was treated by MVP ESCs prior to entering stream S-KL36. See Figures 1 and 2.

**Figure 1: STA 13996+50** – Turbid stormwater discharge from offsite and upslope logging operation. Run-on treated by MVP ESC prior to entering stream S-KL36.

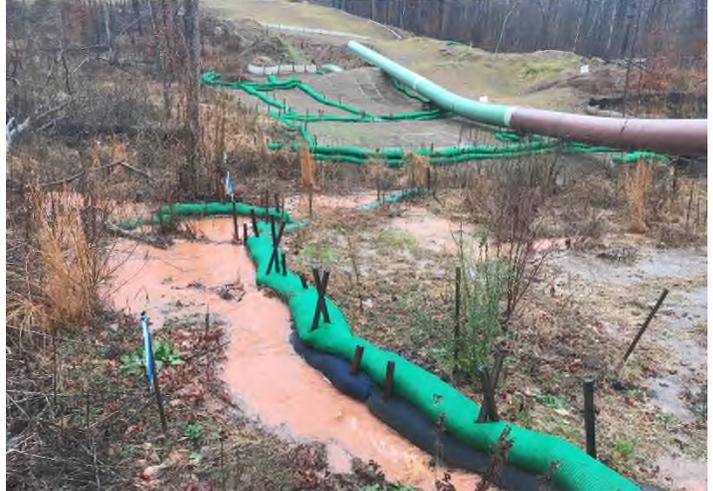
**Figure 2: STA 13996+50** – Turbid stormwater discharge from offsite and upslope logging operation. Run-on treated by MVP ESC prior to entering stream S-KL36.

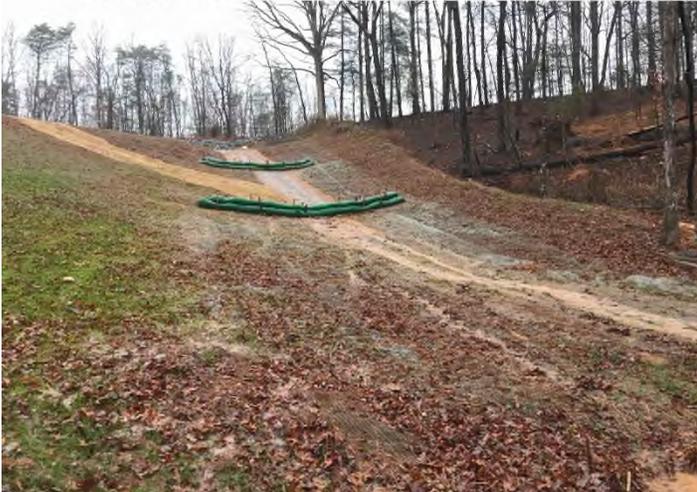
**Figure 3: STA 14064+50** – Controls in place and functioning properly.

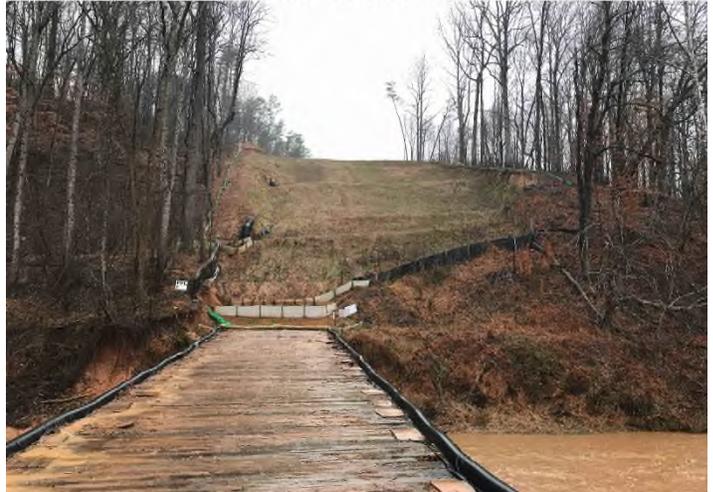
**Figure 4: STA 14233+50** – Maggodee Creek crossing looking W. Controls in place and functioning properly.
