FIELD INSPECTION

Project Name:	Mountain Valley Pipeline	Inspector:	Marshall Willis
Inspection Date:	Thursday, March 14, 2019	Project Contact:	Brian Clauto
Spread I: Franklin County	STA 14802+17 – 14881+54 LY 045/046	Weather (Wet/Dry/Rain):	Dry

FIELD INSPECTION PHOTO LOG

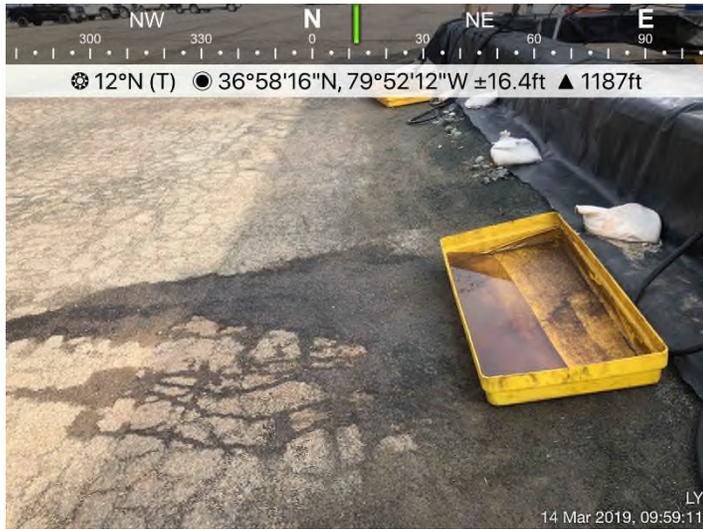
Fig. 1: LY 045/046 – Clean out secondary containment. Clean up and properly document diesel spill immediately.

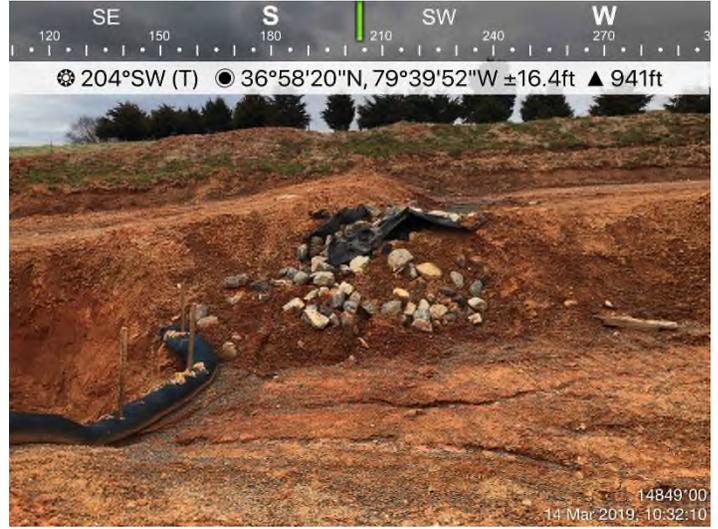
Fig. 2: STA 14849+00 – Repair/maintain slope protection.

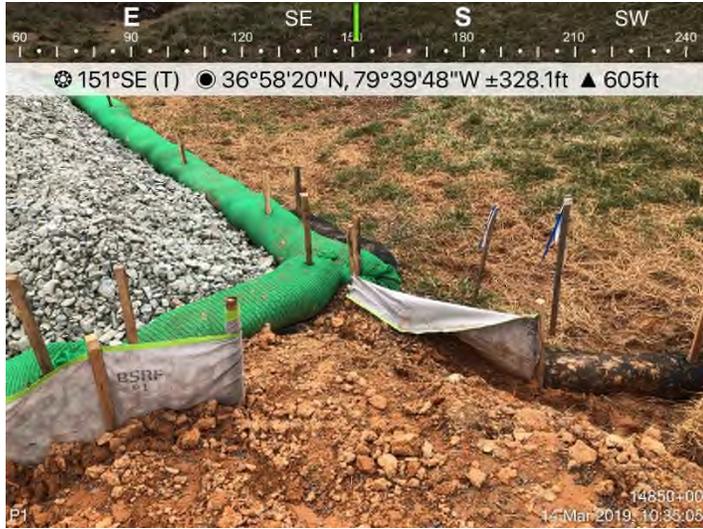
Fig. 3: STA 14850+00 – Maintain P1.

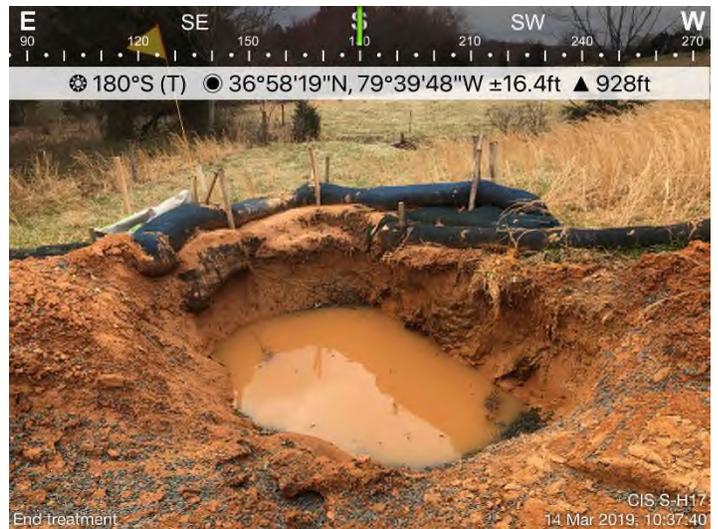
Fig. 4: STA 14852+00 – Repair/maintain end treatment.

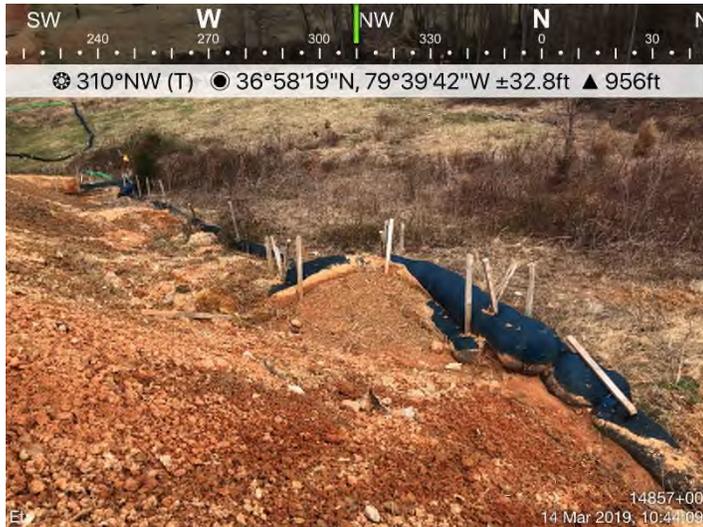
Fig. 5: STA 14857+00 – Maintain CFS.

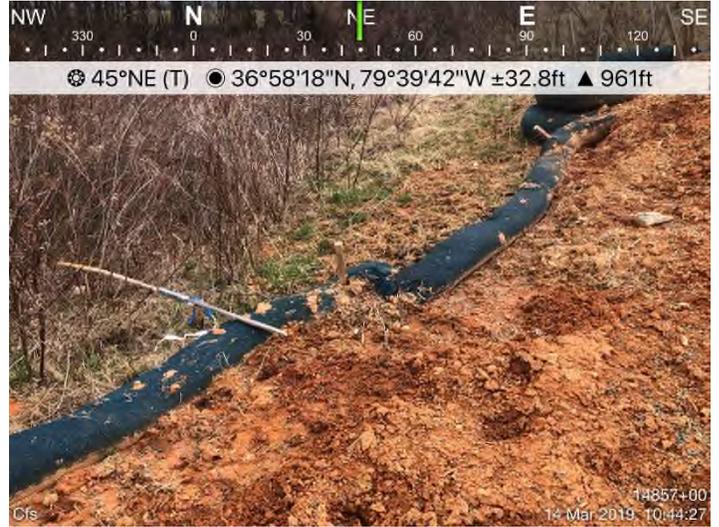
Fig. 6: STA 14857+00 – Repair/maintain CFS.

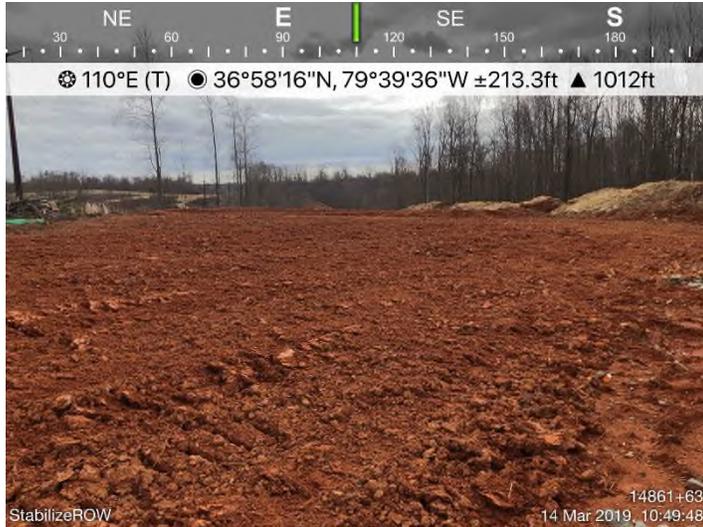
Fig. 7: STA 14861+63 – 14881+54 – Stabilize ROW.

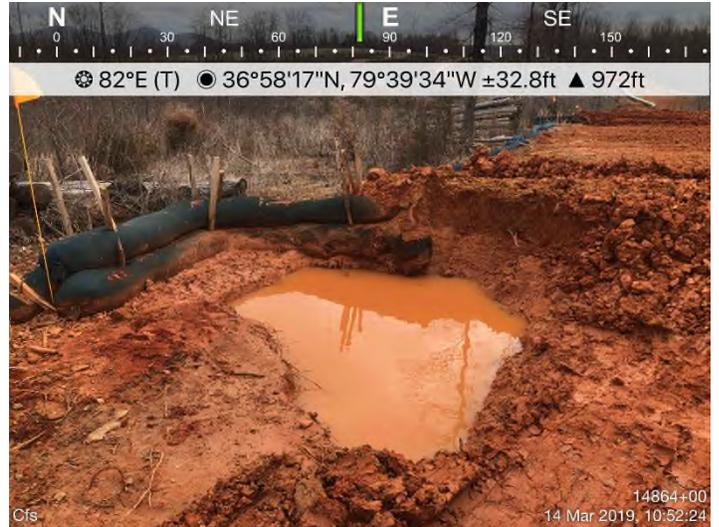
Fig. 8: STA 14864+00 – Repair/maintain end treatment.

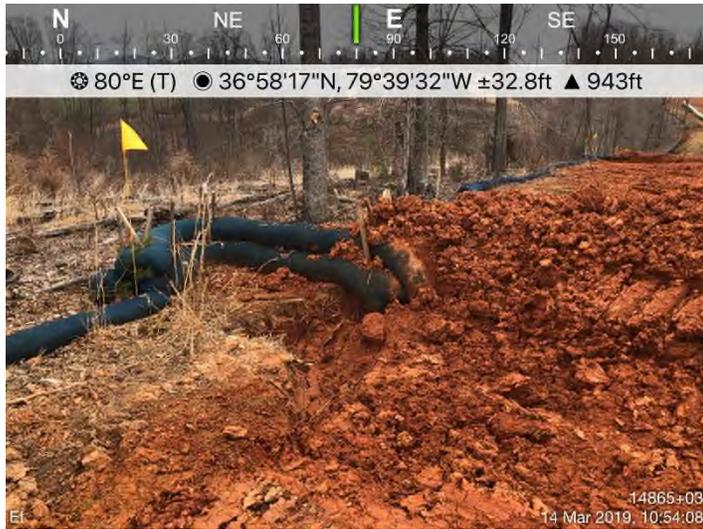
Fig. 9: STA 14865+03 – Install sump per PSS&S.

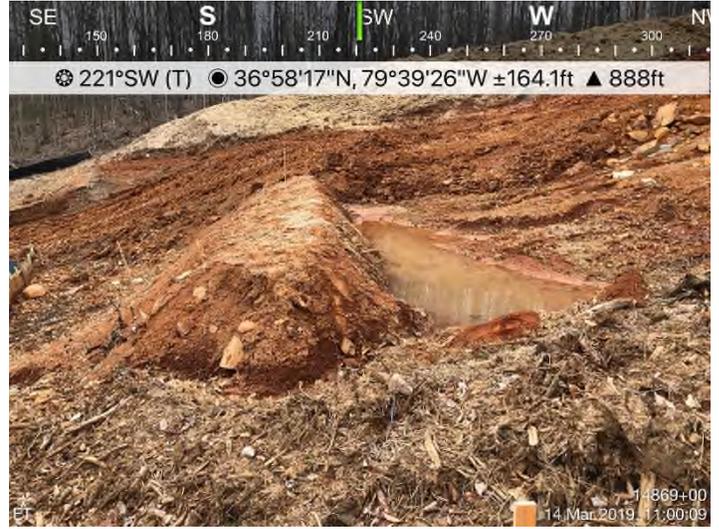
Fig. 10: STA 14869+00 – Install waterbar and end treatment per PSS&S.

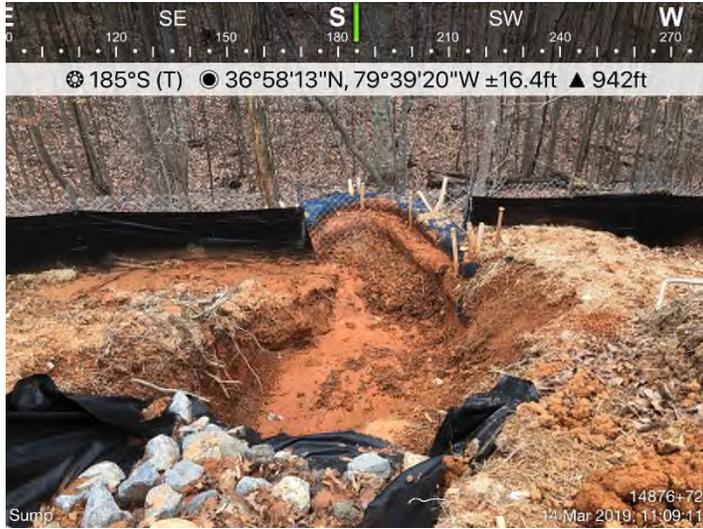
Fig. 11: STA 14876+72 – Maintain/cleanout sump.

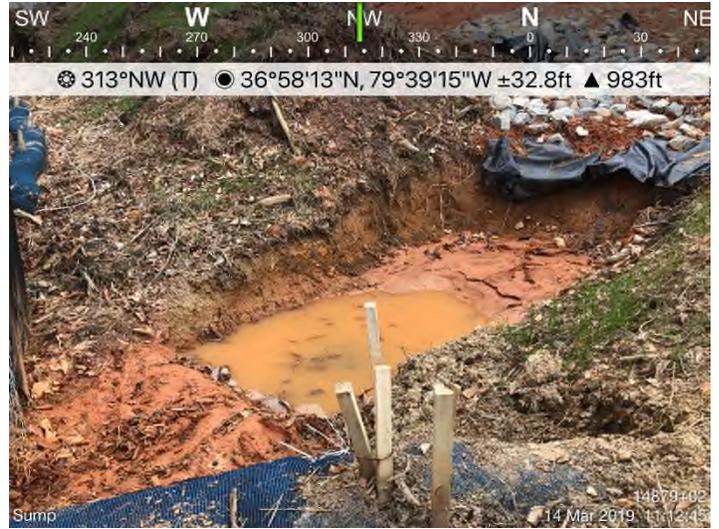
Fig. 12: STA 14879+02 – Maintain/cleanout sump.

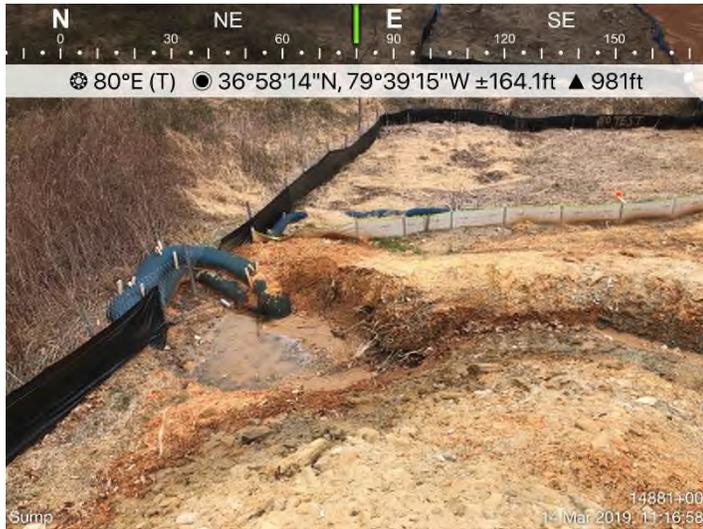
Fig. 13: **STA 14881+00** – Maintain/cleanout sump.

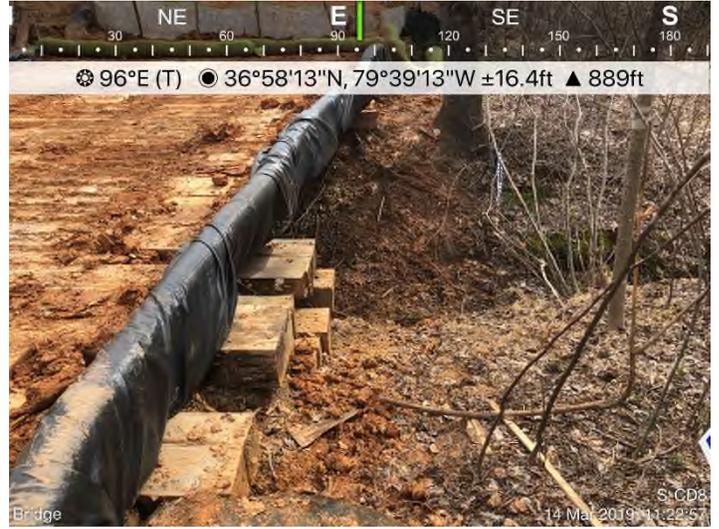
Fig. 14: **S-CD8** – Clean bridge, remove sediment overflow, stabilize bank.

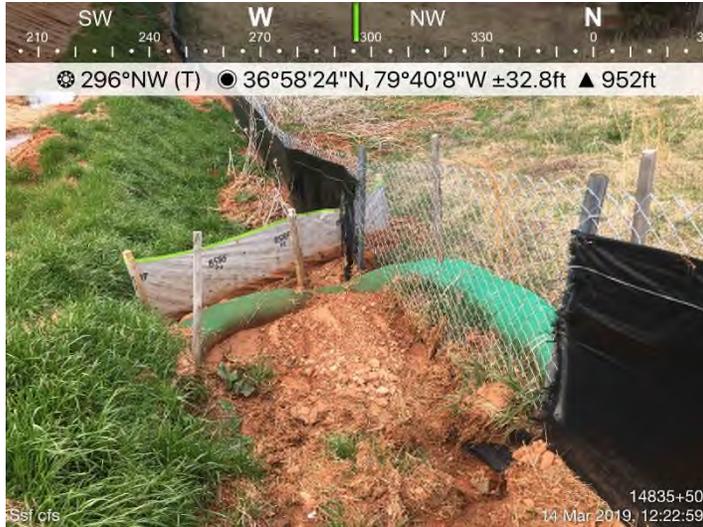
Fig. 15: **STA 14835+50** – Clean out/maintain CFS. Repair SSF.

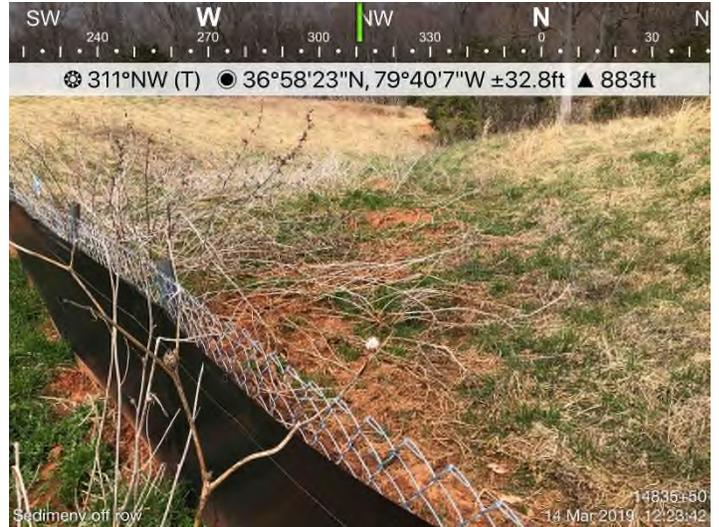
Fig. 16: **STA 14835+50** – Sediment off ROW.
