FIELD INSPECTION

Project Name:	Mountain Valley Pipeline	Inspector:	Matthew Grant
Inspection Date:	Wednesday, March 20, 2019	Project Contact:	Brian Clauto
Spread: Franklin County MP256-255 St1347-13496 MP261 St13818-13805	Spread I	Weather (Wet/Dry/Rain):	Dry

FIELD INSPECTION PHOTO LOG

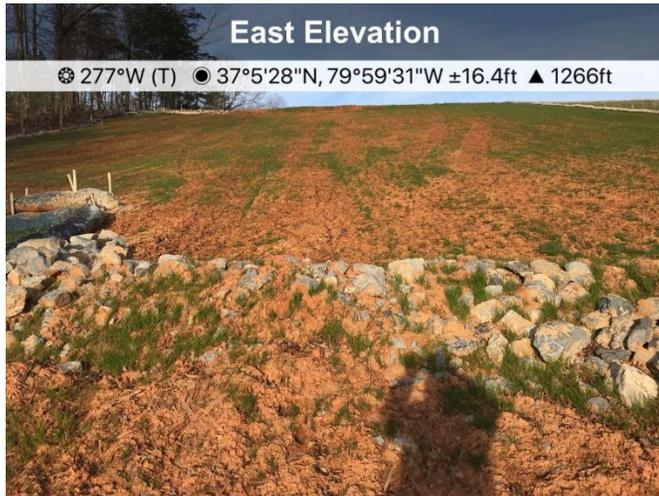
▪ Fig. 1 St#13539+14 Slope lacks adequate stabilization

Recommended Corrective Action: Maintain all controls per the approved plan and specs.

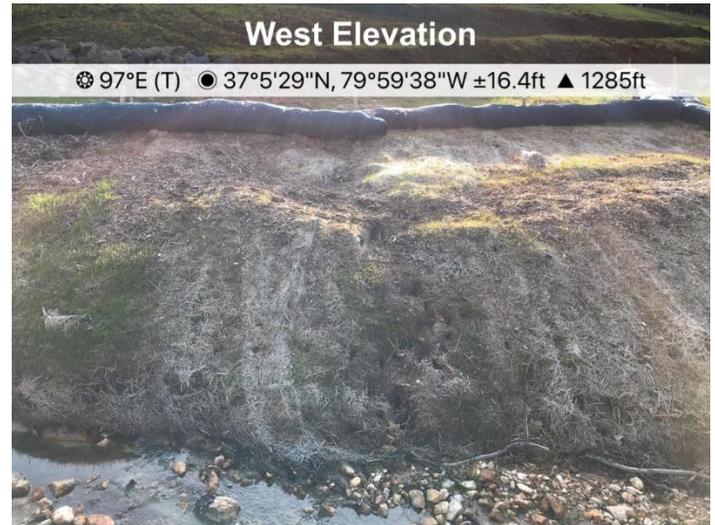
▪ Fig. 2 St#13533+52 Banks require repair and stabilization

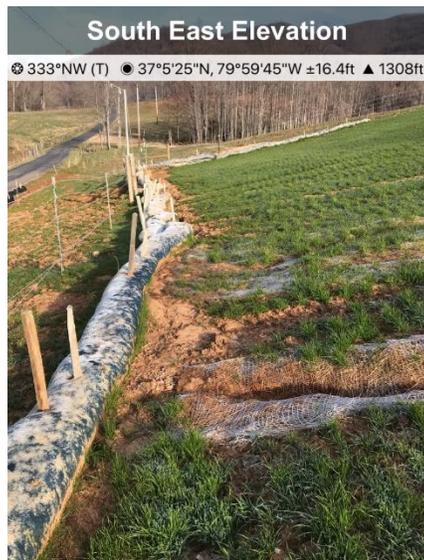
▪ Fig. 3 St#13528+00 Rills at farmer road crossing and CFS requires maintenance

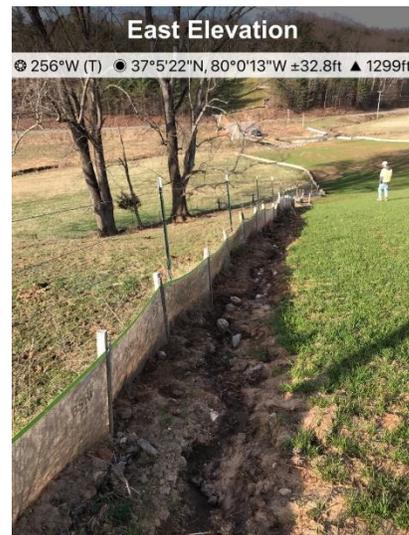
▪ Fig. 4 St#13500+00 Rill erosion along P1 SF and J-hook is overtopped

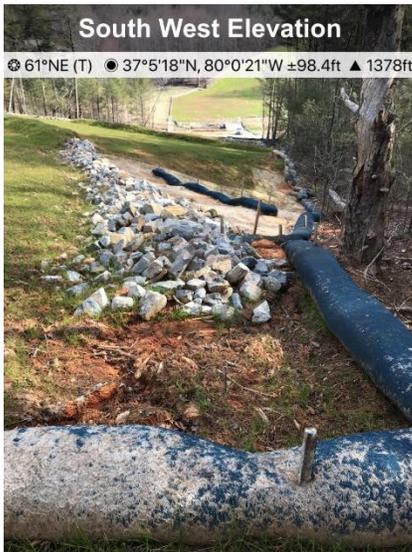
▪ Fig. 5 St#13494+00 Rill erosion above blanket matting

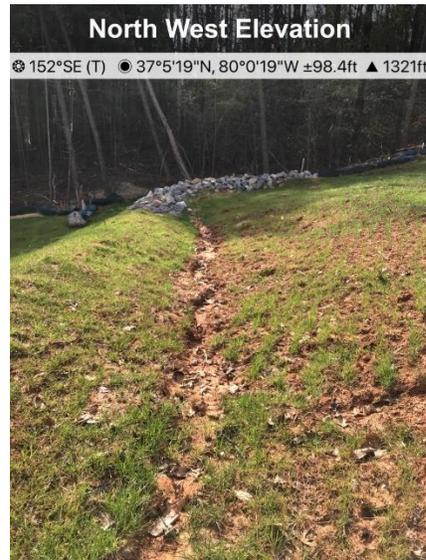
▪ Fig. 6 St#13496+00 Flow path of waterbar eroded

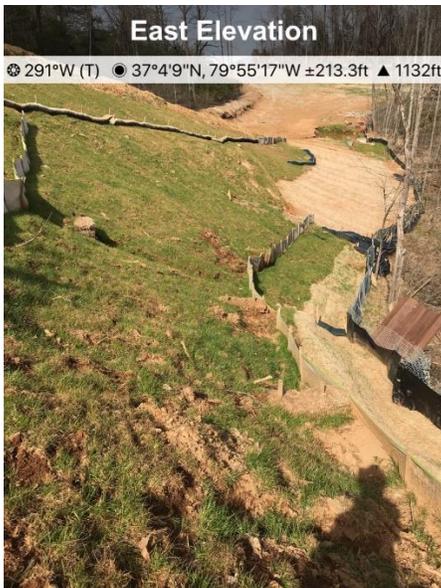
▪ Fig. 7 St#13818+60 P1 half the height with sediment/possible slip
