## FIELD INSPECTION

Project Name:	Mountain Valley Pipeline	Inspector:	Marshall Willis
Inspection Date:	Wednesday, March 20, 2019	Project Contact:	Brian Clauto
Spread I: Franklin County	STA 13755+49 – 13784+95	Weather (Wet/Dry/Rain):	Dry

# FIELD INSPECTION PHOTO LOG

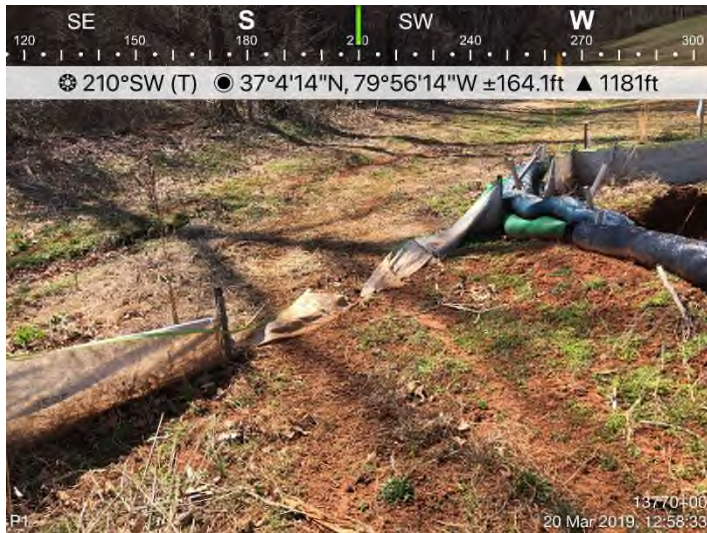
Fig. 1: **STA 13770+00** – Repair P1.

**Recommended Corrective Action:** Maintain and install all controls per the approved plan and specs.

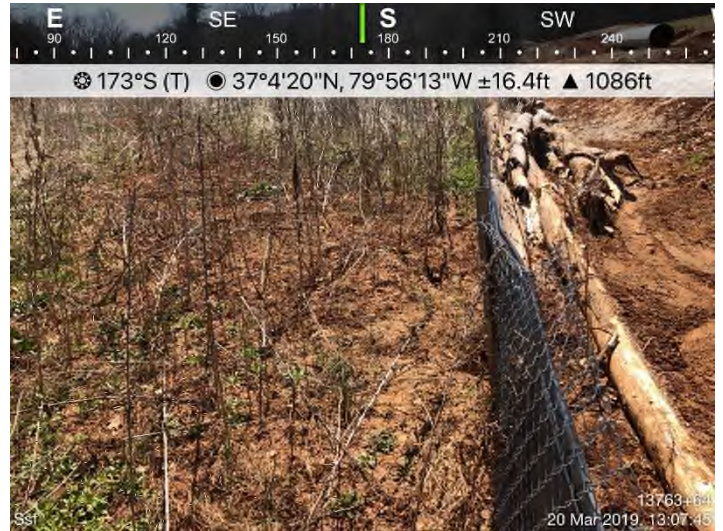
Fig. 2: **STA 13763+64** – SSF undermined. Sediment off ROW.

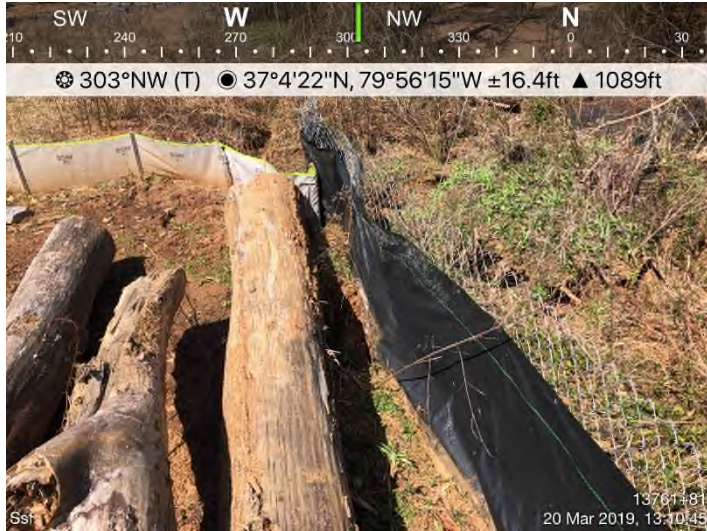
Fig. 3: **STA 13761+87** – SSF undermined.

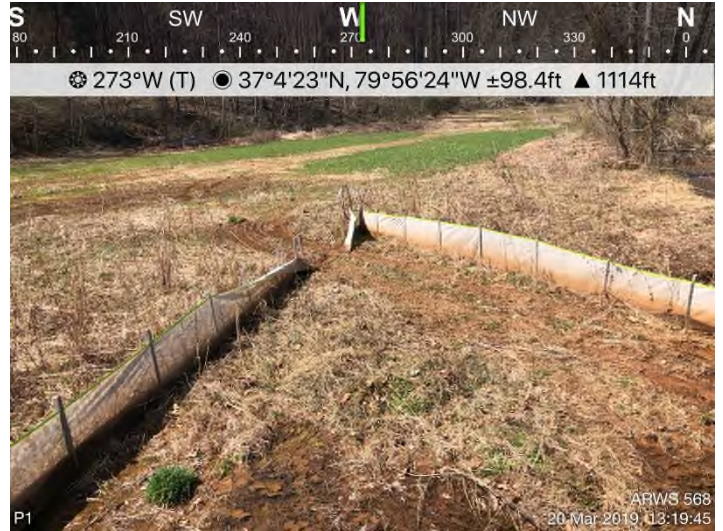
Fig. 4: **ATWS 568** – Repair P1.
