FIELD INSPECTION

| Project Name: | Mountain Valley Pipeline | Inspector: | Matthew Grant |
| Inspection Date: | Wednesday, March 27, 2019 | Project Contact: | Brian Clauto |
| Spread: Pittsylvania County MP287-288 MP293-295 St15498-15584 | Spread I | Weather (Wet/Dry/Rain): | Dry |

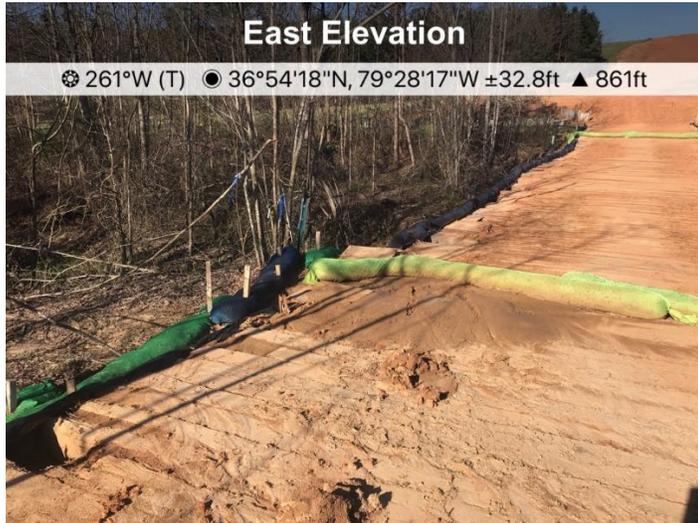
- Fig. 1 St#15508+15 CFS on bridge and to the side of bridge requires clean out.

Recommended Corrective Action: Maintain all controls per the approved plan and specs, remove sediment per DEQ approval.

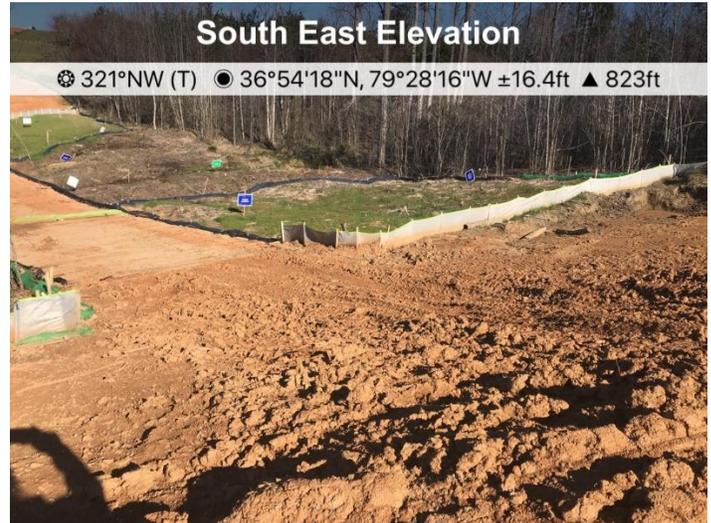
- Fig. 2 St#15508+55 stabilization from waterbar to the stream crossing bridge requires stabilization

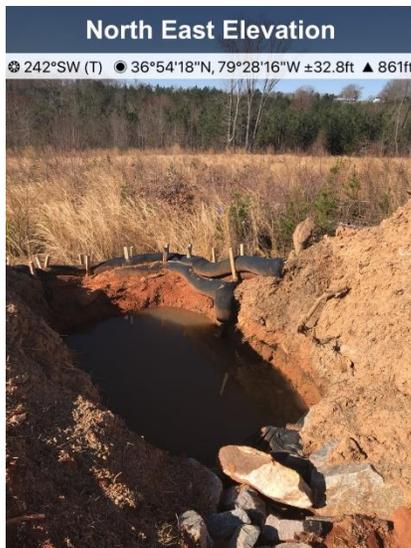
- Fig. 3 St# 15514+00 sump end treatment is falling into sump

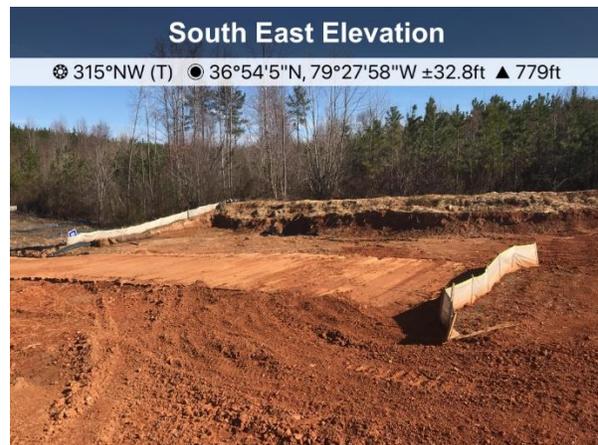
- Fig. 4 St# St#15529+00 stabilization from waterbar to the stream crossing bridge requires stabilization

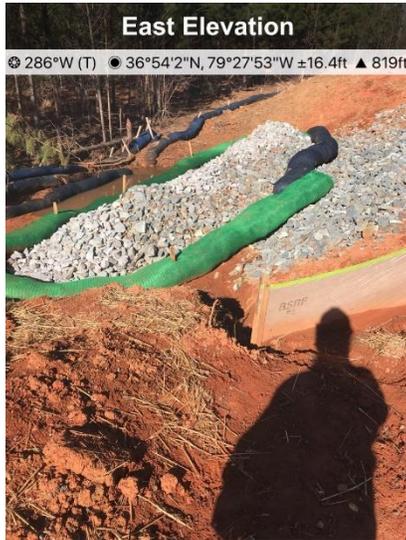
- Fig. 5 St#15534+00 P1 fence near CWD has eroded on side

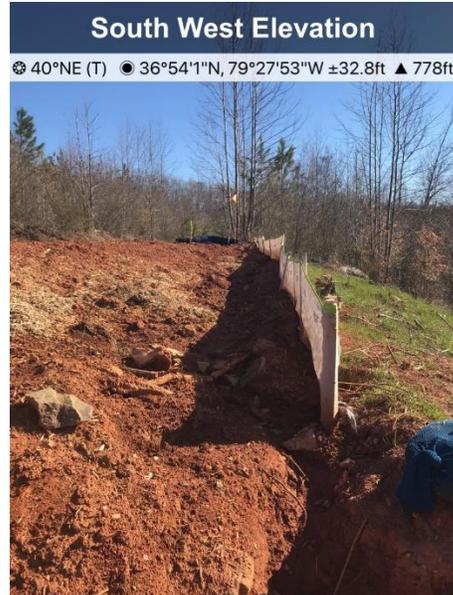
- Fig. 6 St#15541+00 sump not allowing water off of the ROW

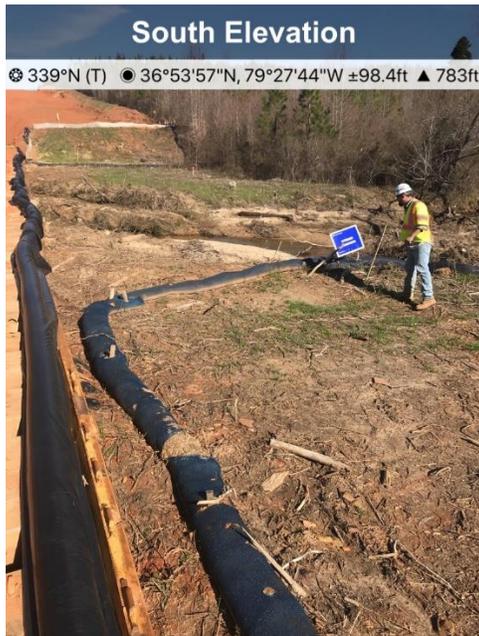
- Fig. 7 St#15543+00 at SCC5 buffer area CFS has a hole in it

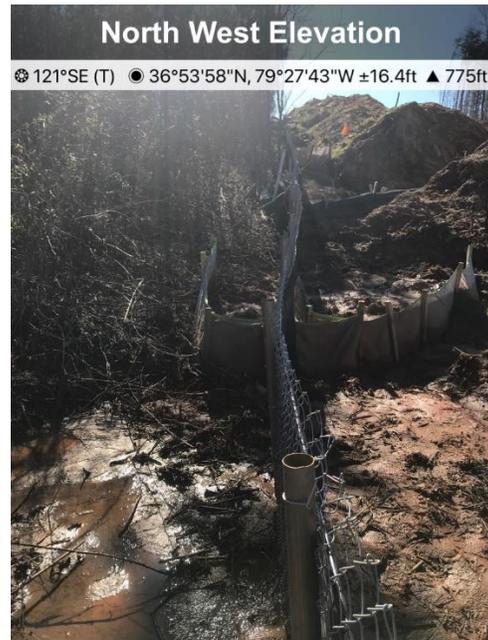
- Fig. 8 St#15543+20 sediment has escaped off of ROW

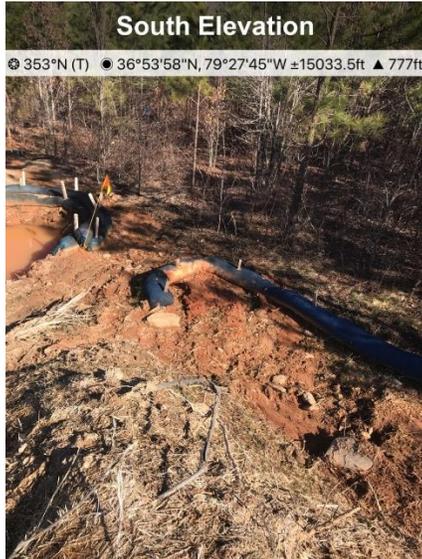
- Fig. 9 St#15546+00 CFS at j hook is full

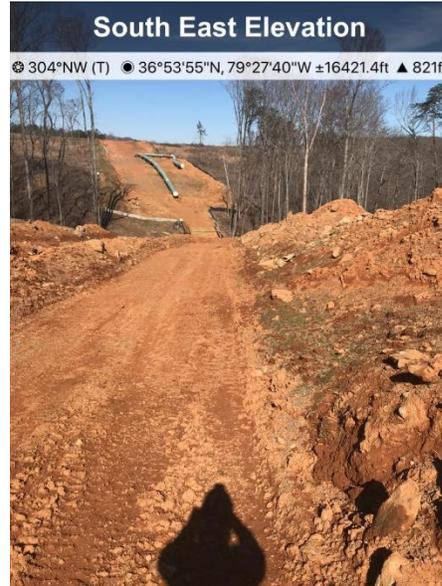
- Fig. 10 St#15564+70 waterbar does not go the full length

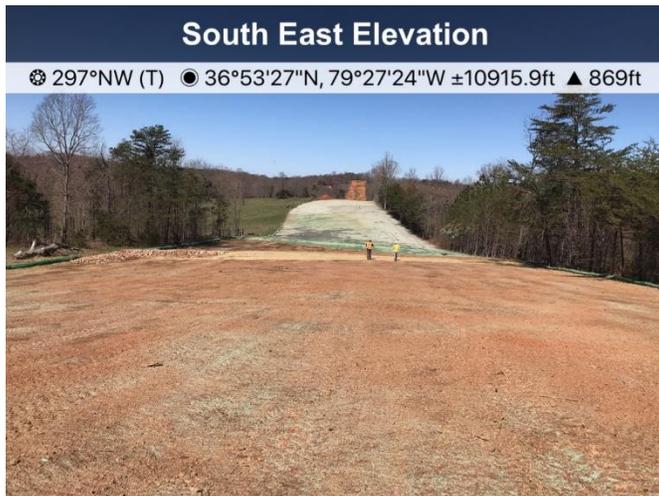
- Fig. 11 Near MP287 final restoration in process
