FIELD INSPECTION REPORT

Project Name:	Mountain Valley Pipeline	Inspector:	Marshall Willis
Inspection Date:	Thursday, March 5, 2020	Project Contact:	Brian Clauto, Cory Chalmers
Spread I: Pittsylvania County	STA 15647+03 – 15743+08 MVP-PI-336.01/337 ATWS 1392/497/498/625/626/627	Weather:	Dry

FIELD INSPECTION PHOTO LOG

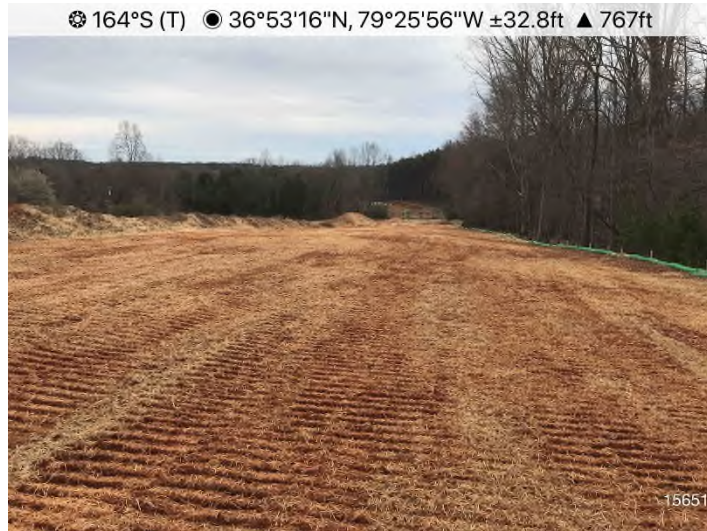
Figure 1: STA 15651+00 – Controls in place and functioning properly.

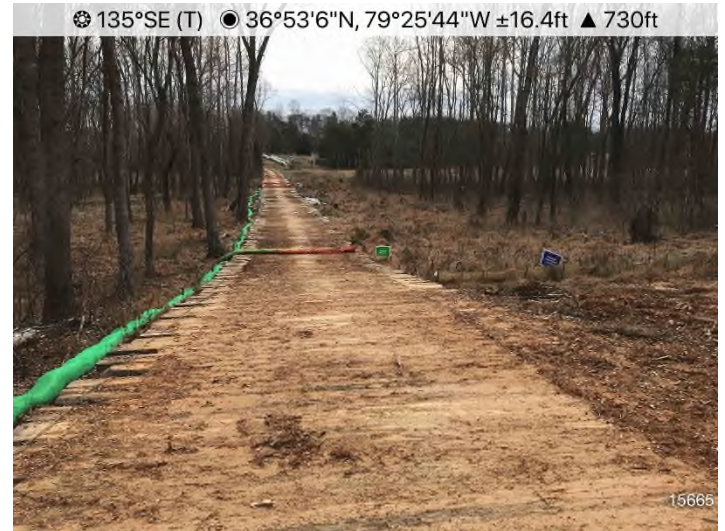
Figure 2: STA 15665+00 – Controls in place and functioning properly.

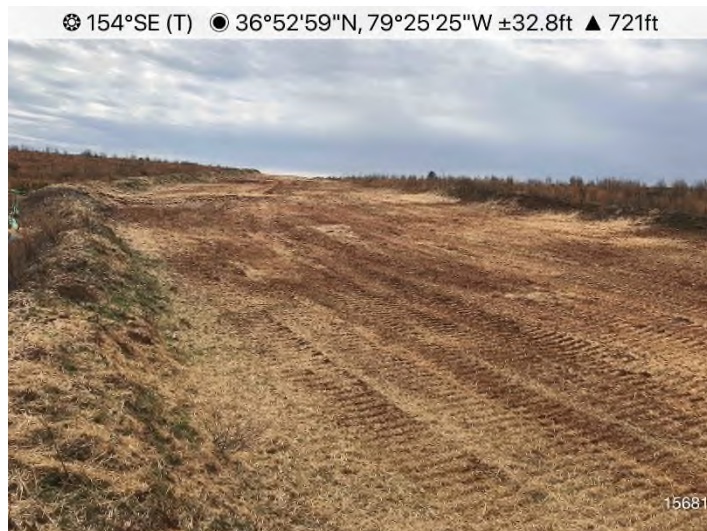
Figure 3: STA 15681+00 – Controls in place and functioning properly.

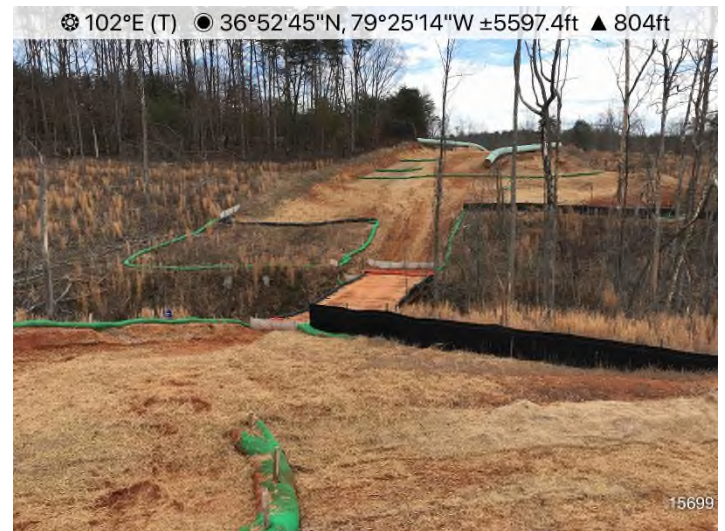
Figure 4: STA 15699+00 – Controls in place and functioning properly.
