## FIELD INSPECTION

Project Name:	Mountain Valley Pipeline	Inspector:	Matthew Grant
Inspection Date:	Wednesday, April 10, 2019	Project Contact:	Brian Clauto
Spread: Franklin County FR34 MP271 St#14354 MP263-265 St#13948-14000	Spread I	Weather (Wet/Dry/Rain):	Dry

## FIELD INSPECTION PHOTO LOG

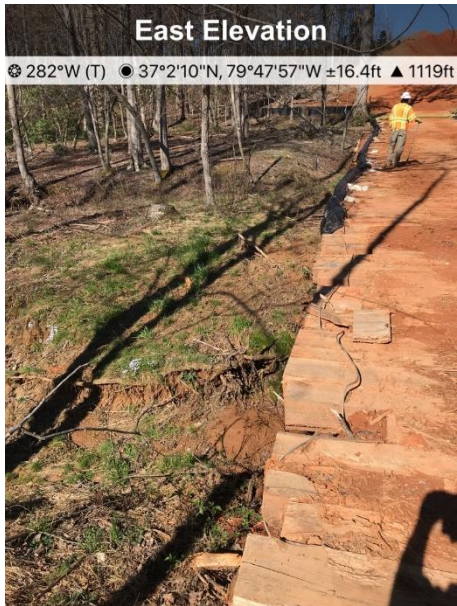
- Fig. 1 Designated stream SA-40 has been impacted this area was inspected and noted for corrective action on 4-9-19.

**Recommended Corrective Action:** Maintain all controls per the approved plan and specs, remove sediment per DEQ approval.

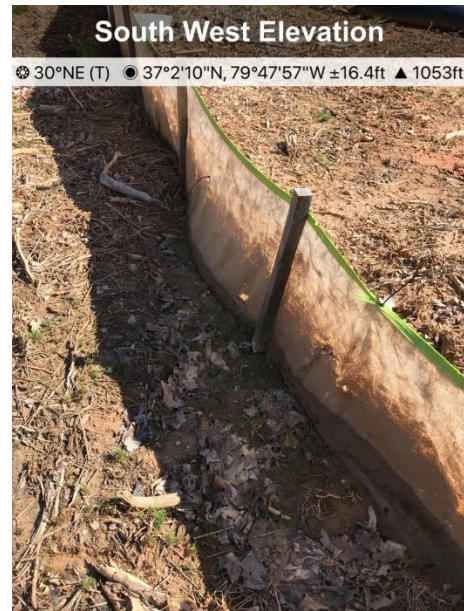
- Fig. 2 St#14354+10 hole in P1 fence

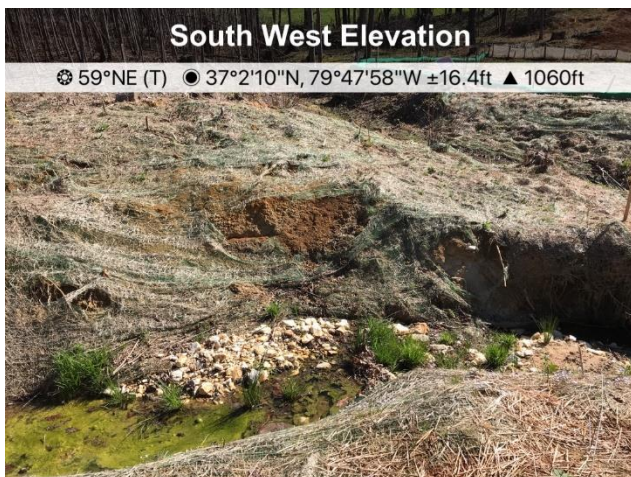
- Fig. 3 St#14353+17 bank stabilization matting has fallen off slope

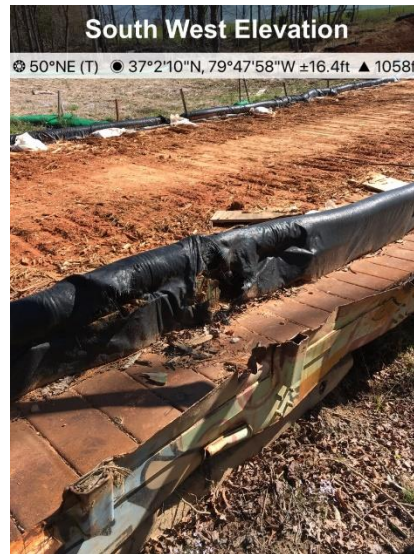
- Fig. 4 St#14354+20 hole in sidewall protection of bridge

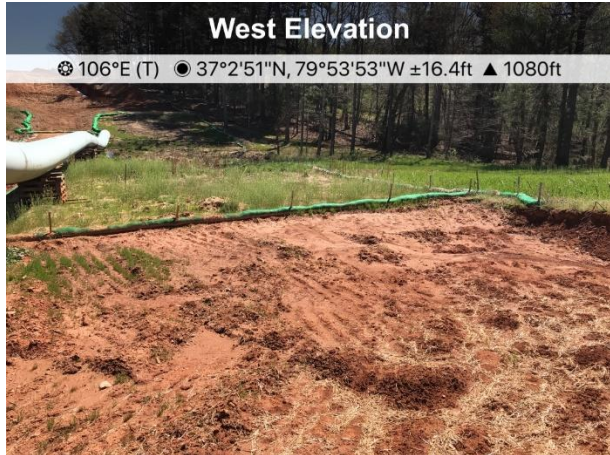
- Fig. 5 St#13948+80 re-stabilization required before aquatic resource

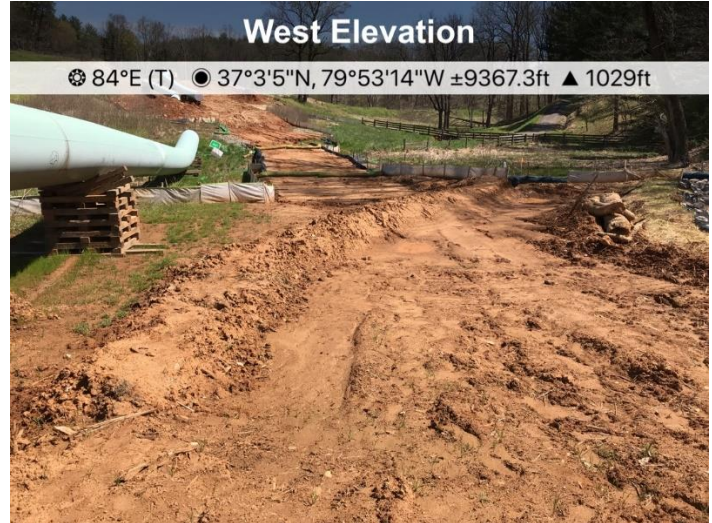
- Fig. 6 St#13990+31 re-stabilization required before aquatic resource
