## FIELD INSPECTION

| Project Name: | Mountain Valley Pipeline | Inspector: | Marshall Willis |
| Spread I:<br>Franklin County | STA 14524+76 – 14549+84<br>STA 14616+62 – 14649+47 | Weather (Wet/Dry/Rain): | Rainy |

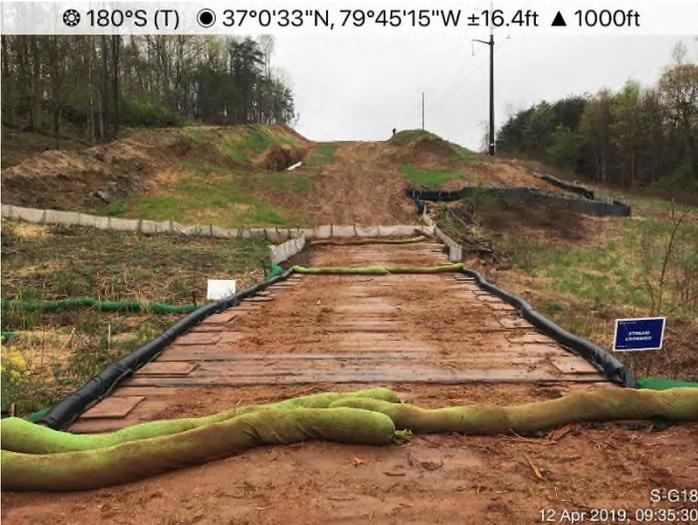
Comments: Inspected the following resources: S-G18.

| <p>Fig. 1: <b>S-G18</b> – Controls in place.</p> <p style="text-align: center;">☉ 180°S (T) ● 37°0'33"N, 79°45'15"W ±16.4ft ▲ 1000ft</p> <p style="text-align: right; font-size: small;">S-G18<br/>12 Apr 2019, 09:35:30</p> | <p>Fig. 2: <b>STA 14532+00</b> – Repair/replace waddle.</p> <p style="text-align: center;">☉ 8°N (T) ● 37°0'32"N, 79°45'15"W ±16.4ft ▲ 1044ft</p> <p style="text-align: right; font-size: small;">14532+00<br/>Waddle<br/>12 Apr 2019, 09:33:53</p> |

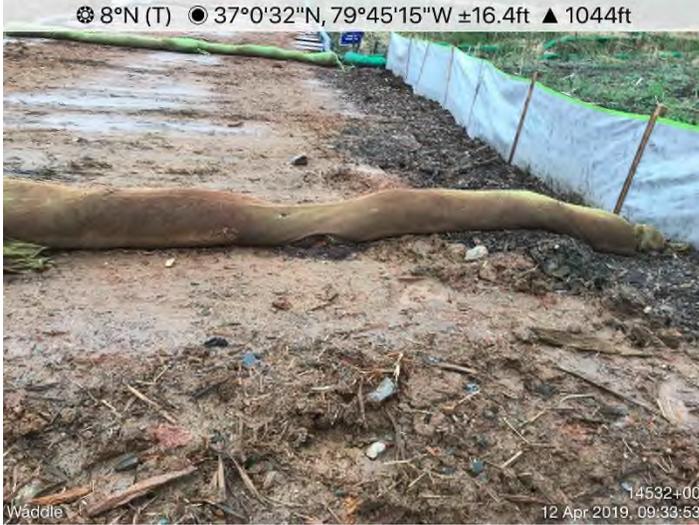
- STA 14532+00: Replace waddle.
- STA 14533+00: Waterbar not per spec.
- STA 14533+00: CWD does not have inlet protection. Inlet elevation too high.

**Recommended Corrective Action:** Maintain and install all controls per the approved plan and specs.

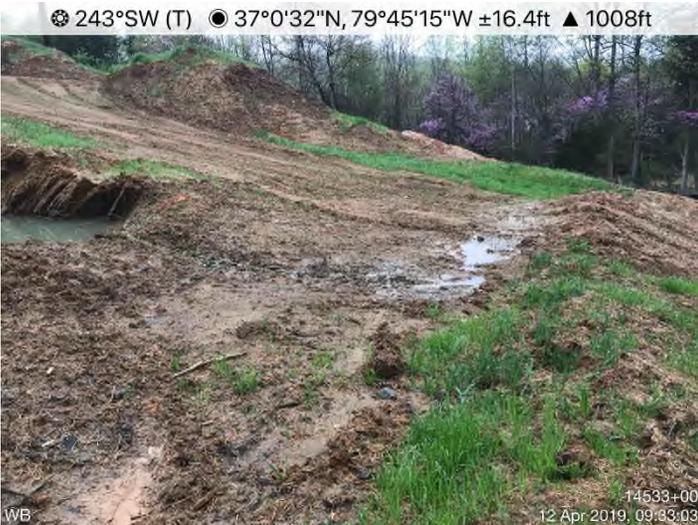
| <p>Fig. 3: <b>STA 14533+00</b> – Waterbar not per spec.</p> <p style="text-align: center;">☉ 243°SW (T) ● 37°0'32"N, 79°45'15"W ±16.4ft ▲ 1008ft</p> <p style="text-align: right; font-size: small;">14533+00<br/>WB<br/>12 Apr 2019, 09:33:03</p> | <p>Fig. 4: <b>STA 14533+00</b> – No inlet protection. Inlet too high.</p> <p style="text-align: center;">☉ 169°S (T) ● 37°0'31"N, 79°45'15"W ±16.4ft ▲ 1017ft</p> <p style="text-align: right; font-size: small;">14533+00<br/>CWD<br/>12 Apr 2019, 09:30:20</p> |
