FIELD INSPECTION

Project Name:	Mountain Valley Pipeline	Inspector:	Marshall Willis
Inspection Date:	Thursday, April 18, 2019	Project Contact:	Brian Clauto
Spread I: Franklin County	STA 14712+33 – STA 14730+00 STA 13541+73, STA 13416+00 STA 14549+84, STA 14532+00	Weather (Wet/Dry/Rain):	Dry

FIELD INSPECTION PHOTO LOG

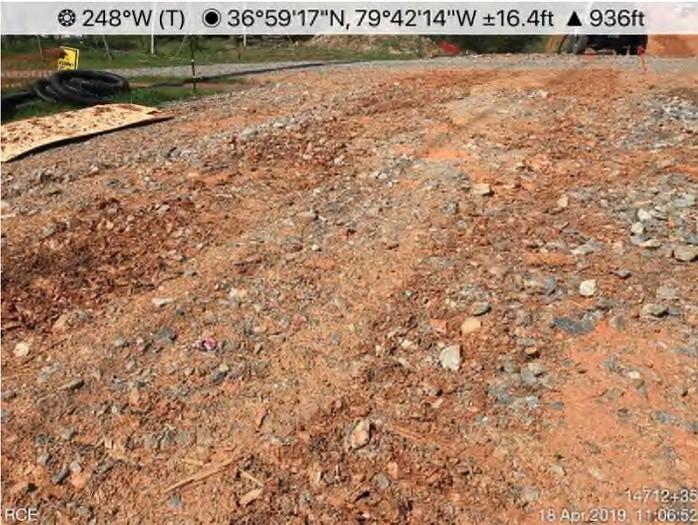
STA 13416+00: Sediment off ROW potentially impacting W-IJ3.
 STA 14712+35: Maintenance required on RCEs.
 STA 14719+37: Maintenance required on RCEs.
 STA 14719+37: Adequately stabilize ATWS 1279.
 STA 14722+11: Sump and CFS clean out in ATWS 1279.
 STA 14727+07: CFS and end treatment repair CIS of S-A19.
 STA 14727+00 – 14728+00: Stabilize stockpiles around S-A19/A20.

<p>Fig. 1: STA 14712+35 – Repair/maintain RCEs.</p>

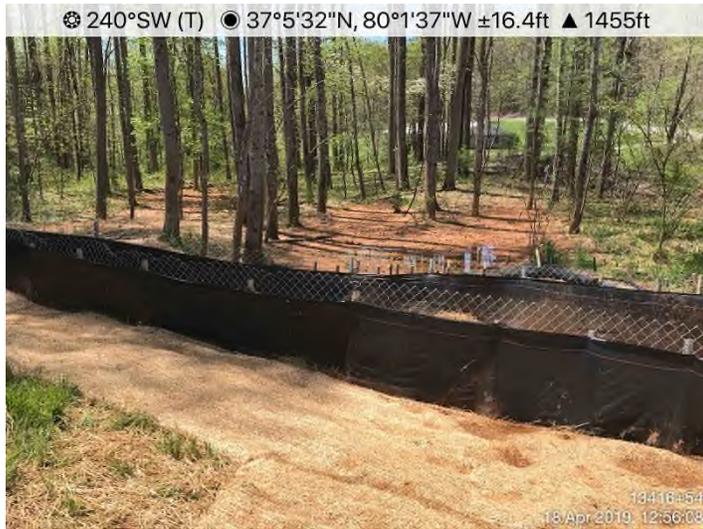
Fig. 9: STA 13416+00 – Sediment off ROW. Potential impact to W-IJ3.

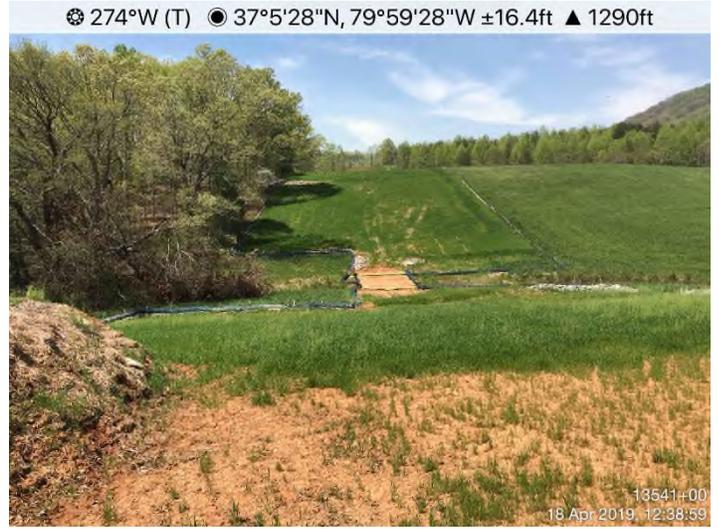
Fig. 10: STA 13541+00: Controls in place.in place.

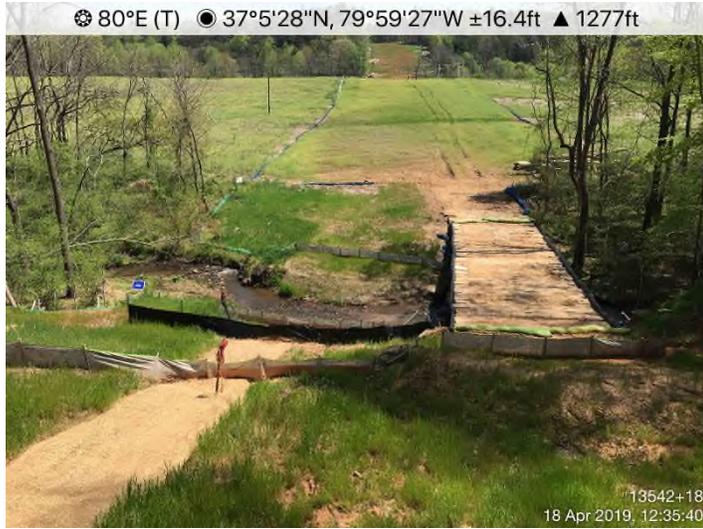
Fig. 11: STA 13542+18: Controls in place.

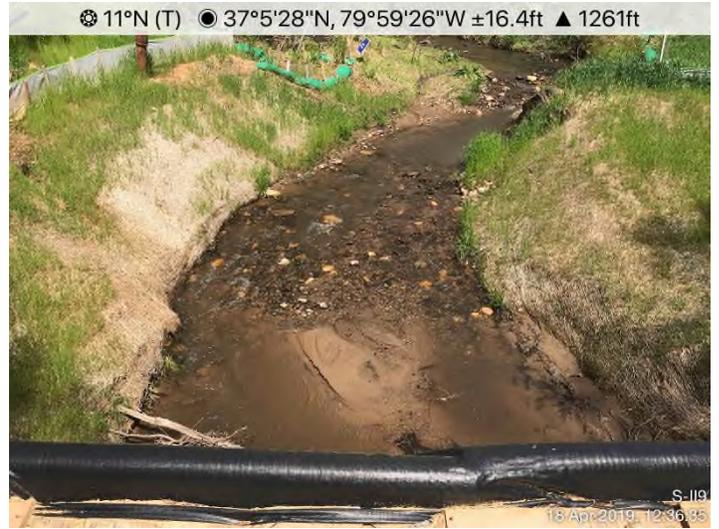
Fig. 12: S-II9 – Controls in place. Banks Stabilized.
