FIELD INSPECTION

Project Name:	Mountain Valley Pipeline	Inspector:	Marshall Willis
Inspection Date:	Friday, April 19, 2019	Project Contact:	Brian Clauto
Spread I: Franklin County	STA 14062+17 – STA 14072+87 STA 13541+66, STA 13496+76 STA 13415+91, STA 13690+91	Weather (Wet/Dry/Rain):	Rainy

FIELD INSPECTION PHOTO LOG

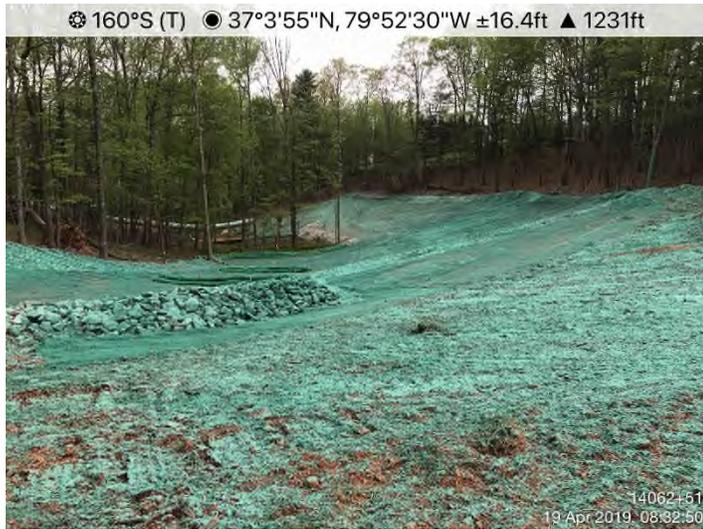
Fig. 1: **STA 14062+51** – Controls in place.

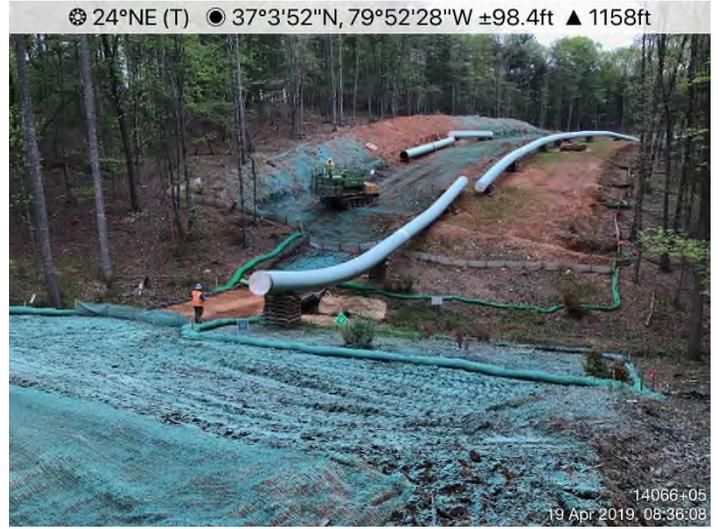
Fig. 2: **14066+05** – Controls in place. Hydro-seeding in progress.

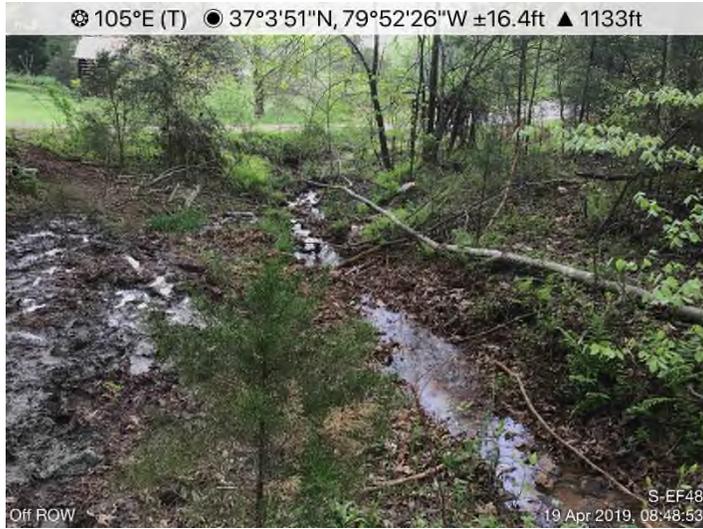
Fig. 3: **S-EF48** – Downstream following clean up.

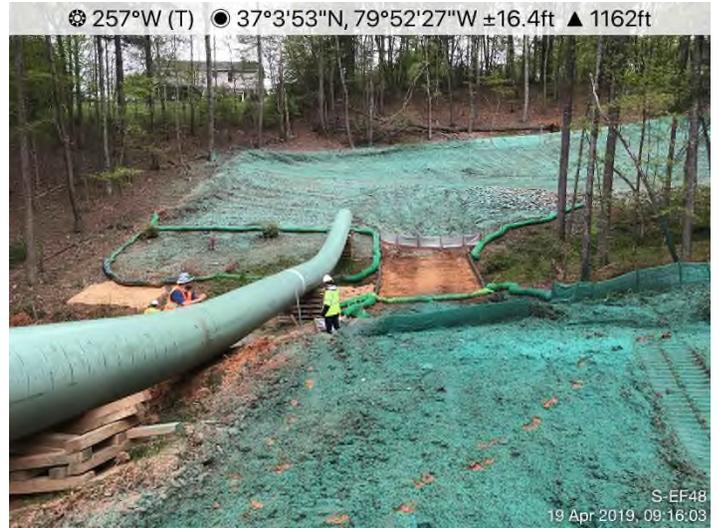
Fig. 4: **S-EF48** – Controls in place.
