## FIELD INSPECTION

Project Name:	Mountain Valley Pipeline	Inspector:	Marshall Willis
Inspection Date:	Tuesday, April 2, 2019	Project Contact:	Brian Clauto
Spread I: Franklin County	STA 14546+85 – 14599+24	Weather (Wet/Dry/Rain):	Dry

# FIELD INSPECTION PHOTO LOG

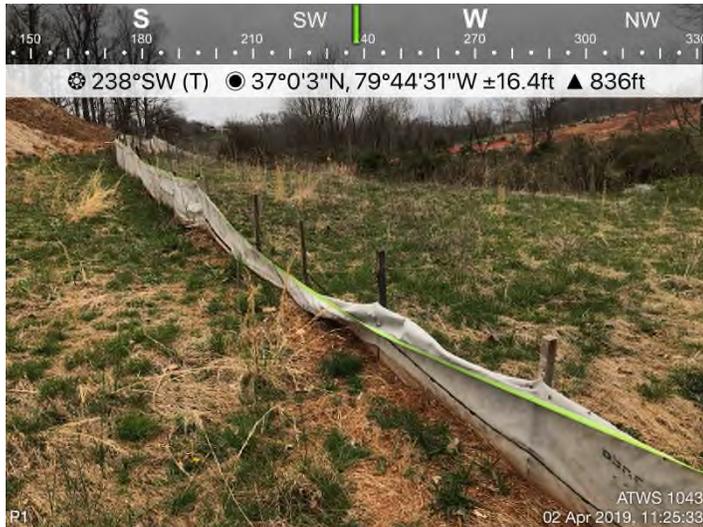
STA 14583+56: Repair P1.  
 STA 14549+84: No inlet protection on CWD.

**Fig. 1: STA 14583+56 – ATWS 1043: Repair P1.**

**Recommended Corrective Action:** Maintain and install all controls per the approved plan and specs.

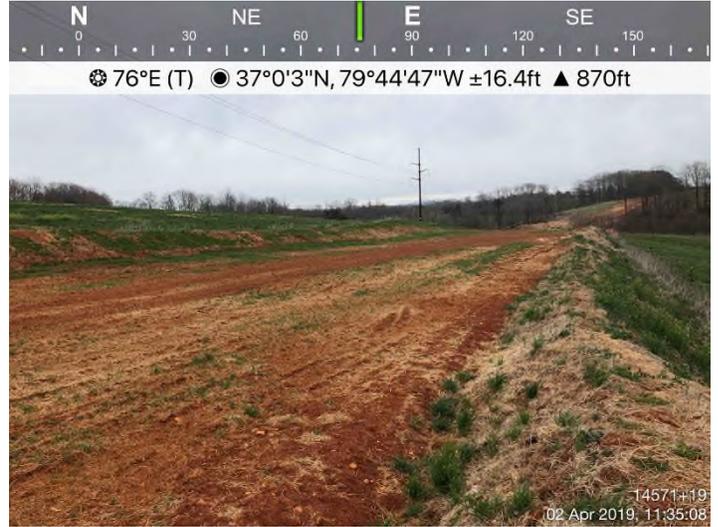
**Fig. 2: STA 14571+19 – Area adequately stabilized. Controls in place.**

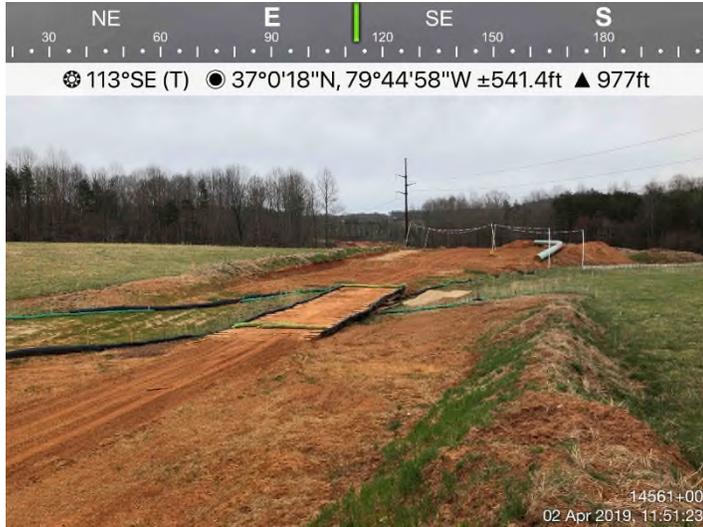
**Fig. 3: STA 14561+00 – Area adequately stabilized. Controls in place.**

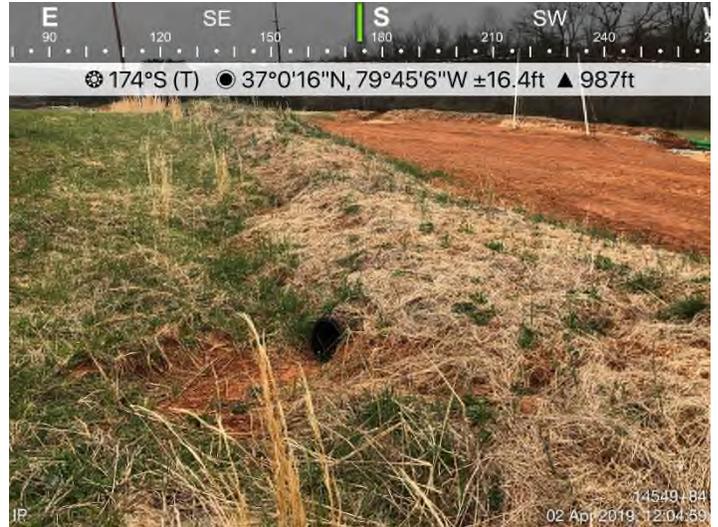
**Fig. 4: STA 14549+84 – CWD does not have inlet protection.**
