FIELD INSPECTION

Project Name:	Mountain Valley Pipeline	Inspector:	Matthew Grant
Inspection Date:	Wednesday, April 24, 2019	Project Contact:	Brian Clauto
Spread: Franklin County MP266 St14063-14077 Pittsylvania MP295-296 St15584+49-15664+94 MP298 St15781-15735+16	Spread I	Weather (Wet/Dry/Rain):	Dry

FIELD INSPECTION PHOTO LOG

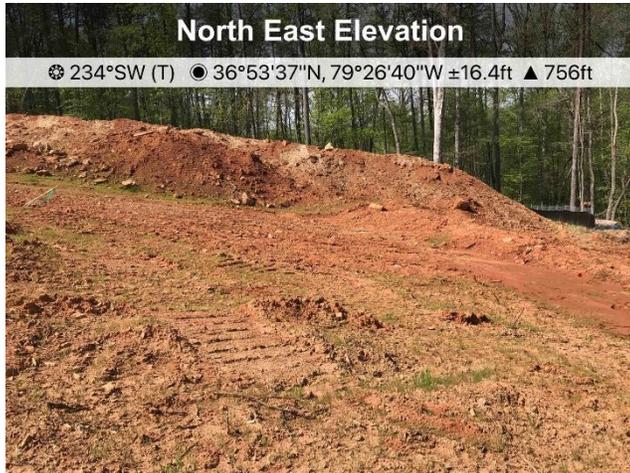
Fig. 5 St#15600+50-15601+50 lacks adequate stabilization

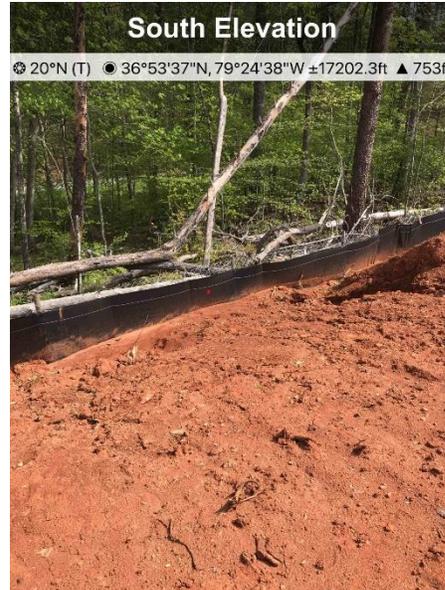
Fig. 6 St#155603+20 SSF requires maintenance

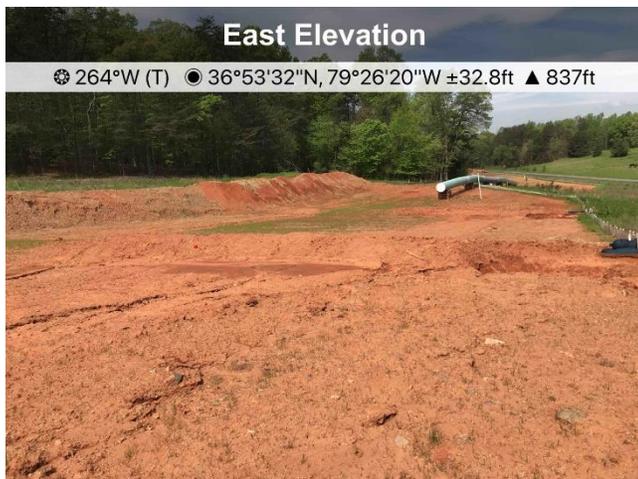
Fig. 7 St#15617+75 waterbar requires maintenance, 15617+75- 15618+18 requires additional stabilization

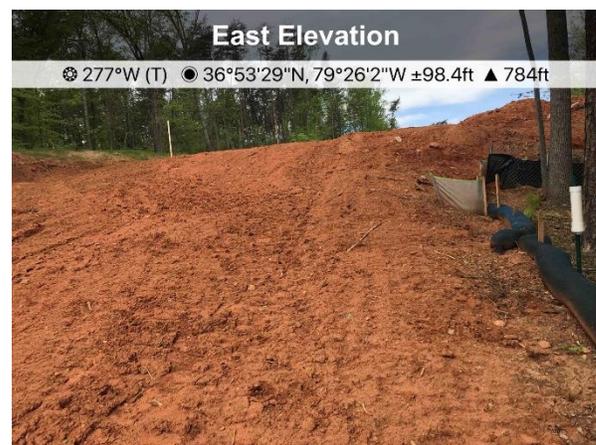
Fig. 8 St#15635+47- stream S-IJ10 lacks adequate stabilization

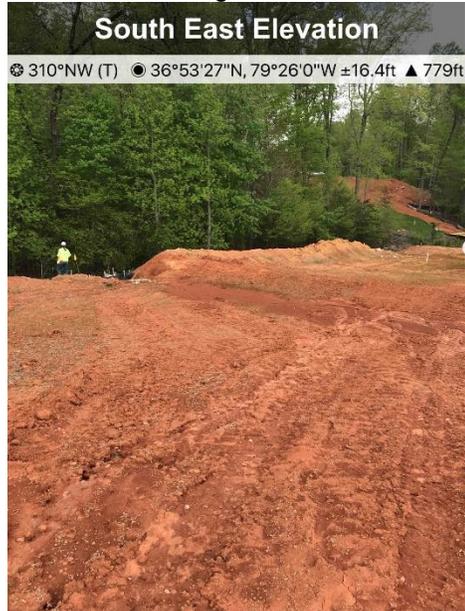
- Fig. 9 St#15638+50 waterbar requires maintenance and stabilization through 15639+25

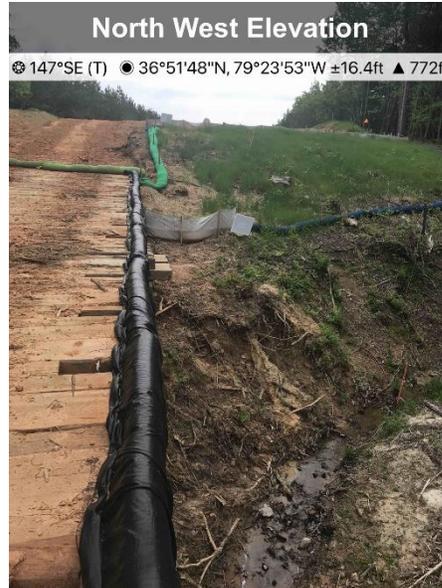
- Fig. 10 St#15795+16 bank of SC-1 requires stabilization
