FIELD INSPECTION

Project Name:	Mountain Valley Pipeline	Inspector:	Marshall Willis
Inspection Date:	Thursday, April 25, 2019	Project Contact:	Brian Clauto
Spread I: Pittsylvania County	STA 15826+88 – STA 15947+64	Weather (Wet/Dry/Rain):	Dry

FIELD INSPECTION PHOTO LOG

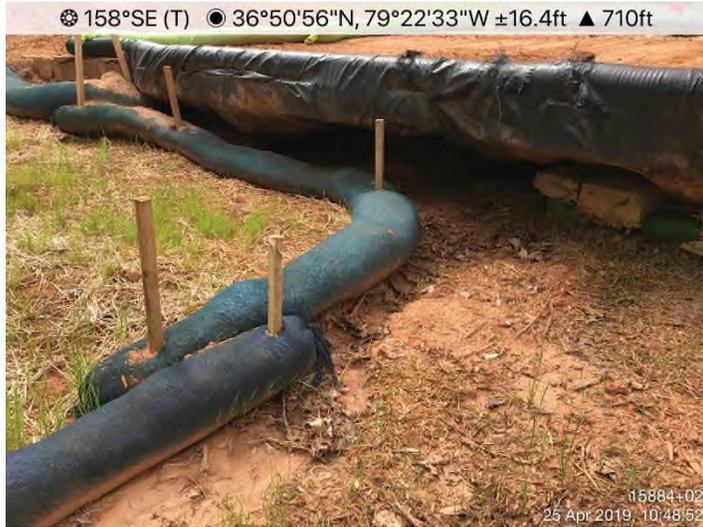
Fig. 1: STA 15884+02 – Bridge underlayment damaged.

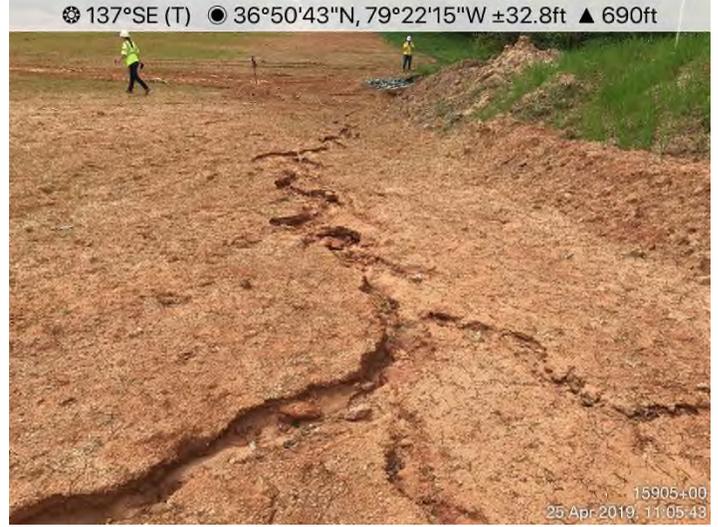
Fig. 2: STA 15905+00 – Stabilize erosion.

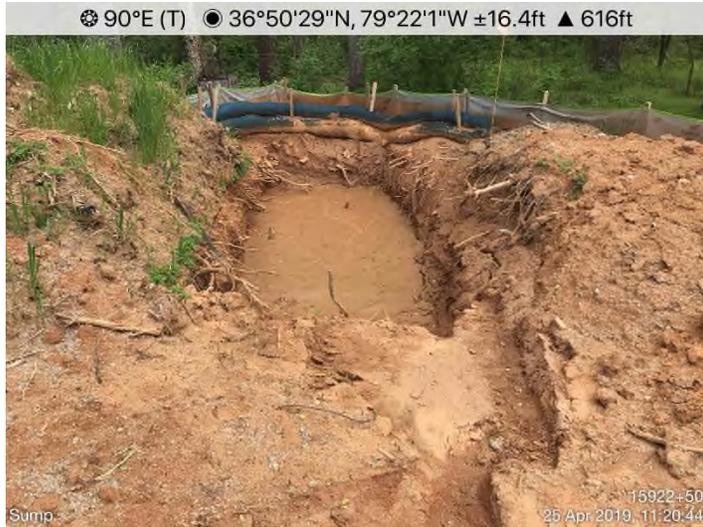
Fig. 3: STA 15922+50 – Sump needs maintenance.

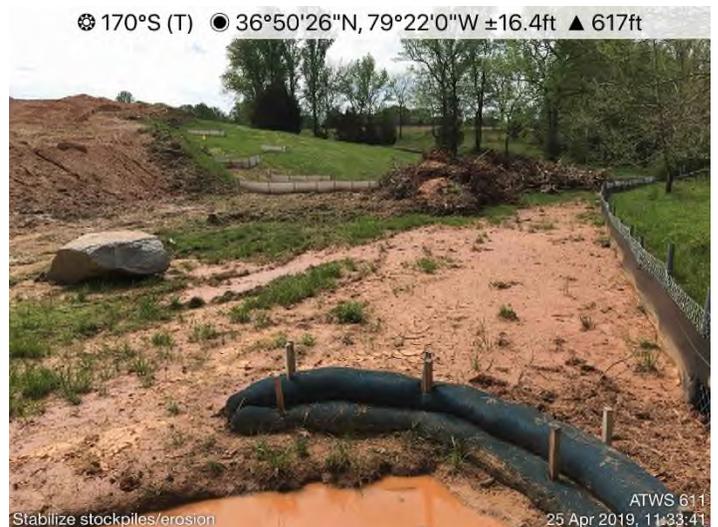
Fig. 4: STA 15924+60 – Stabilize.

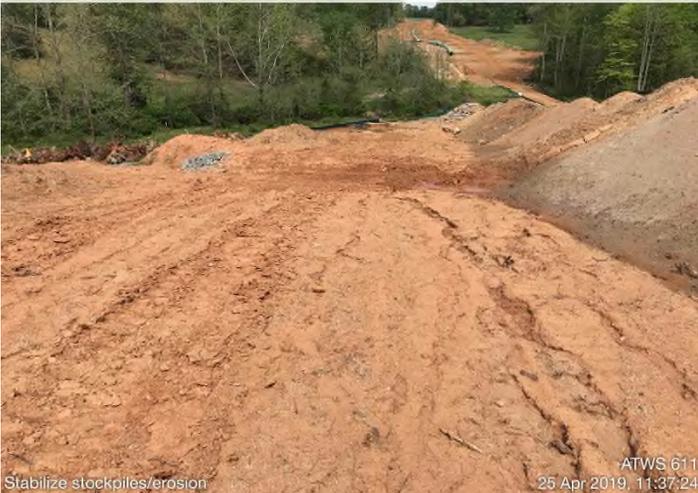
<p>Fig. 5: STA 15924+70 – STA 15929+00 – Stabilize stockpiles and areas outside travel lane in ATWS 611.</p> <div style="border: 1px solid black; padding: 2px; margin-bottom: 5px;"> 320°NW (T) 36°50'24"N, 79°21'58"W ±32.8ft ▲ 655ft </div>

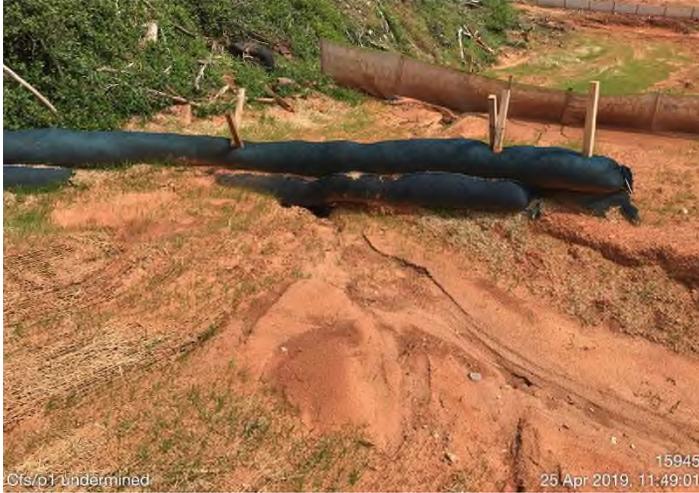
<div style="display: flex; justify-content: space-between; font-size: x-small; margin-top: 5px;"> Stabilize stockpiles/erosion ATWS 611 25 Apr 2019, 11:37:24 </div>	<p>Fig. 6: STA 15945+00 – CFS and P1 undermined.</p> <div style="border: 1px solid black; padding: 2px; margin-bottom: 5px;"> 59°NE (T) 36°50'14"N, 79°21'43"W ±16.4ft ▲ 603ft </div>

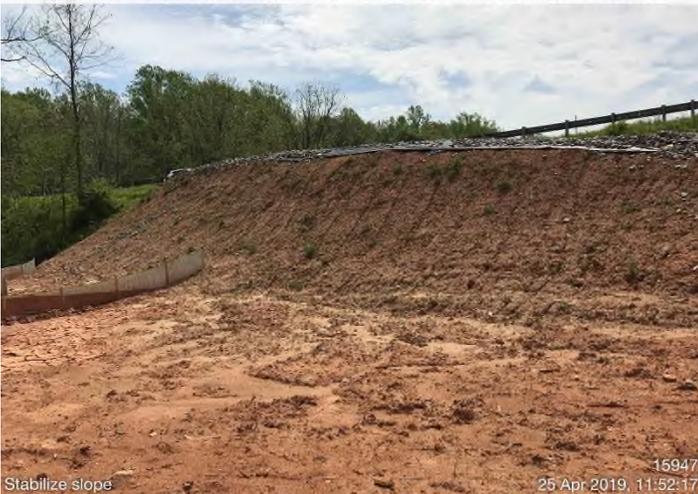
<div style="display: flex; justify-content: space-between; font-size: x-small; margin-top: 5px;"> CFS/P1 undermined 15945 25 Apr 2019, 11:49:01 </div>
<p>Fig. 7: STA 15947+00 – Stabilize slope.</p> <div style="border: 1px solid black; padding: 2px; margin-bottom: 5px;"> 127°SE (T) 36°50'14"N, 79°21'39"W ±7963.0ft ▲ 593ft </div>

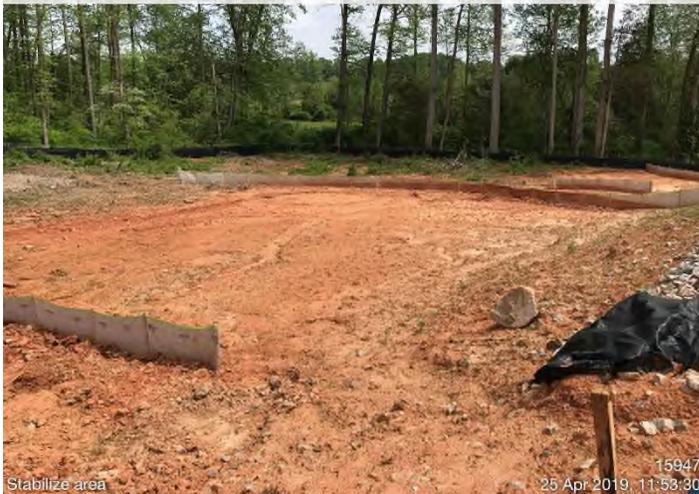
<div style="display: flex; justify-content: space-between; font-size: x-small; margin-top: 5px;"> Stabilize slope 15947 25 Apr 2019, 11:52:17 </div>	<p>Fig. 8: STA 15947+00 – Stabilize area.</p> <div style="border: 1px solid black; padding: 2px; margin-bottom: 5px;"> 43°NE (T) 36°50'14"N, 79°21'41"W ±16.4ft ▲ 607ft </div>
