## FIELD INSPECTION

<b>Project Name:</b>	Mountain Valley Pipeline	<b>Inspector:</b>	Marshall Willis
<b>Inspection Date:</b>	Tuesday, April 30, 2019	<b>Project Contact:</b>	Brian Clauto
<b>Spread I: Franklin County</b>	STA 13690+91 – 13748+30 STA 13631+27 – 13644+52	<b>Weather (Wet/Dry/Rain):</b>	Dry

## FIELD INSPECTION PHOTO LOG

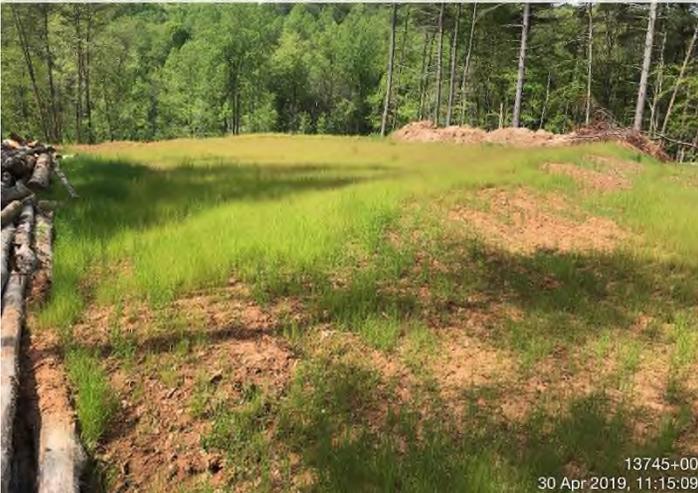
<p>Fig. 1: <b>STA 13745+00</b> – Area stabilized. Controls in place.</p> <div style="border: 1px solid black; padding: 5px; margin-bottom: 5px;"> <p>☉ 241°SW (T) ● 37°4'31"N, 79°56'24"W ±16.4ft ▲ 1228ft</p> </div>

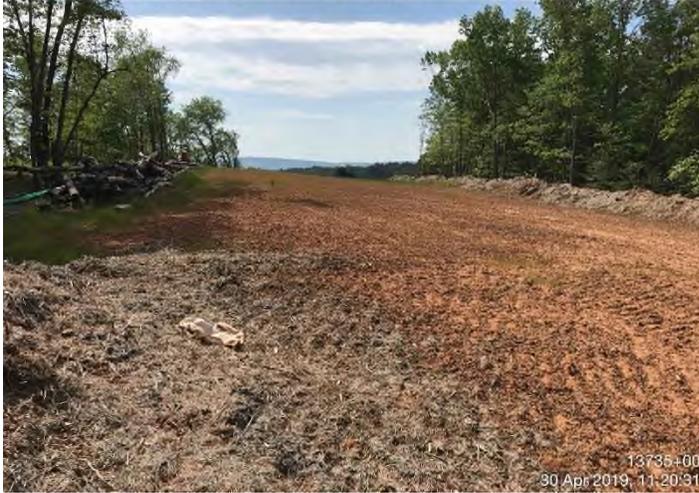
<div style="text-align: right; font-size: small; margin-top: 5px;"> <p>13745+00 30 Apr 2019, 11:15:09</p> </div>	<p>Fig. 2: <b>STA 13735+00</b> – Controls in place. Area stabilized with Earth Guard.</p> <div style="border: 1px solid black; padding: 5px; margin-bottom: 5px;"> <p>☉ 161°S (T) ● 37°4'41"N, 79°56'23"W ±16.4ft ▲ 1226ft</p> </div>

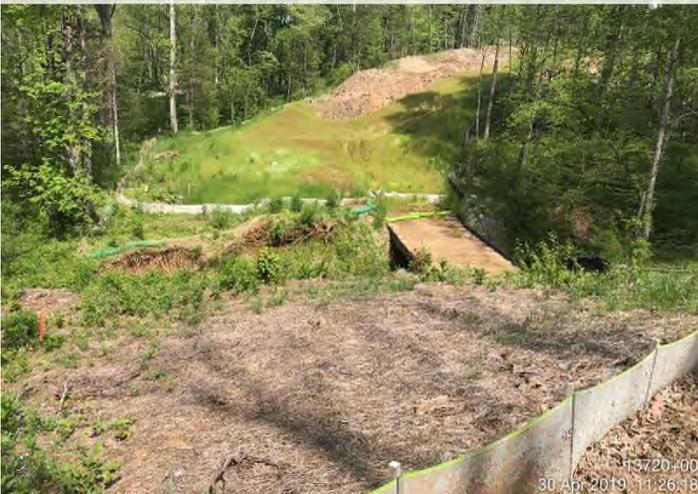
<div style="text-align: right; font-size: small; margin-top: 5px;"> <p>13735+00 30 Apr 2019, 11:20:31</p> </div>
<p>Fig. 3: <b>STA 13720+00</b> – Controls in place. Area stabilized.</p> <div style="border: 1px solid black; padding: 5px; margin-bottom: 5px;"> <p>☉ 4°N (T) ● 37°4'43"N, 79°56'30"W ±16.4ft ▲ 1144ft</p> </div>

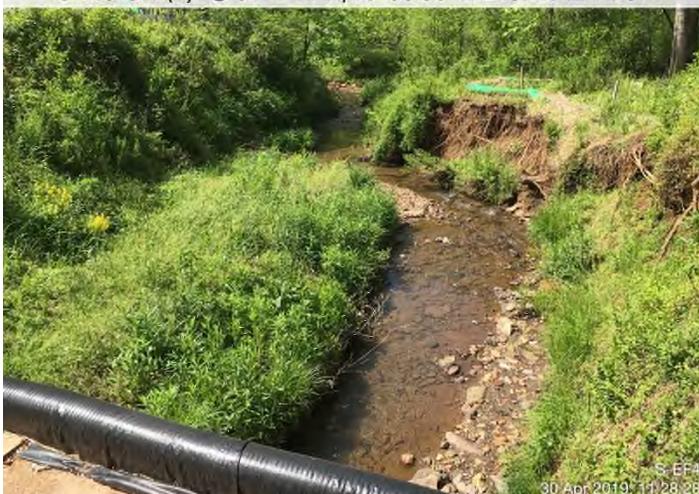
<div style="text-align: right; font-size: small; margin-top: 5px;"> <p>13720+00 30 Apr 2019, 11:26:18</p> </div>	<p>Fig. 4: <b>Stream S-EF4</b> – Controls in place.</p> <div style="border: 1px solid black; padding: 5px; margin-bottom: 5px;"> <p>☉ 215°SW (T) ● 37°4'44"N, 79°56'30"W ±16.4ft ▲ 1123ft</p> </div>

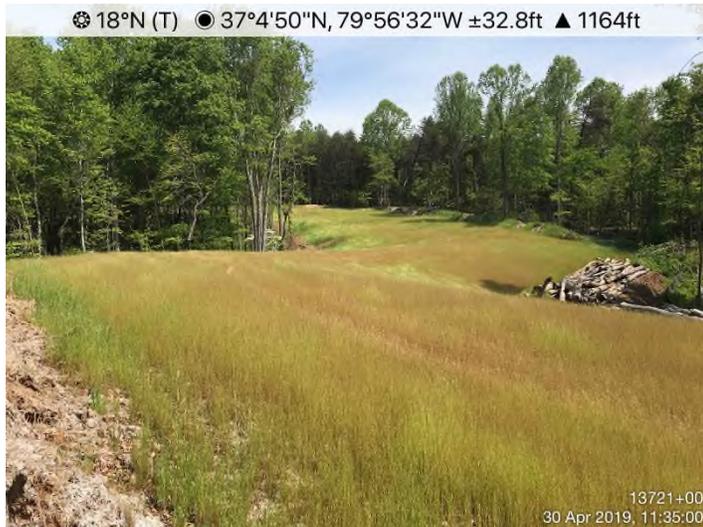
**Fig. 5: STA 13721+00** – Area stabilized. Controls in place.

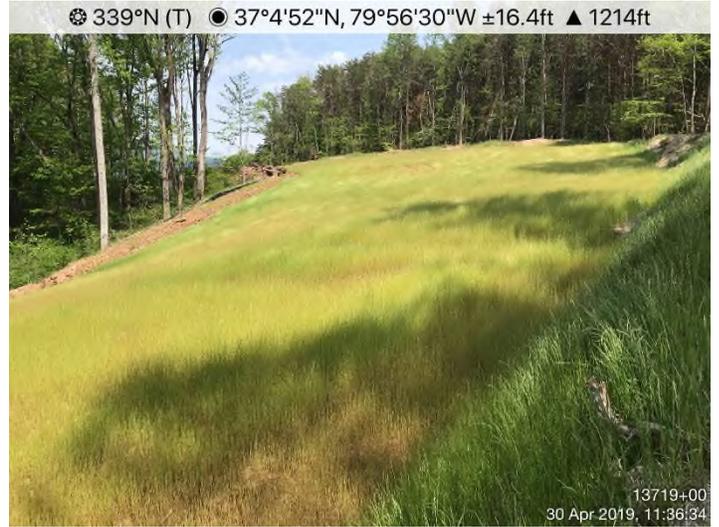
**Fig. 6: STA 13719+00** – Area stabilized. Controls in place.

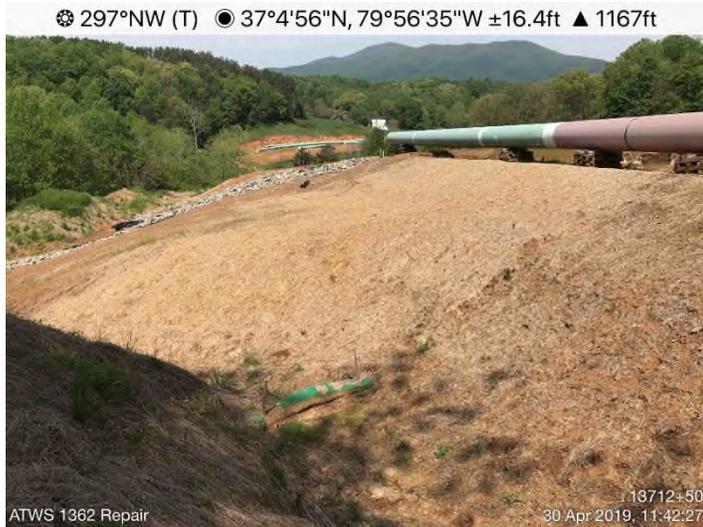
**Fig. 7: STA 13712+50** – Area stabilized with straw and curlex.

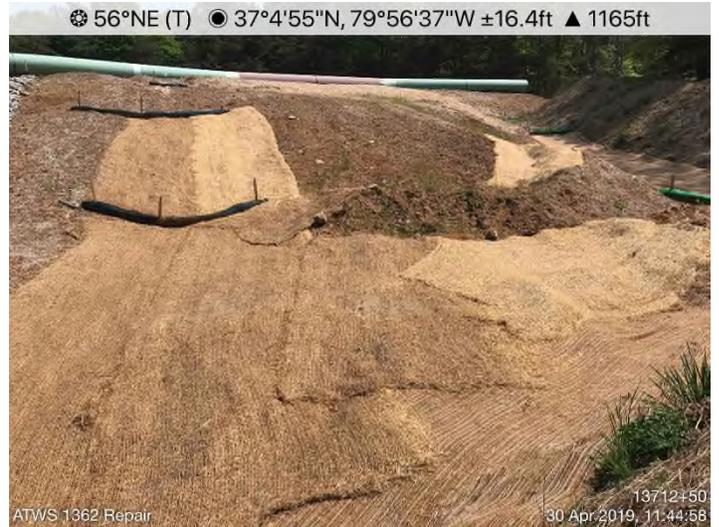
**Fig. 8: STA 13712+50** – Area stabilized with straw and curlex.
