FIELD INSPECTION REPORT

Project Name:	Mountain Valley Pipeline	Inspector:	Marshall Willis
Inspection Date:	Monday, May 11, 2020	Project Contact:	Brian Clauto, Cory Chalmers
Spread I: Franklin County	STA 14845+68 – 14928+52 ATWS 375/376/540/541/377	Weather:	Dry

FIELD INSPECTION PHOTO LOG

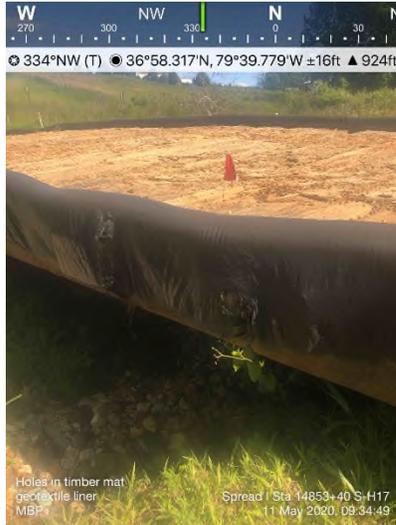
Figure 1: STA 14853+40 – Bridge underlayment damaged at S-H17 crossing.

- STA 14853+40: Hole in bridge underlayment of S-H17 crossing. Repair needed.
- STA 14854+75: Hole in bridge underlayment of S-A7 crossing. Repair needed.
- STA 14901+00: End-treatment undermined. Repair needed.
- STA 14903+00: CFS at full capacity. Cleanout needed.

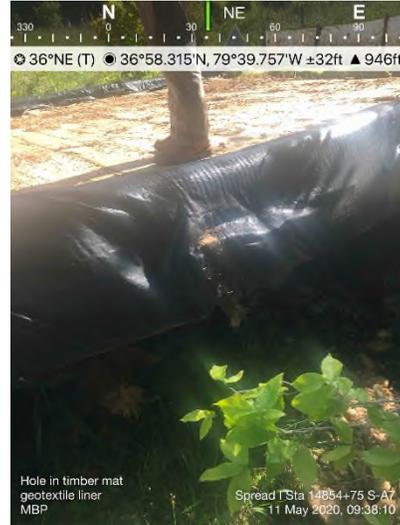
Figure 2: STA 14854+75 – Bridge underlayment damaged at S-A7 crossing.

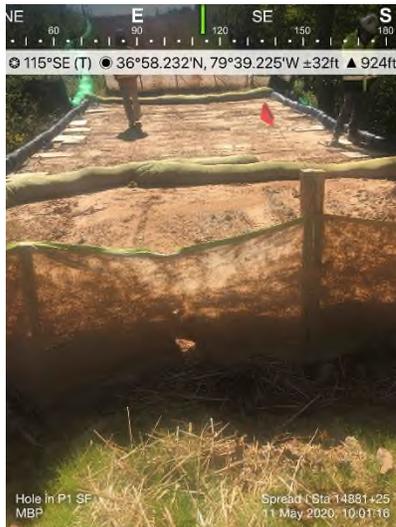
Figure 3: STA 14881+25 – P1 damaged.

- STA 14881+25: Hole in P1. Maintenance needed.
- STA 14881+75: Hole in P1. Maintenance needed.

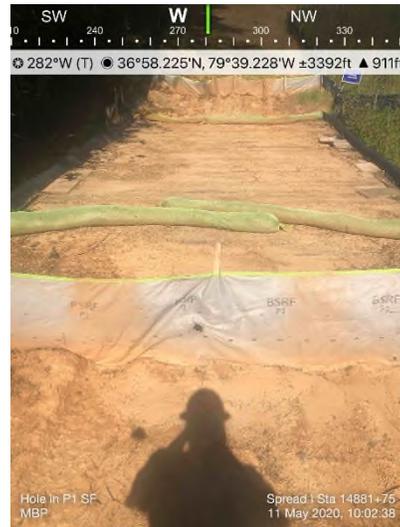
Figure 4: STA 14881+75 – P1 damaged.

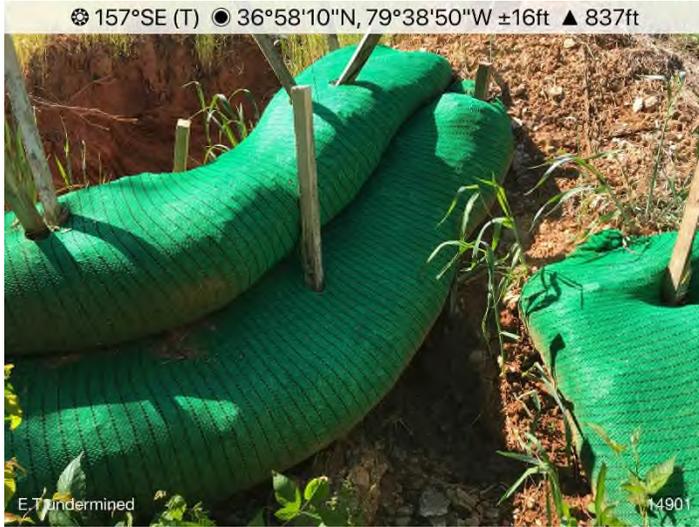
Figure 5: STA 14901+00 – End-treatment undermined.

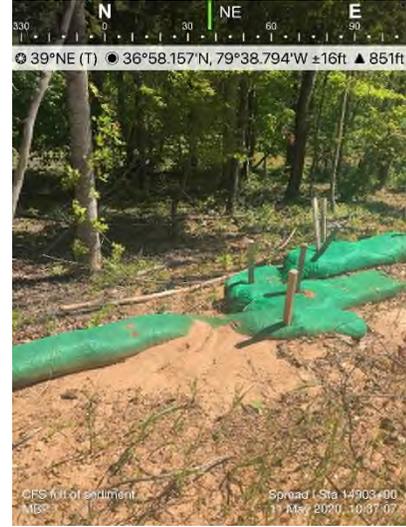
Figure 6: STA 14903+00 – CFS at capacity.
