FIELD INSPECTION

Project Name:	Mountain Valley Pipeline	Inspector:	Marshall Willis
Inspection Date:	Tuesday, May 14, 2019	Project Contact:	Brian Clauto
Spread I: Pittsylvania County	STA 15584+23 – 15647+03	Weather (Wet/Dry/Rain):	Wet

FIELD INSPECTION PHOTO LOG

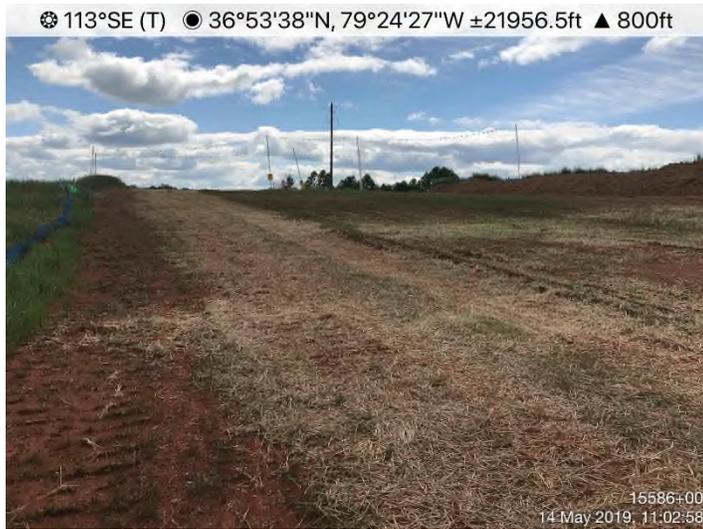
Fig. 1: STA 15586+00 – Controls in place. Area adequately stabilized with straw and Earth Guard.

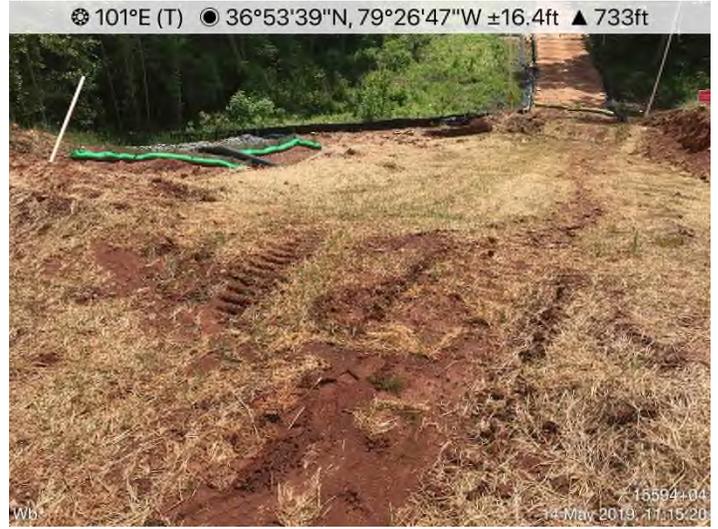
- STA 15594+04 – Waterbar maintenance required.
- STA 15614+00 – Additional stabilization needed.
- STA 15632+00 – CFS undermined.

Fig. 2: STA 15594+04 – Waterbar maintenance required.

Recommended Corrective Action: Maintain and install all controls per the approved plan and specs.

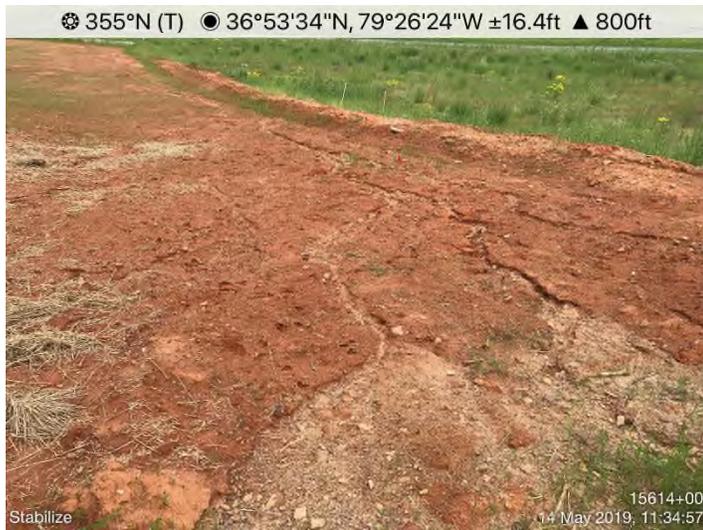
Fig. 3: STA 15614+00 – Inadequate stabilization.

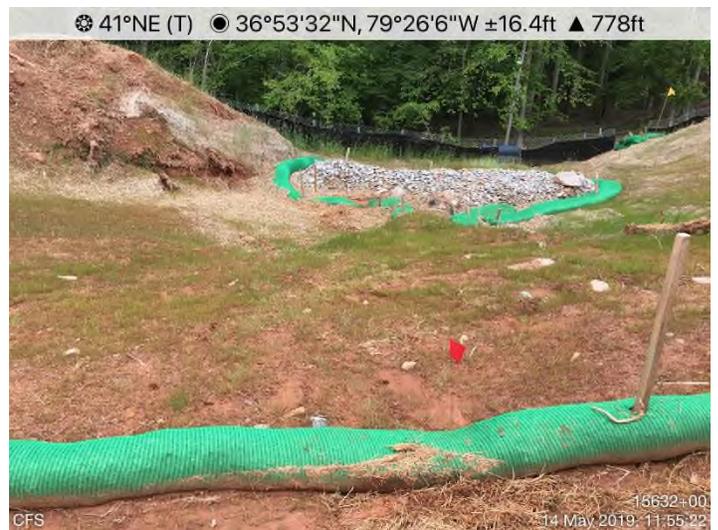
Fig. 4: STA 15623+00 – CFS undermined.

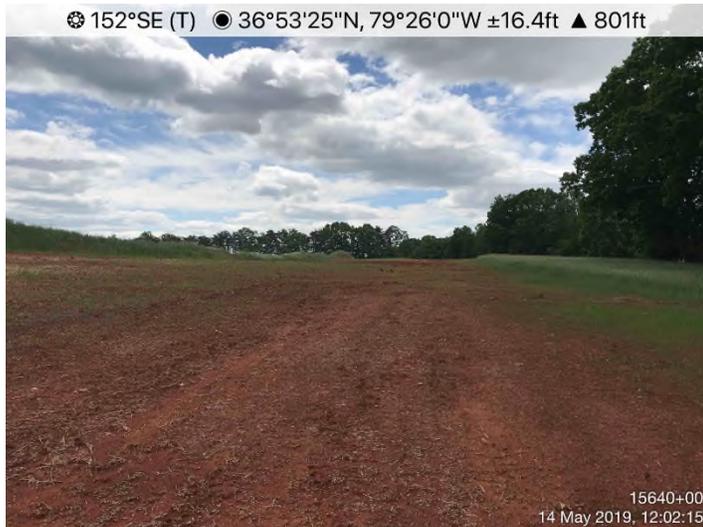
Fig. 5: **STA 15640+00** – Controls in place. Area adequately stabilized with straw and Earth Guard.

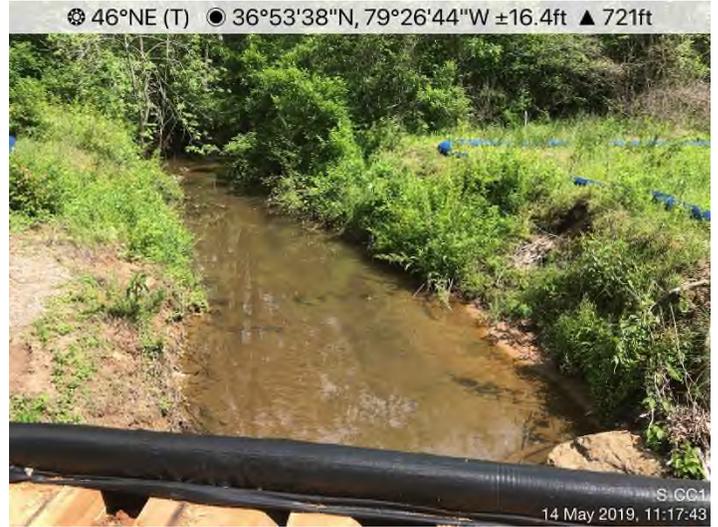
Fig. 6: **Stream S-CC1** – Controls in place.

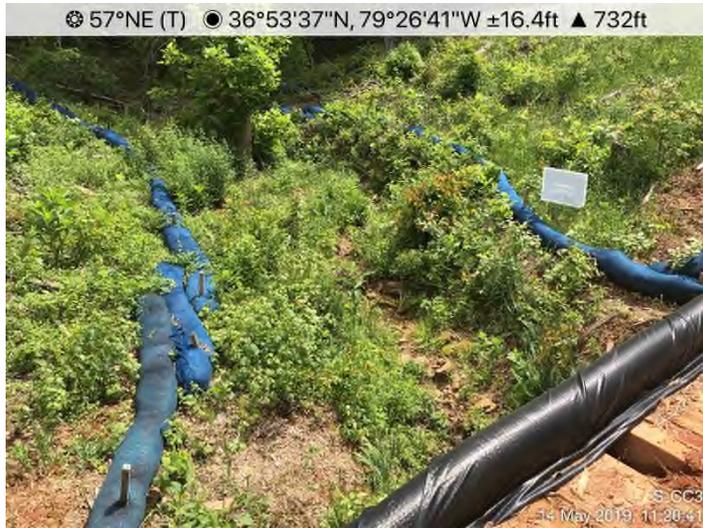
Fig. 7: **Stream S-CC3** – Controls in place.

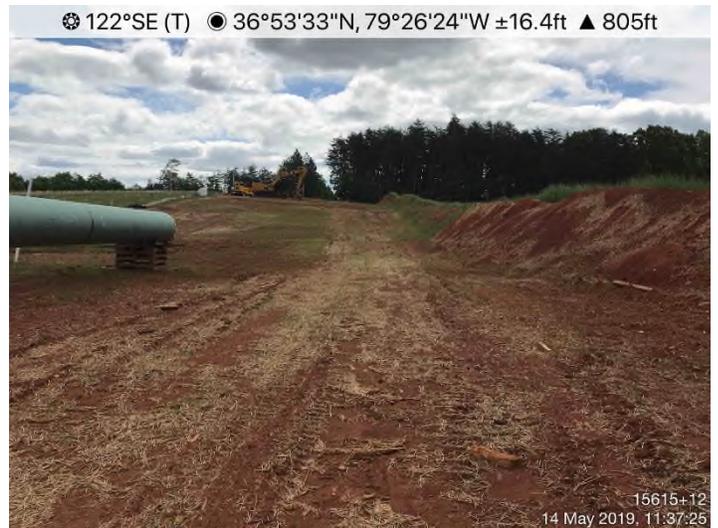
Fig. 8: **STA 15615+12** – Controls in place. Area adequately stabilized with straw and Earth Guard.
