FIELD INSPECTION REPORT

Project Name:	Mountain Valley Pipeline	Inspector:	Marshall Willis
Inspection Date:	Monday, May 18, 2020	Project Contact:	Brian Clauto, Cory Chalmers
Spread I: Franklin County	STA 13415+50 – 13441+50 MVP-FR-293.02 ATWS 1351/1342/1343	Weather:	Rainy

FIELD INSPECTION PHOTO LOG

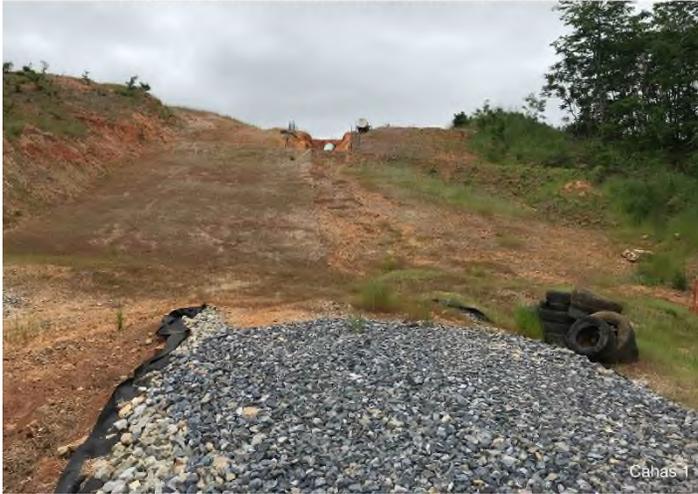
Figure 1: STA 13416+00 – Controls in place and functioning properly.

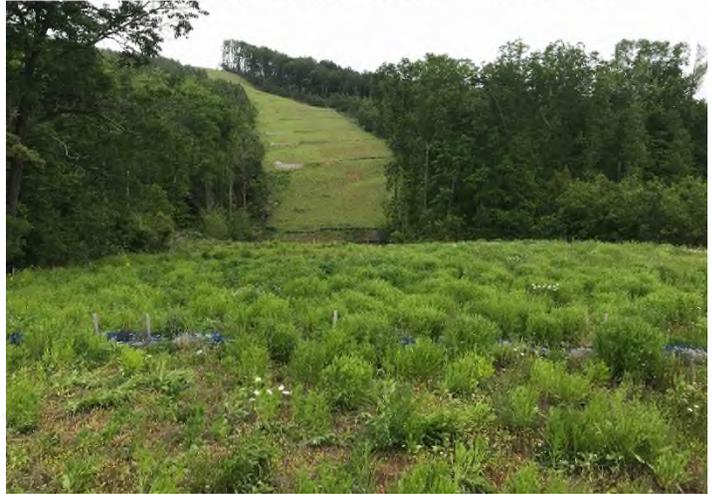
Figure 2: STA 13423+00 – Controls in place and functioning properly.

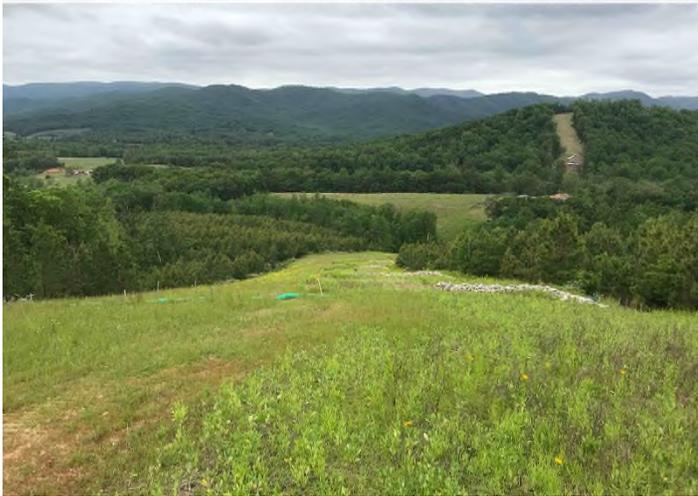
Figure 3: STA 13436+00 – Controls in place and functioning properly.

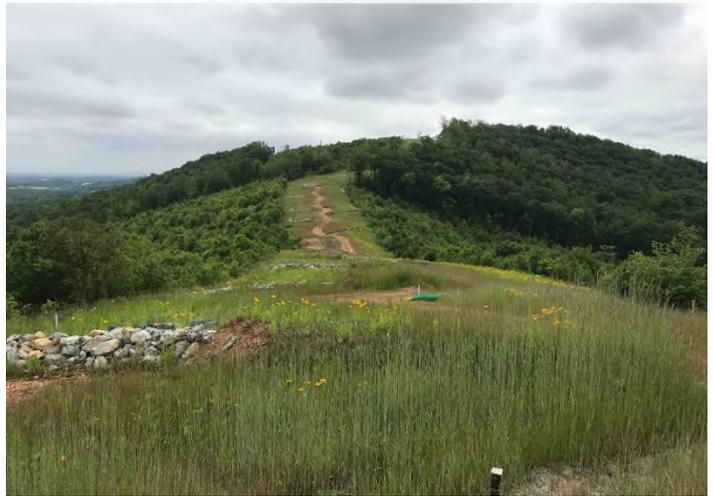
Figure 4: STA 13440+00 – Controls in place and functioning properly.
