FIELD INSPECTION

Project Name:	Mountain Valley Pipeline	Inspector:	Marshall Willis
Inspection Date:	Monday, May 20, 2019	Project Contact:	Brian Clauto
Spread I: Franklin County	STA 13958+31 – 14010+00 STA 14011+00 – 14018+58	Weather (Wet/Dry/Rain):	Dry

FIELD INSPECTION PHOTO LOG

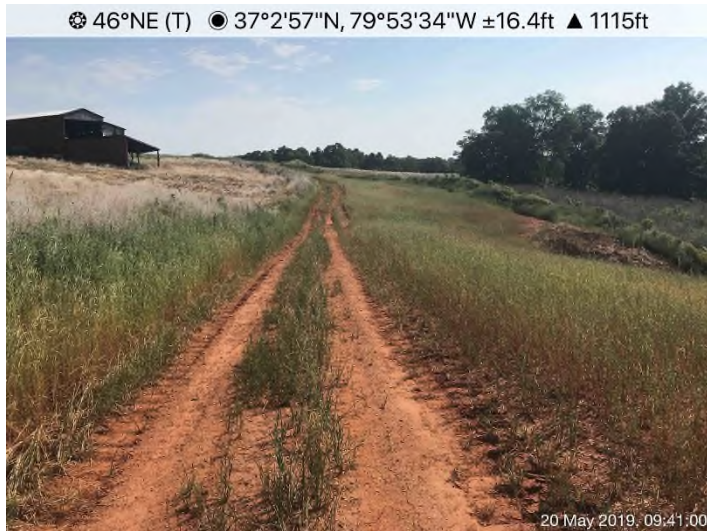
Fig. 1: STA 13970+00 – Controls in place.

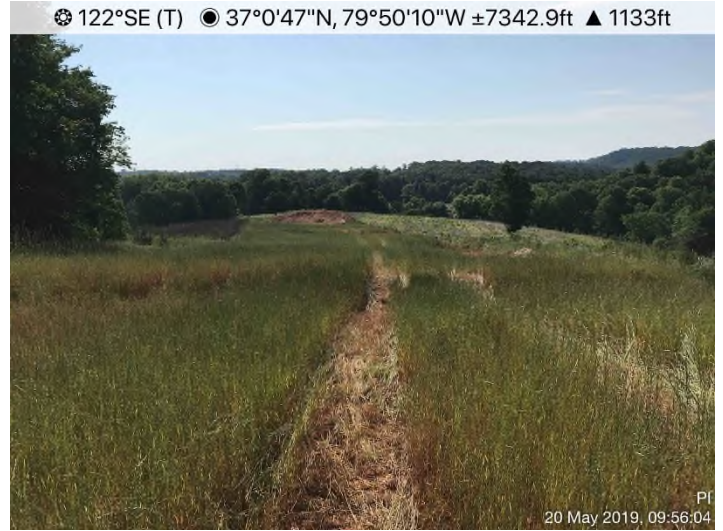
Fig. 2: STA 13980+00 – Controls in place.

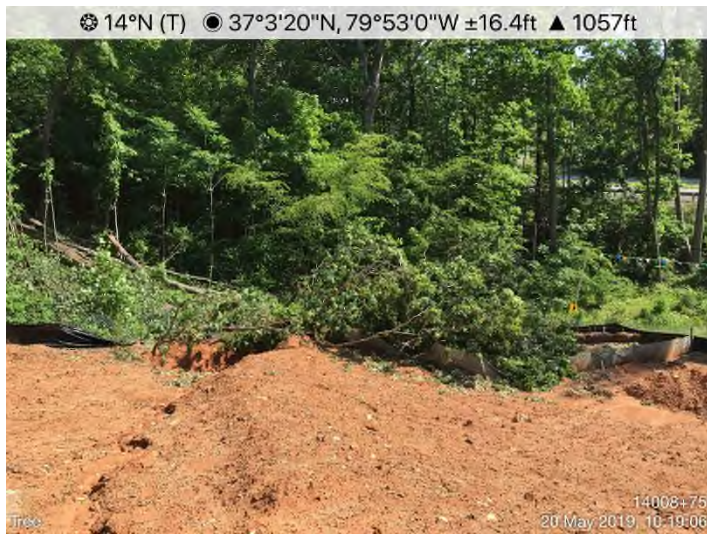
Fig. 3: STA 14008+75 – Remove fallen tree. Repair ECDs.

- STA 14008+75 – Remove fallen tree and repair ECDs.

Recommended Corrective Action: Maintain and install all controls per the approved plan and specs.

Deadline: Within 24-hr notification

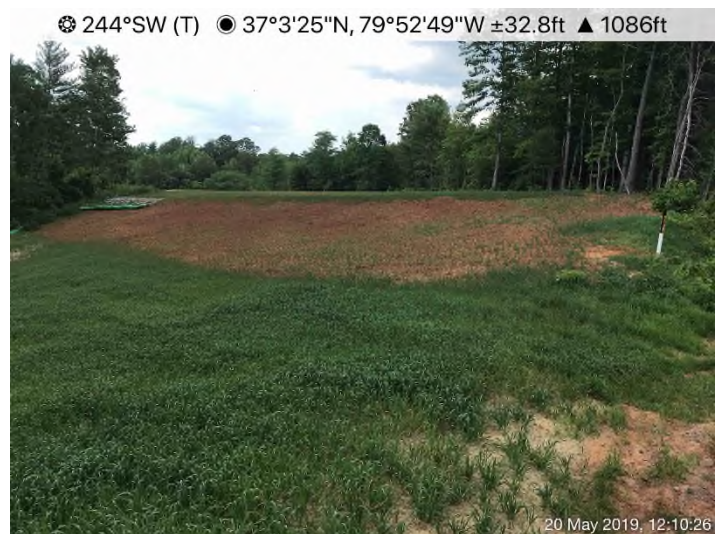
Fig. 4: STA 14015+55 – Controls in place.
