FIELD INSPECTION

Project Name:	Mountain Valley Pipeline	Inspector:	Matthew Grant
Inspection Date:	Wednesday, May 29, 2019	Project Contact:	Brian Clauto
Spread: Franklin County MP272-273 MP275 MP255 MP266	Spread I	Weather (Wet/Dry/Rain):	Dry

FIELD INSPECTION PHOTO LOG

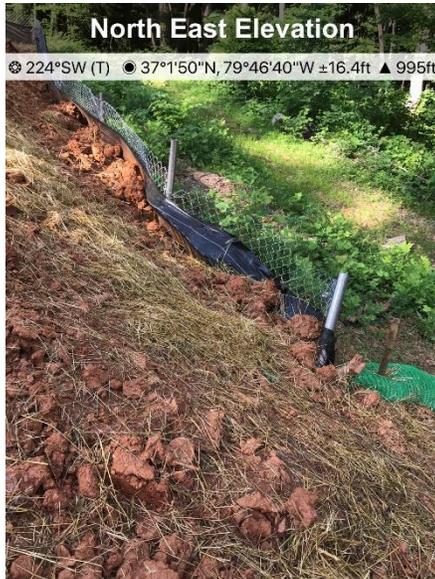
- Streams / wetlands inspected included: S-KL17, S-GH39, SA-41, W-DD1, S-E18, S-KL36, S-EF48, S-YZ4
- St#14421+89 SSF requires maintenance

Fig. 1 St#14421+89 SSF requires maintenance

Recommended Corrective Action: Maintain all controls per the approved plan and specs.

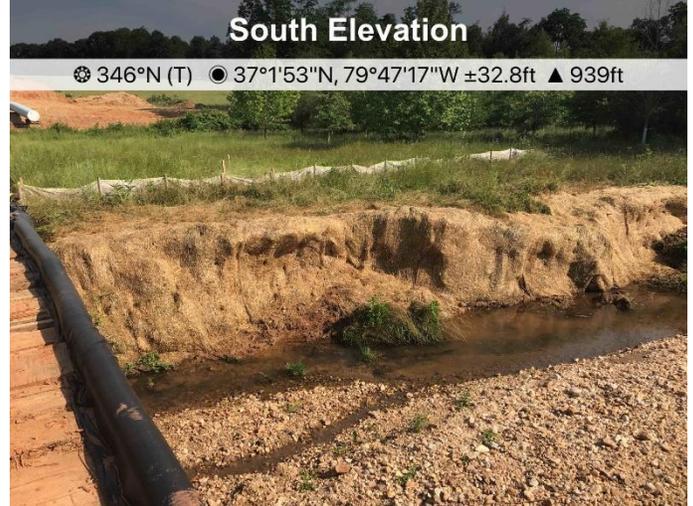
Fig. 2 Designated stream S-A41 banks have been matted

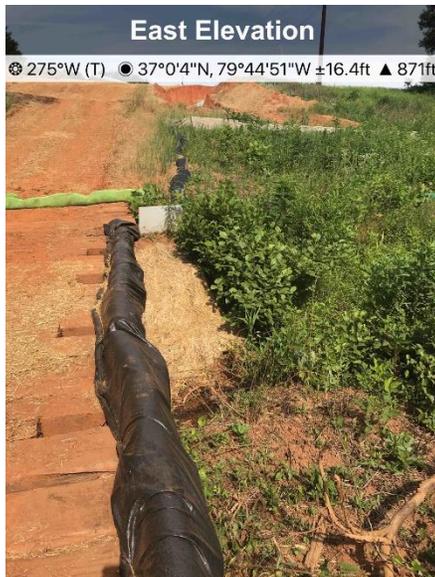
Fig. 3 Designated stream S-E18 area near bridge has been matted

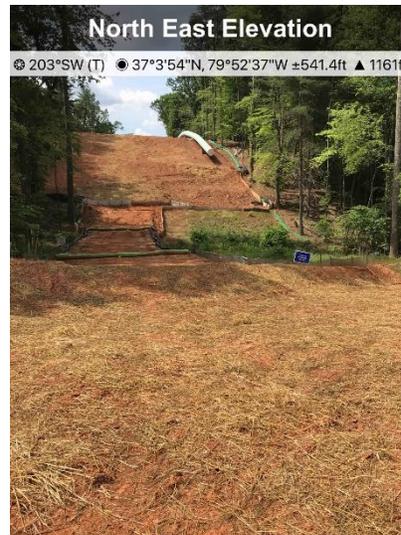
Fig. 4 Designated stream S-YZ4 controls in place and functioning.
