FIELD INSPECTION REPORT

Project Name:	Mountain Valley Pipeline	Inspector:	Marshall Willis
Inspection Date:	Friday, May 29, 2020	Project Contact:	Brian Clauto, Cory Chalmers
Spread I: Pittsylvania County	H-602 STA 0+00 – 22+00 H-603 STA 0+00 – 14+00 Transco Interconnect	Weather:	Wet

FIELD INSPECTION PHOTO LOG

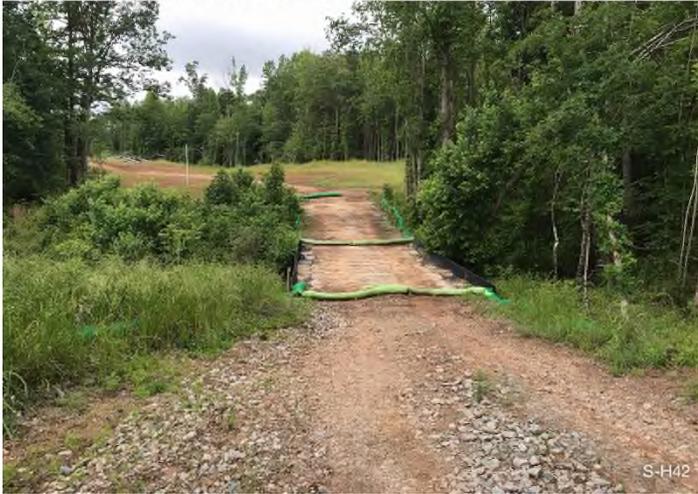
Figure 1: Stream S-H42 – Controls in place and functioning properly.

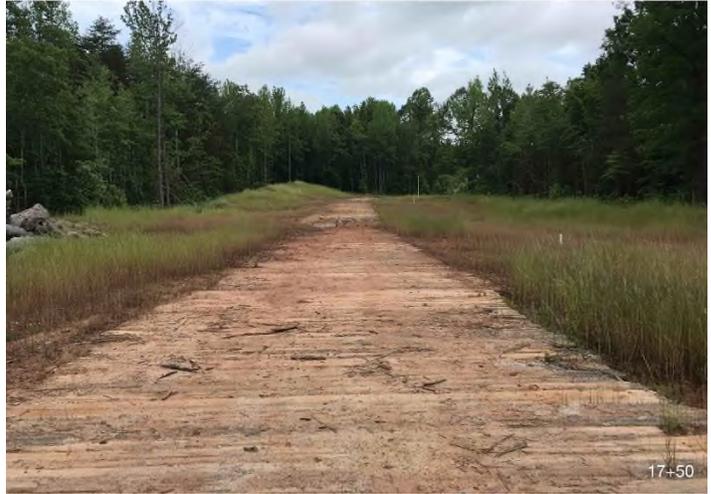
Figure 2: H-602 STA 17+50 – Controls in place and functioning properly. Area stabilized.

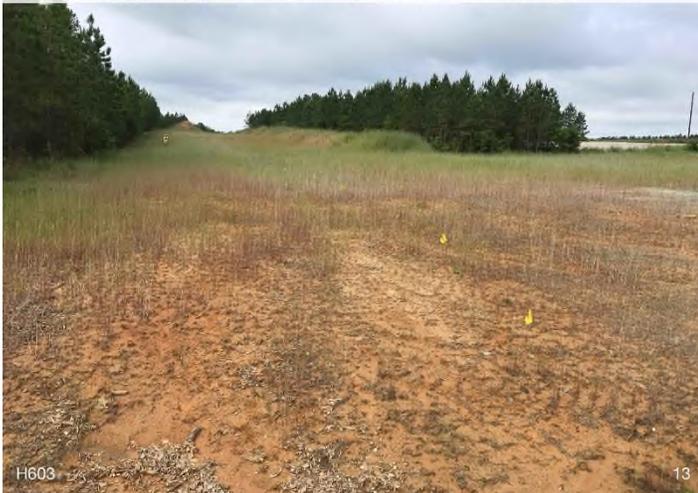
Figure 3: H-603 STA 13+00 – Controls in place and functioning properly. Area stabilized.
