FIELD INSPECTION

Project Name:	Mountain Valley Pipeline	Inspector:	Marshall Willis
Inspection Date:	Thursday, May 30, 2019	Project Contact:	Brian Clauto
Spread I: Franklin County Pittsylvania County	STA 14062+17 – 14171+36 STA 14981+55 – 15063+85	Weather (Wet/Dry/Rain):	Dry

FIELD INSPECTION PHOTO LOG

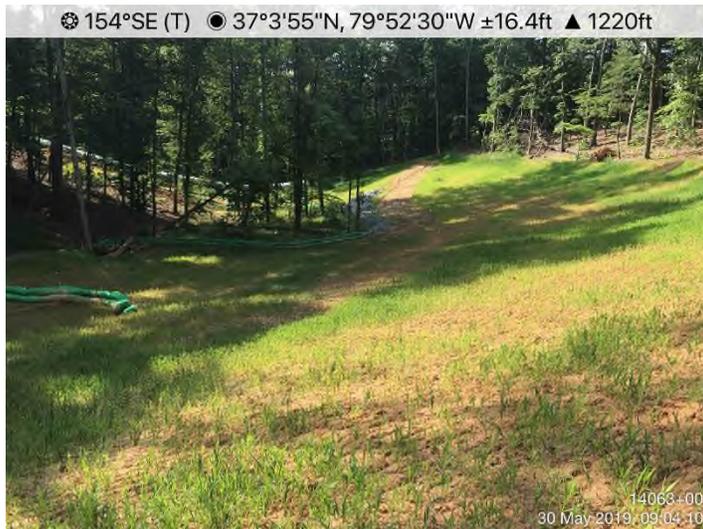
Fig. 1: **STA 14063+00** – Controls in place. Area stabilized.

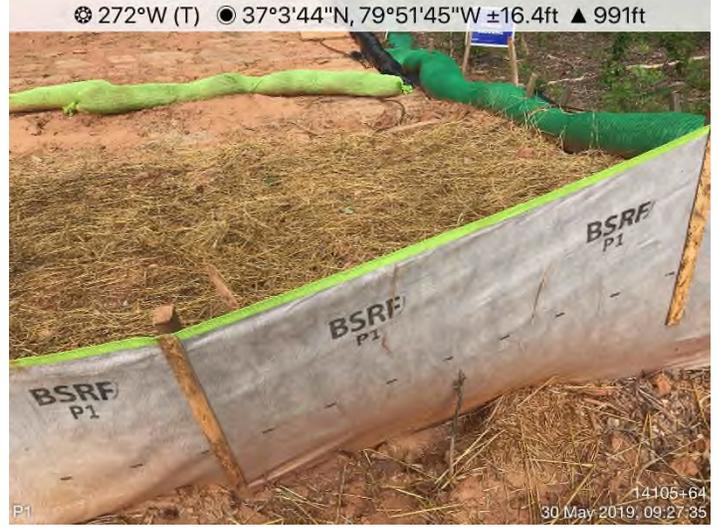
STA 14105+64: Repair undermined P1.

Fig. 2: **STA 14105+64** – P1 undermined above S-KL41.

Recommended Corrective Action: Maintain and install all controls per the approved plan and specs.

Deadline: Within 24-hr notification

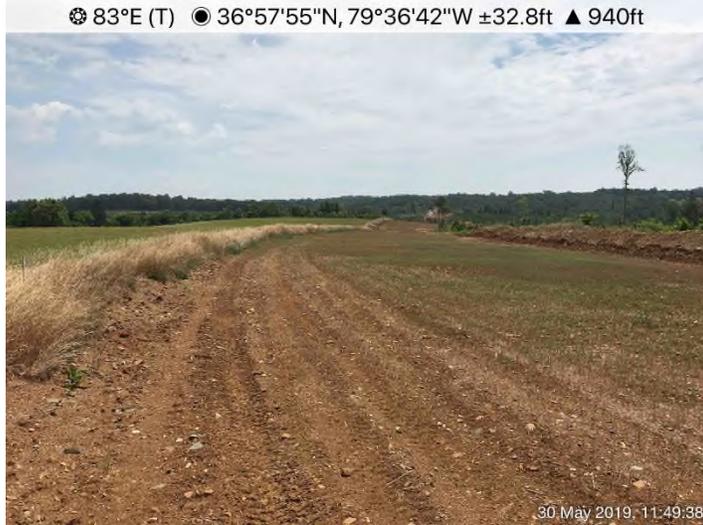
Fig. 3: **STA 15003+33** – Controls in place. Area stabilized.

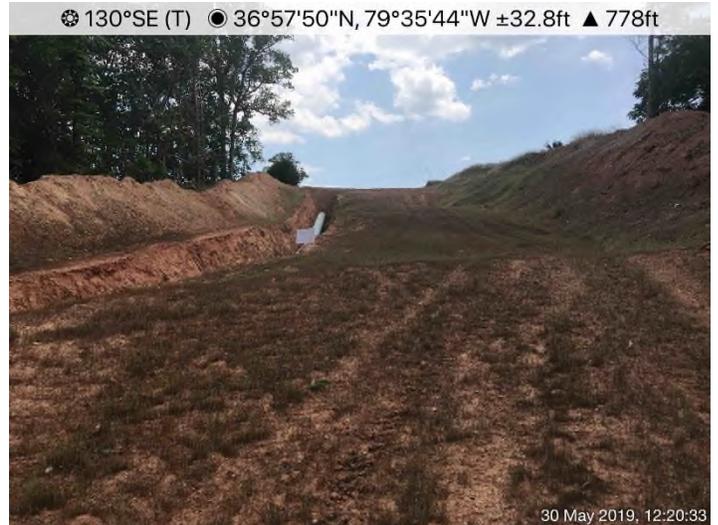
Fig. 4: **STA 15057+76** – Controls in place. Area stabilized.
