FIELD INSPECTION REPORT

Project Name:	Mountain Valley Pipeline	Inspector:	Marshall Willis
Inspection Date:	Monday, May 4, 2020	Project Contact:	Brian Clauto, Cory Chalmers
Spread I: Franklin County	STA 14333+27 – 14454+22 ATWS 1485/526/622/623/356/358	Weather:	Dry

FIELD INSPECTION PHOTO LOG

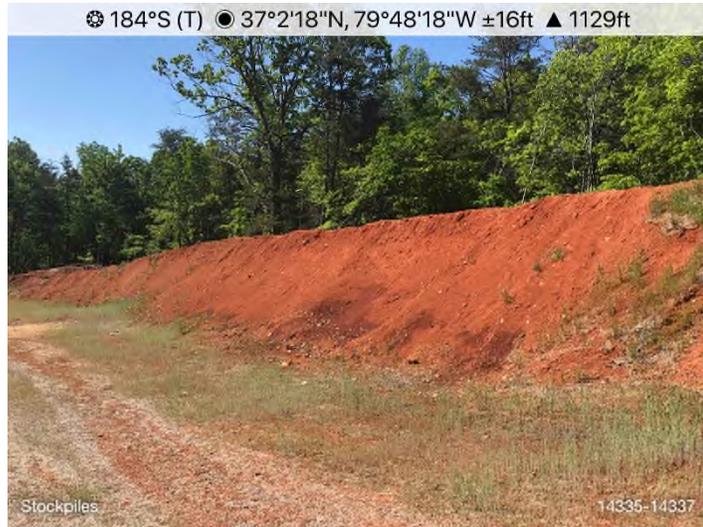
Figure 1: STA 14335+00 – 14337+00 – Re-stabilize stockpile.

- STA 14335+00 – 14337+00: Re-stabilize stockpile.
- STA 14394+50: Re-stabilize stockpile.
- STA 14422+71: CFS maintenance needed.
- STA 14432+00: Waterbar maintenance needed.

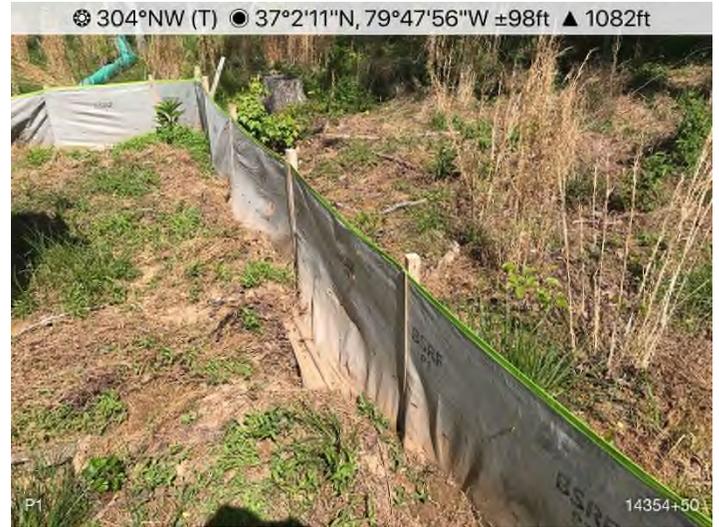
Figure 2: STA 14354+50 – P1 undermined.

- STA 14354+50: P1 undermined. Repair needed.
- STA 14363+00: CFS undermined. Repair needed.
- STA 14371+00: WB end-treatment bypassed. Repair needed.
- STA 14391+30: Stabilize bank erosion along Stream S-A41.
- STA 14394+40: Sediment off ROW. Retrieve and stabilize sediment.
- STA 14394+40: WB end-treatment bypassed. Repair needed.
- STA 14395+00: Sediment off ROW. Retrieve and stabilize sediment.

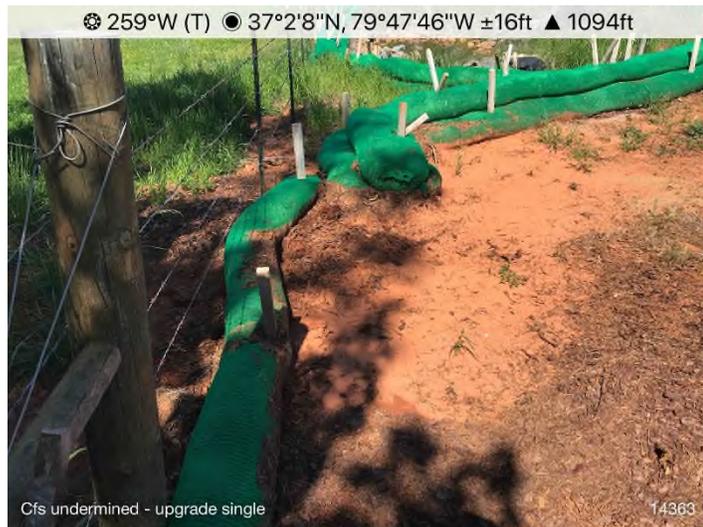
Figure 3: STA 14363+00 – CFS undermined.

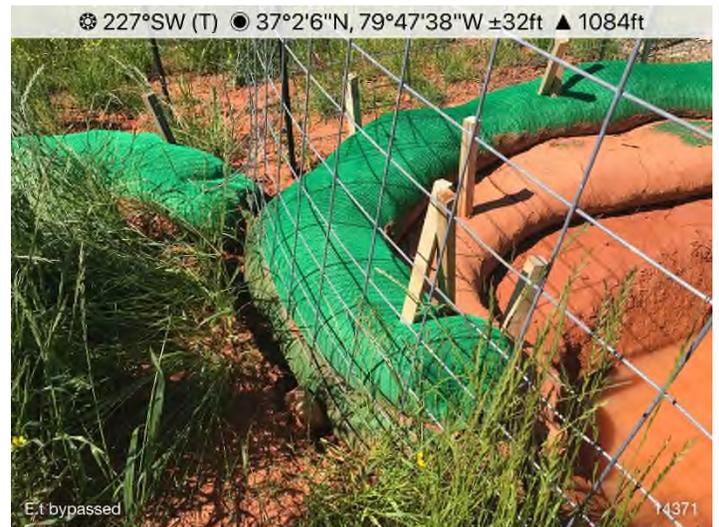
Figure 4: STA 14371+00 – End treatment bypassed.

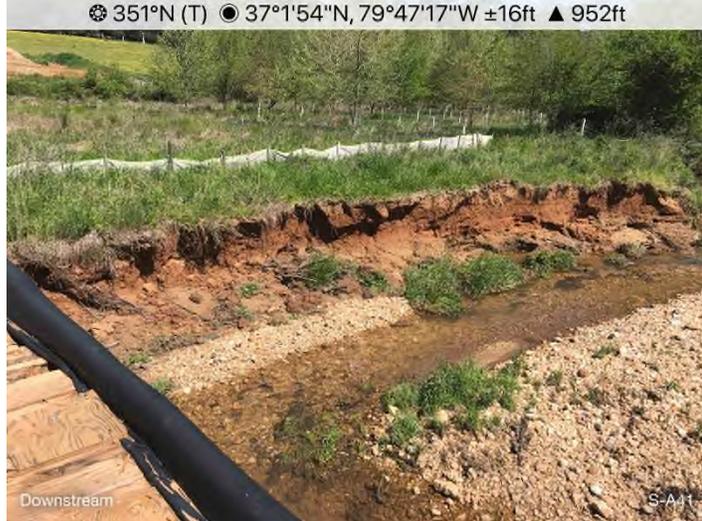
Figure 5: STA 14391+30 – Stream bank erosion downstream of S-A41 crossing.

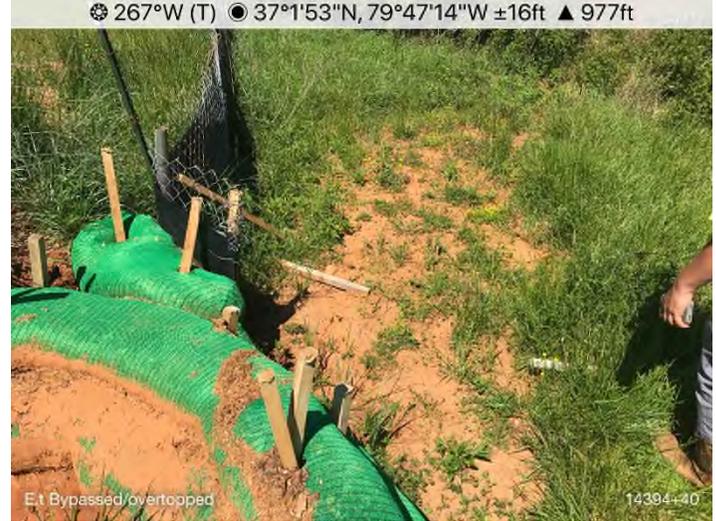
Figure 6: STA 14394+40 – Sediment off ROW.

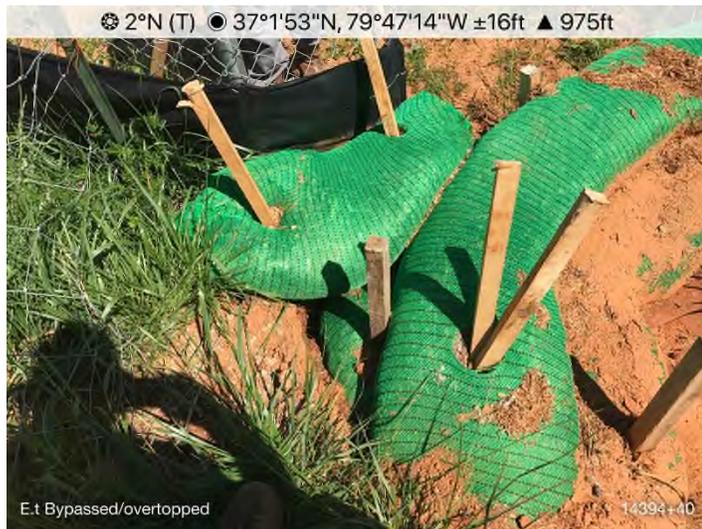
Figure 7: STA 14394+40 – End treatment bypassed.

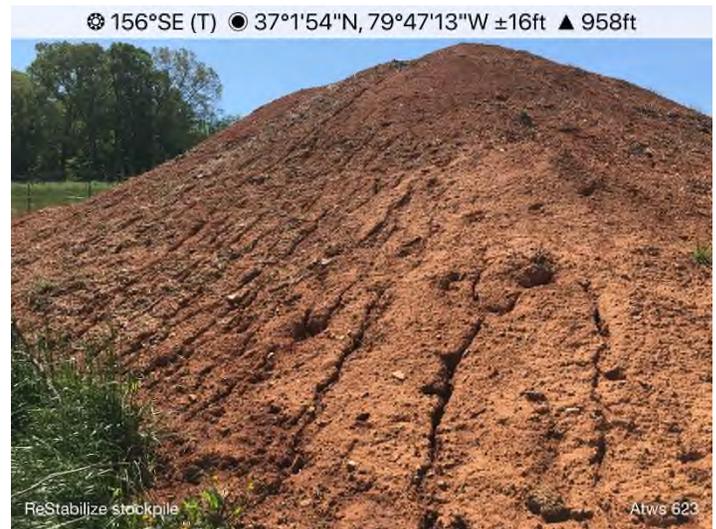
Figure 8: STA 14394+50 – Re-stabilize stockpile in ATWS 623.

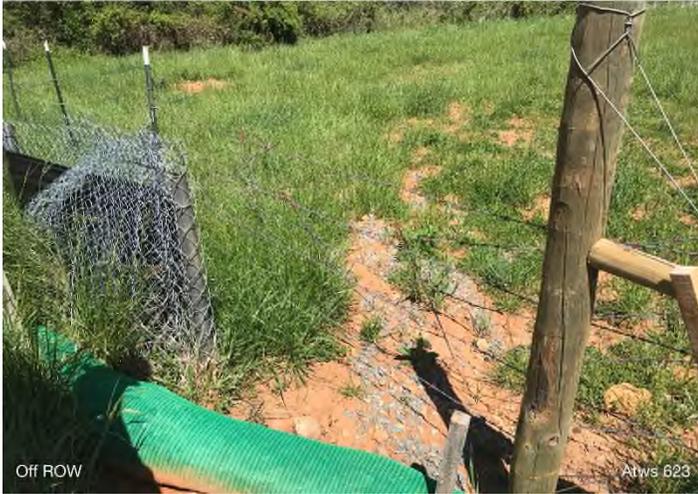
Figure 9: STA 14395+00 – Sediment off ROW from landowner access road.

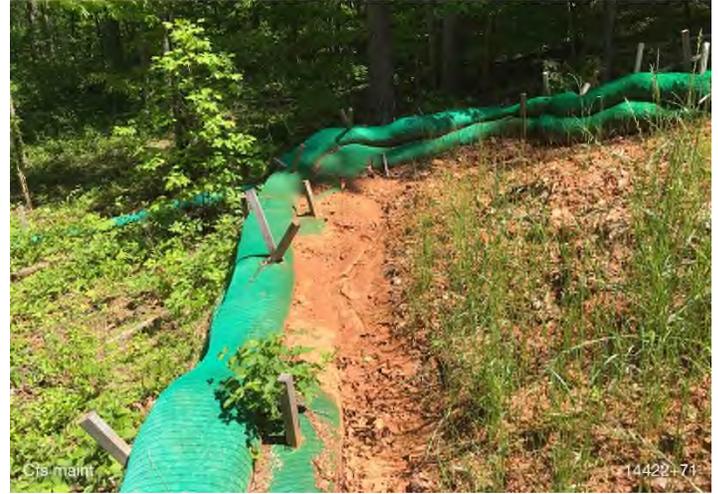
Figure 10: STA 14422+71 – CFS maintenance needed.

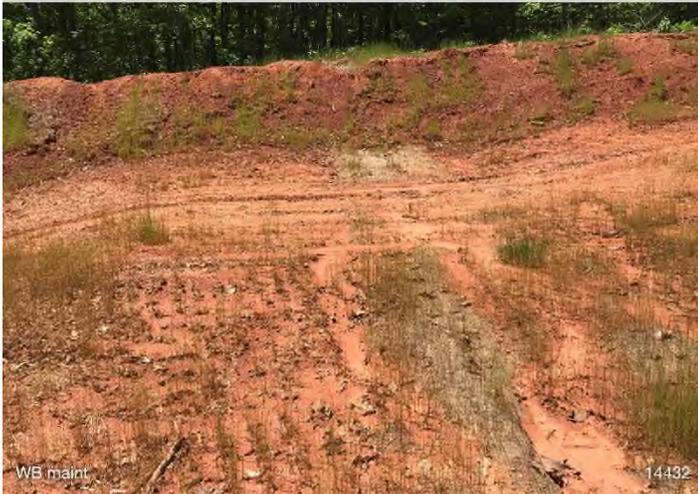
Figure 11: STA 14432+00 – Waterbar maintenance needed.
