## FIELD INSPECTION

Project Name:	Mountain Valley Pipeline	Inspector:	Marshall Willis
Inspection Date:	Monday, May 6, 2019	Project Contact:	Brian Clauto
Spread I: Franklin County	STA 13784+35 – 13826+95 MVP-FR-300/302	Weather (Wet/Dry/Rain):	Wet

# FIELD INSPECTION PHOTO LOG

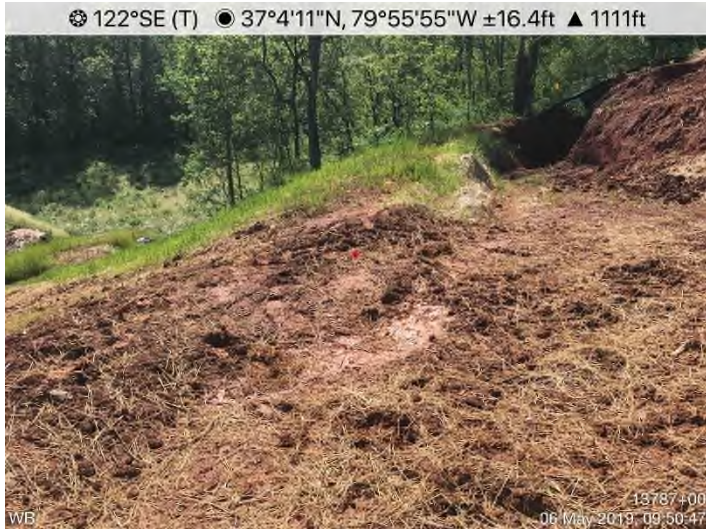
**Fig. 1: STA 13787+00** – Waterbar requires maintenance.

**Recommended Corrective Action:** Maintain and install all controls per the approved plan and specs.

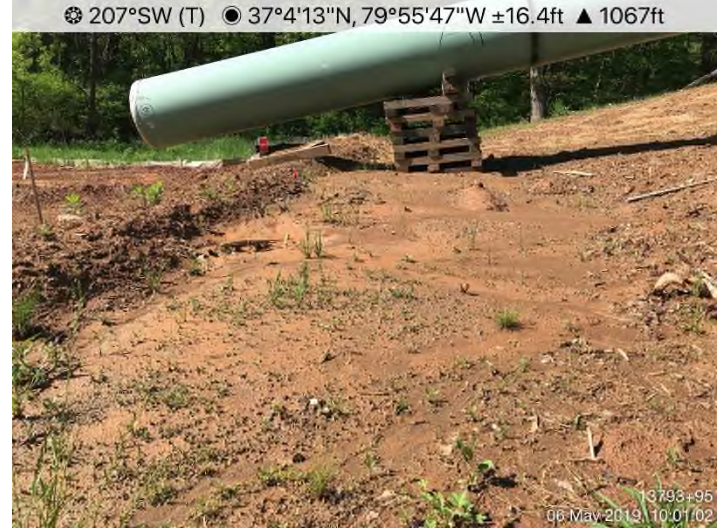
**Fig. 2: STA 13793+95** – Waterbar requires maintenance.

- STA 13797+00: Repair/maintain waterbar.
- STA 13793+95: Repair/maintain waterbar, install per approved PSS&S and stabilize dormant area upslope of waterbar.

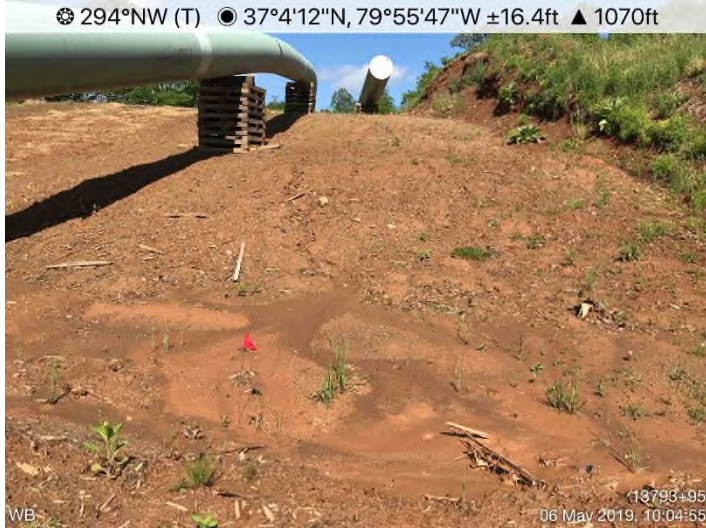
**Fig. 3: STA 13793+95** – Stabilize area upslope of waterbar.

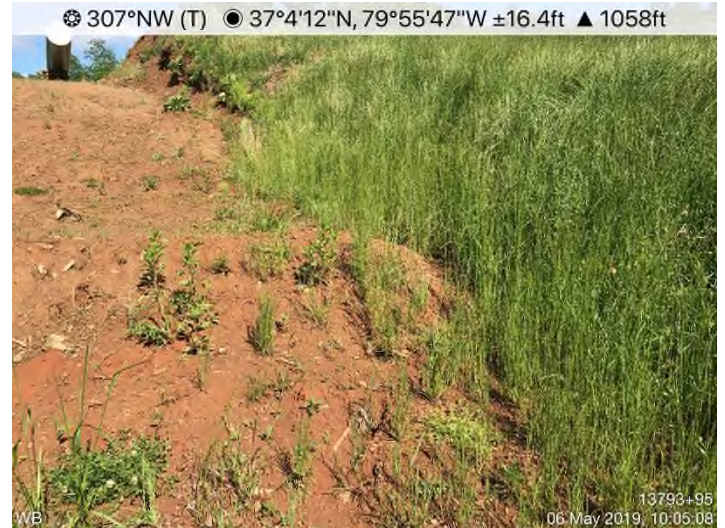
**Fig. 4: STA 13793+95** – Waterbar does not extend to perimeter controls/flow diverting around waterbar.
