FIELD INSPECTION

| Project Name: | Mountain Valley Pipeline | Inspector: | Matthew Grant |
| Inspection Date: | Tuesday, May 7, 2019 | Project Contact: | Brian Clauto |
| Spread: Pittsylvania County MP285.8-284.9 | Spread I | Weather (Wet/Dry/Rain): | Dry |

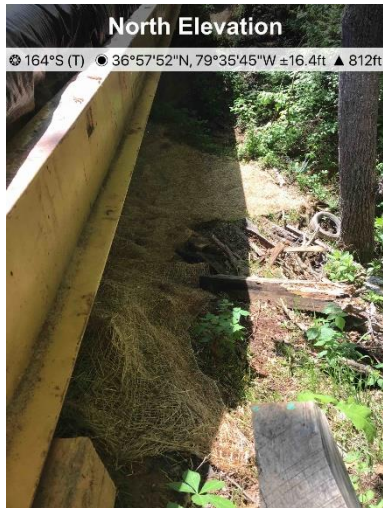
- Fig. 1 GAS-D1-EPH has had bank repair conducted per previous inspection dated 3/6/19.

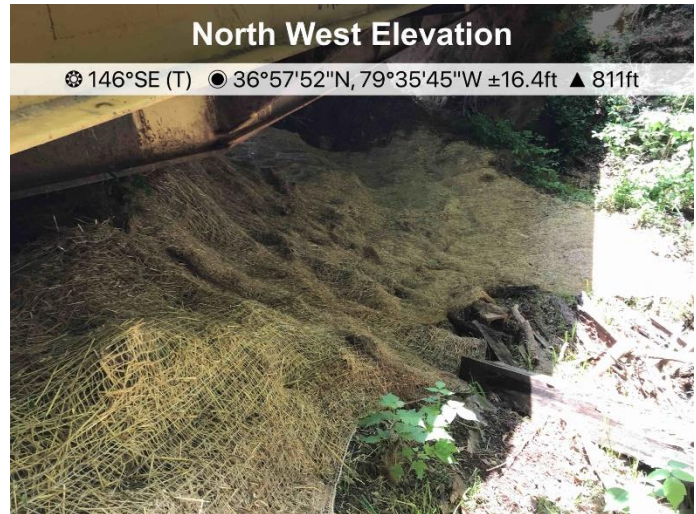
- Fig. 2 GAS-D1-EPH has had bank repair conducted per previous inspection dated 3/6/19.

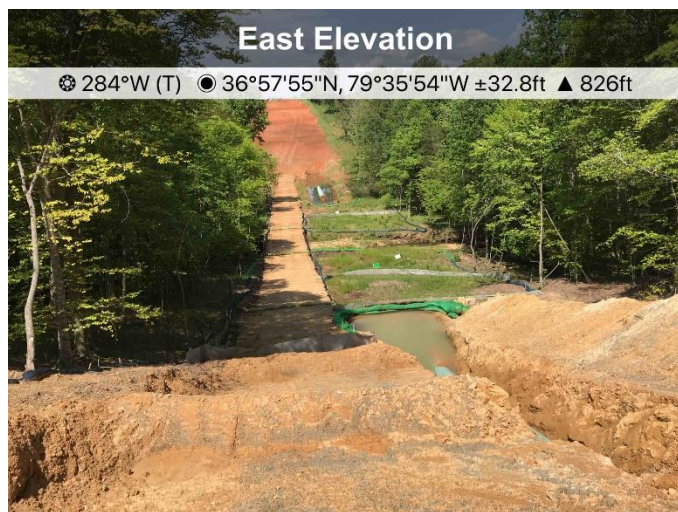
- Fig. 3 Above designated stream S-D2 and wetland W-D3, ECD's are in place and functioning.
