FIELD INSPECTION REPORT

Project Name:	Mountain Valley Pipeline	Inspector:	Marshall Willis
Inspection Date:	Monday, June 1, 2020	Project Contact:	Brian Clauto, Cory Chalmers
Spread I: Franklin County	STA 13437+75 – 13541+66 MVP-FR-293.02 ATWS 1414/1253/1252/1066	Weather:	Dry

FIELD INSPECTION PHOTO LOG

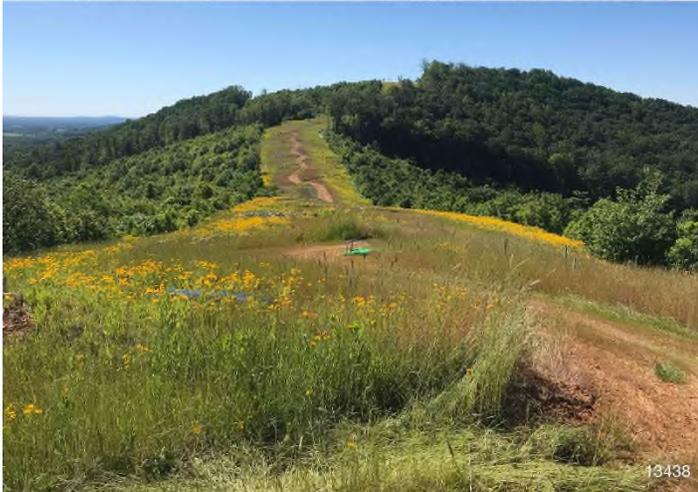
13438

Figure 1: STA 13438+00 – Controls in place and functioning properly. Area stabilized.

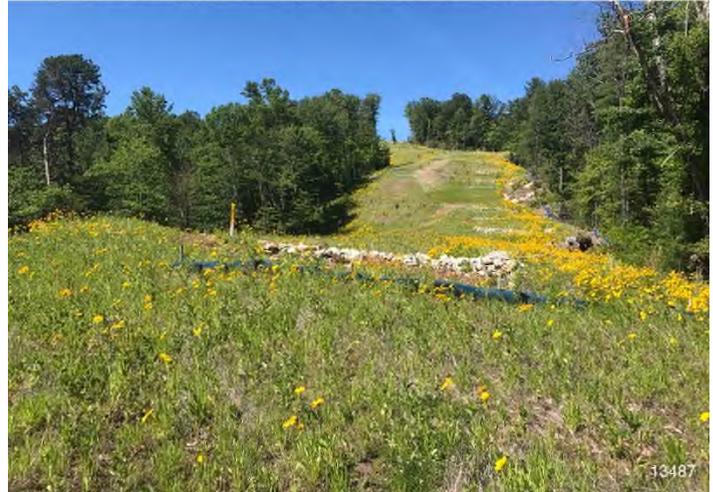
13487

Figure 2: STA 13487+00 – Controls in place and functioning properly. Area stabilized.

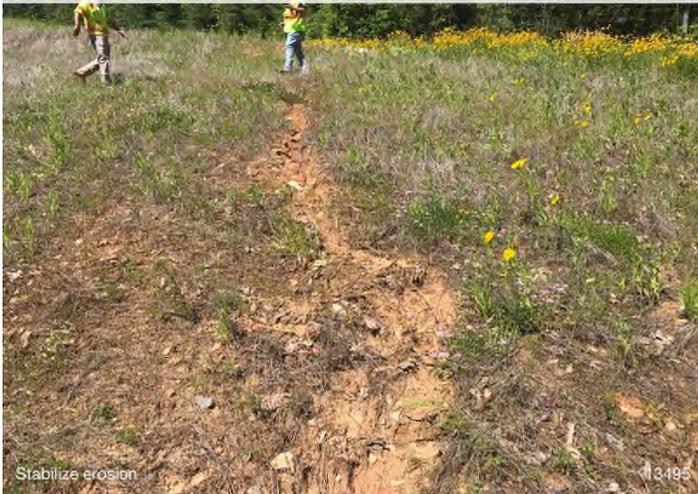
13495

Figure 3: STA 13495+00 – Rill erosion forming in permanently stabilized area. Repair erosion and re-stabilize.

Routine Maintenance: (*72-Hour Deadline from Notification*)
 - STA 13495+00: Repair re-stabilize erosion.

Stabilize erosion

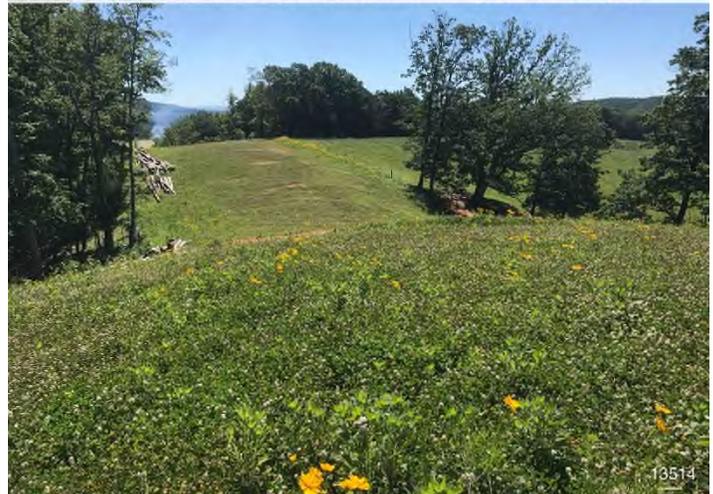
13514

Figure 4: STA 13514+00 – Controls in place and functioning properly. Area stabilized.
