FIELD INSPECTION REPORT

Project Name:	Mountain Valley Pipeline	Inspector:	Marshall Willis
Inspection Date:	Wednesday, June 10, 2020	Project Contact:	Brian Clauto, Cory Chalmers
Spread I: Franklin County	STA 14861+31 – 14981+55 ATWS 376/540/541/377/1364/380	Weather:	Dry

FIELD INSPECTION PHOTO LOG

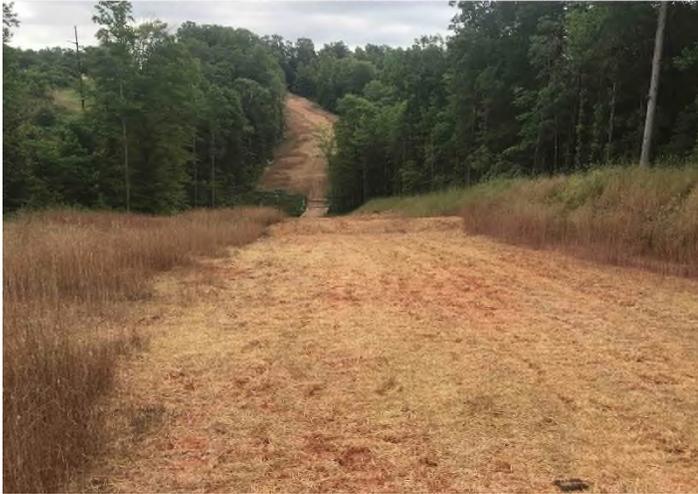
Figure 1: STA 14850+00 – Controls in place and functioning properly. Area stabilized with straw and vegetation.

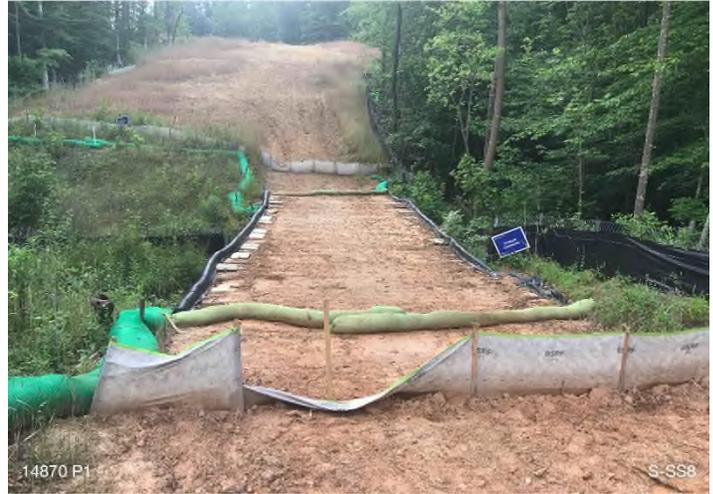
- STA 14870+00: P1 repair needed at Stream S-SS8 crossing.
- STA 14871+50: Waterbar repair needed. Waterbar filled in and does not meet height spec.
- STA 14904+00: Waterbar repair needed. Discharge topping WB causing rilling.

Figure 2: STA 14870+00 – P1 repair needed.

Recommended Corrective Action: Maintain and install all controls per the approved PSS&S.

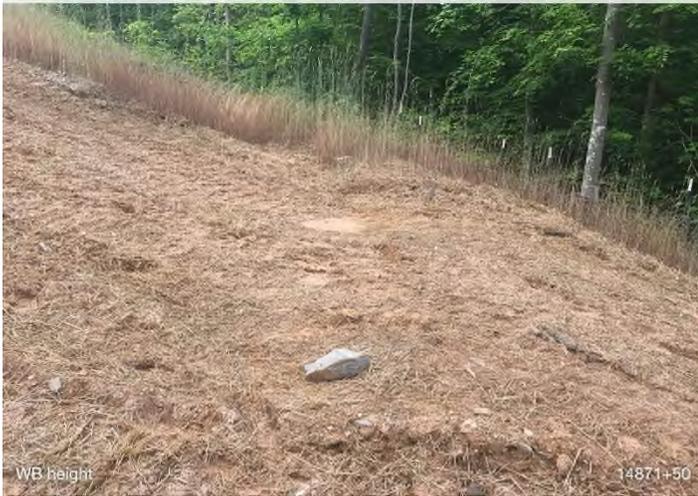
Figure 3: STA 14871+00 – Water bar repair needed. Does not meet height specification.

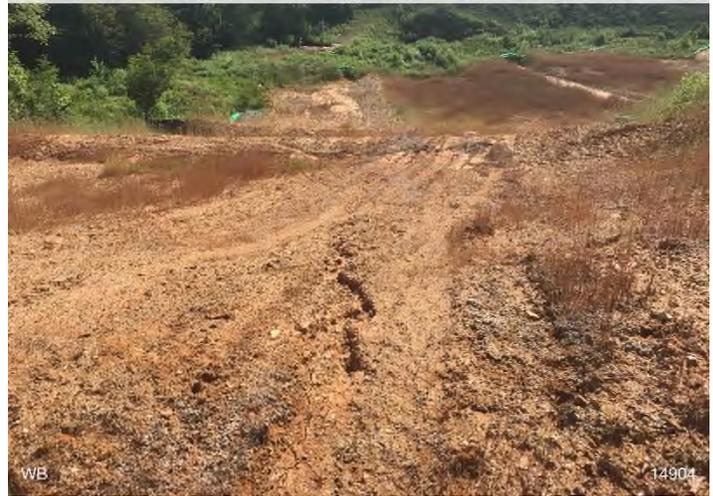
Figure 4: STA 14901+00 – Waterbar repair needed. Discharge overtopping causing rilling.
