FIELD INSPECTION

Project Name:	Mountain Valley Pipeline	Inspector:	Matthew Grant
Inspection Date:	Wednesday, June 12, 2019	Project Contact:	Brian Clauto
Spread: Pittsylvania County AR32 MP269-269	Spread I	Weather (Wet/Dry/Rain):	Dry

FIELD INSPECTION PHOTO LOG

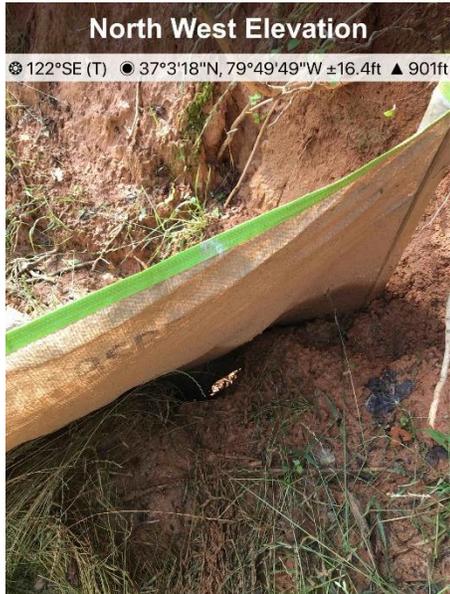
Fig. 1 St1423+00 undermined P1 fence

Recommended Corrective Action: Maintain all controls per the approved plan and specs and remove escaped sediment and bridge debris.

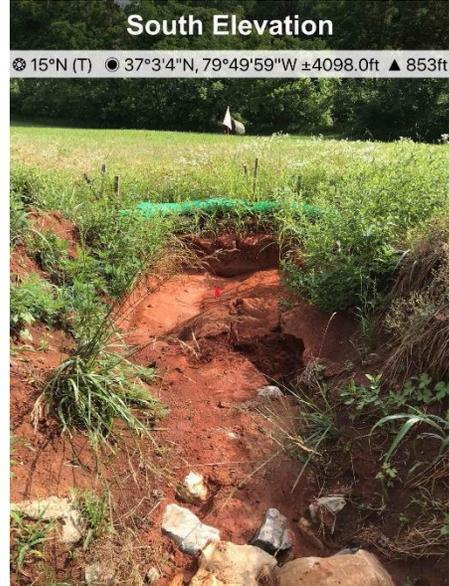
Fig. 2 St14219-14244+34 three sumps require maintenance

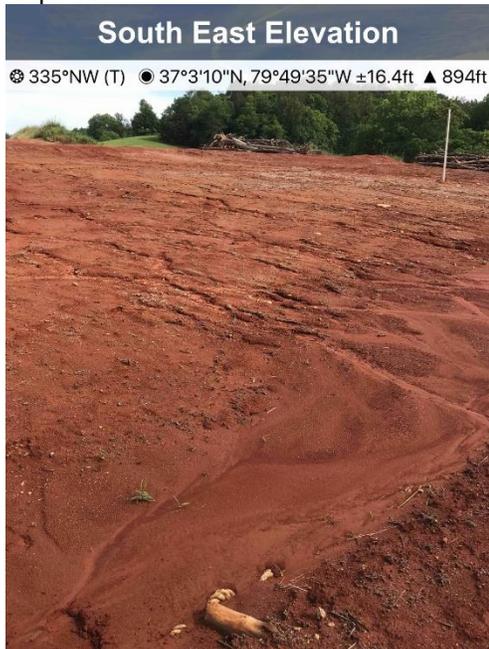
Fig. 3 St14248+12 evidence of rill erosion and flow path requires maintenance

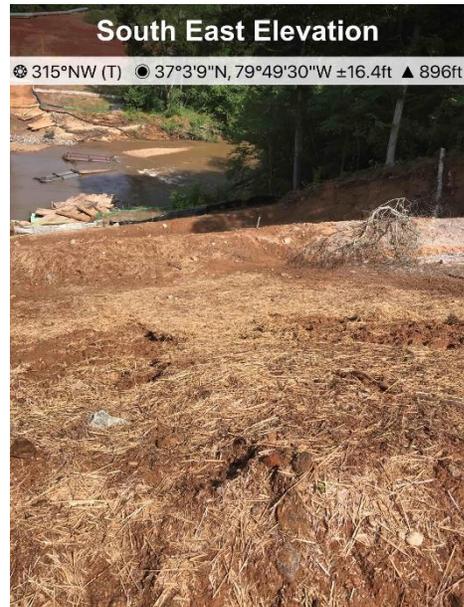
Fig. 4 St14251+97 slip on slope

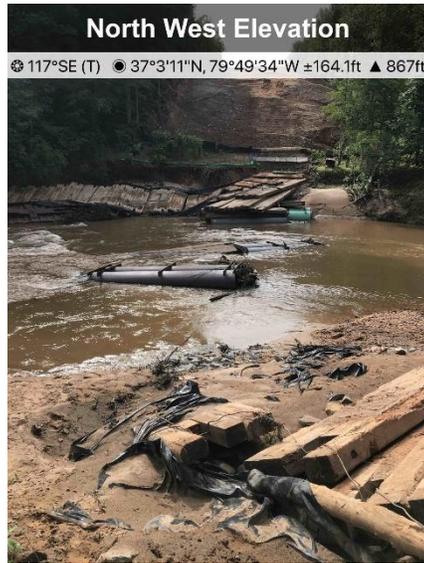
- Fig. 5 S-F11 bridge has been destroyed and debris is off the ROW

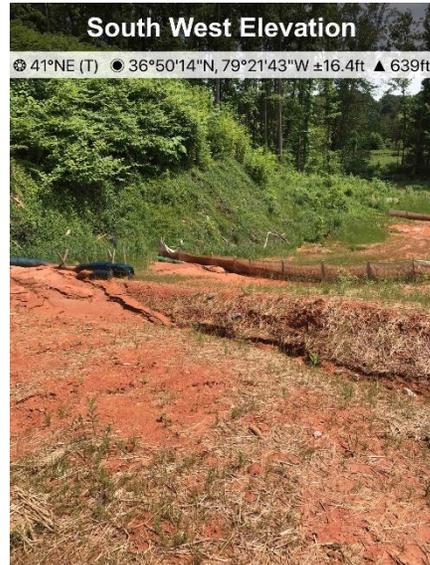
- Fig. 6 St15919+20 CFS and P1 requires maintenance

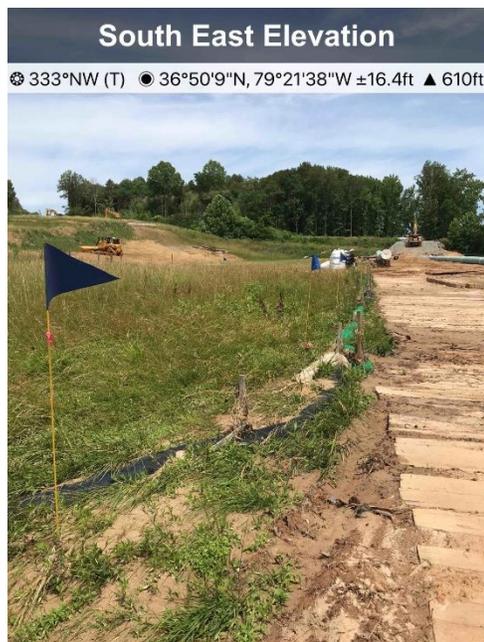
- Fig. 7 St15964+51-15947+75 escaped sediment in wetlands

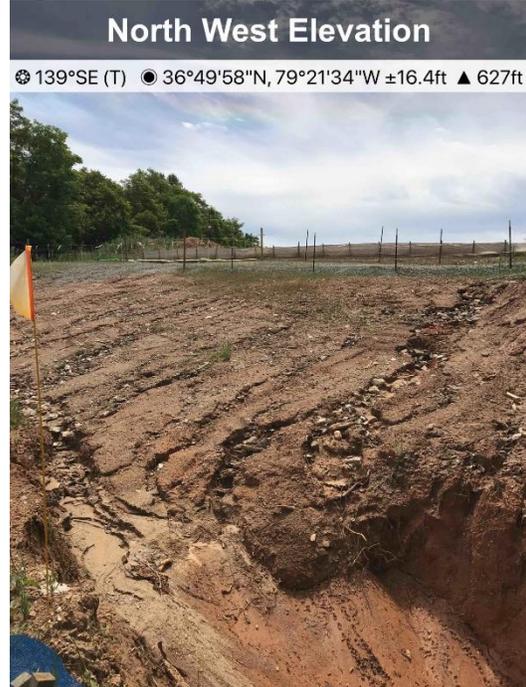
- Fig. 8 St15964+00 rill erosion leading to sump
