FIELD INSPECTION

Project Name:	Mountain Valley Pipeline	Inspector:	Marshall Willis
Inspection Date:	Wednesday, June 12, 2019	Project Contact:	Brian Clauto
Spread I: Franklin County	STA 14062+17 – 14171+36 STA 13415+51 – 13437+75	Weather (Wet/Dry/Rain):	Wet

FIELD INSPECTION PHOTO LOG

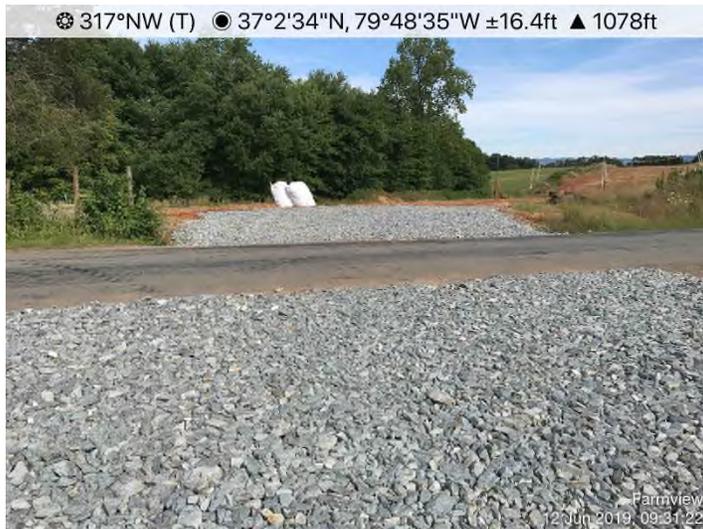
Fig. 1: STA 13415+51 – Controls in place.

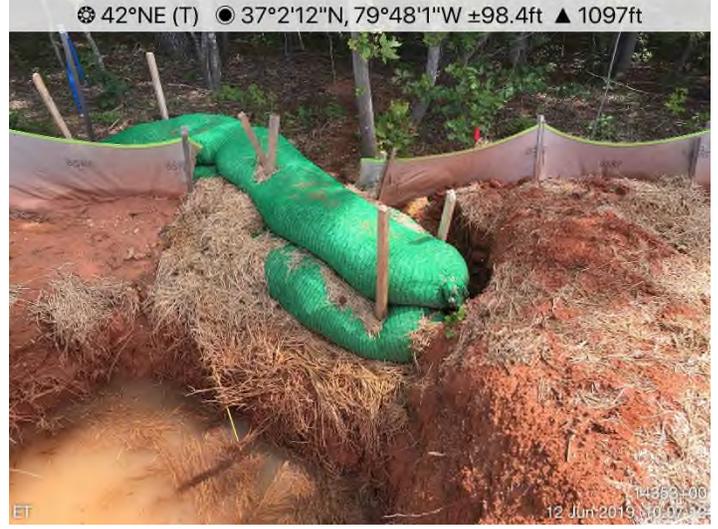
STA 14351+00: Discharge bypassing end treatment.
 STA 14351+00: Sediment off ROW.
 STA 14351+00 to 14352+00: P1 undermined.
 STA 14352+00: CFS undermined.
 ATWS 1351: Properly store fertilizer per SWPPP.
 STA 13434+00: CFS undermined.

Fig. 2: STA 14351+00 – Discharge bypassing end treatment.

Recommended Corrective Action: Maintain and install all controls per the approved plan and specs.

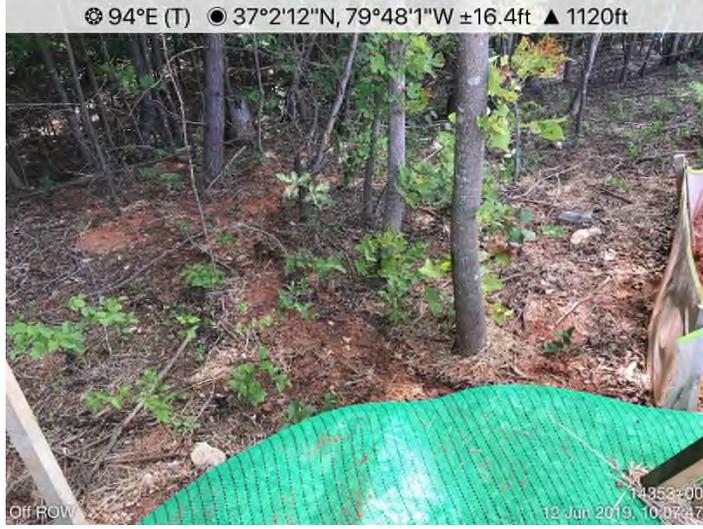
Fig. 3: STA 14351+00 – Sediment off ROW.

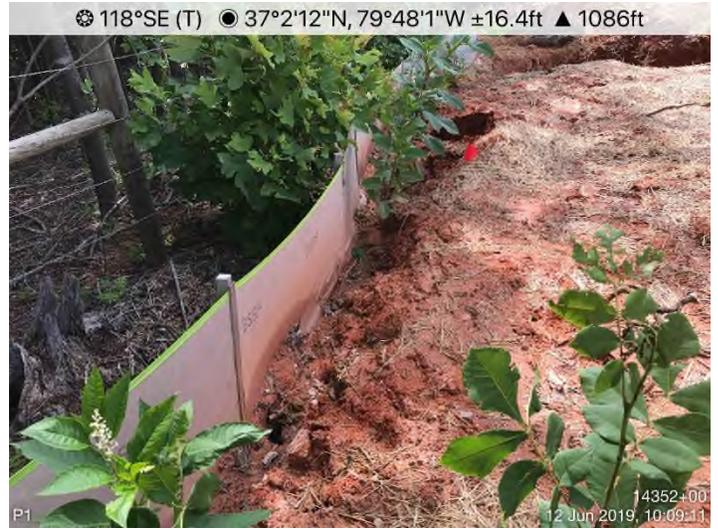
Fig. 4: STA 14351+00 to 14352+00 – P1 undermined.

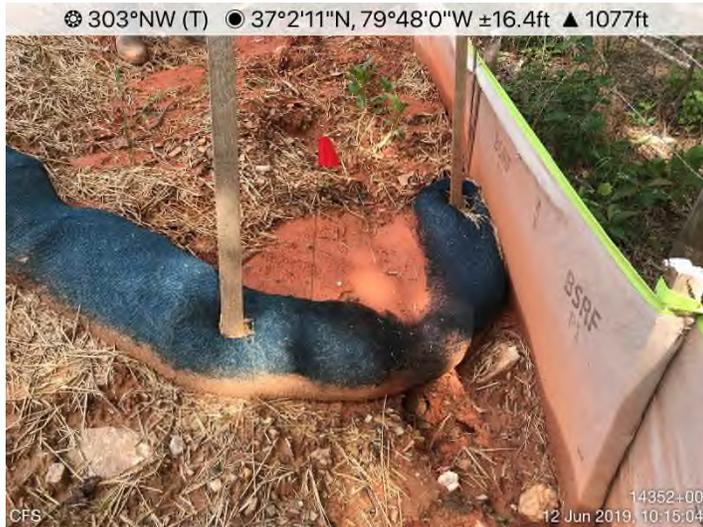
Fig. 5: STA 14352+00 – CFS requires maintenance.

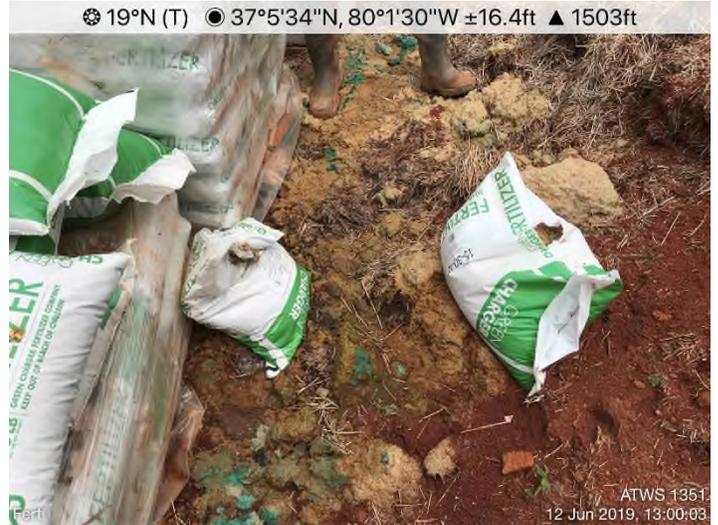
Fig. 6: ATWS 1351 – Opened fertilizer improperly stored.

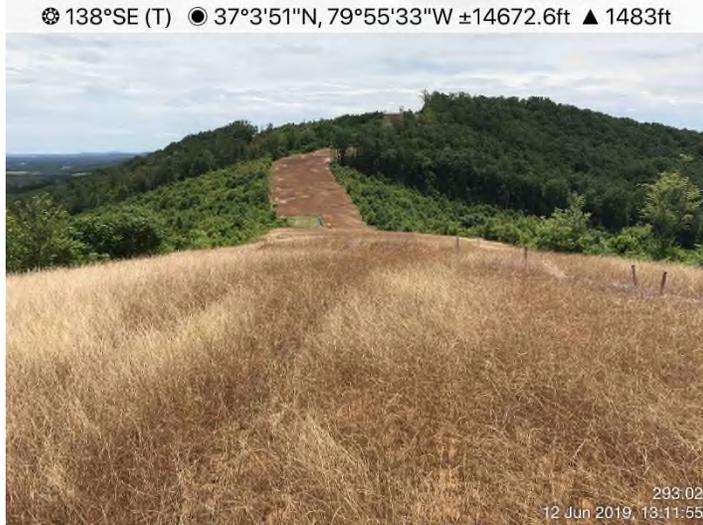
Fig. 7: STA 13436+00 – Controls in place. Area stabilized.

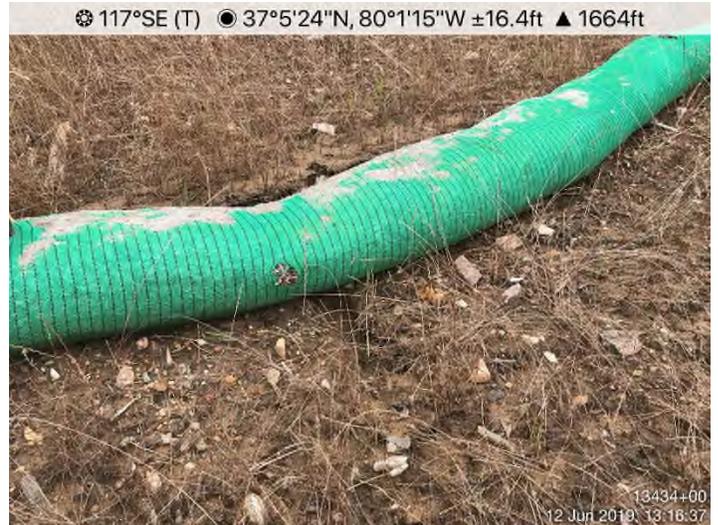
Fig. 8: STA 13434+00 – CFS undermined.
