## FIELD INSPECTION REPORT

<b>Project Name:</b>	Mountain Valley Pipeline	<b>Inspector:</b>	Marshall Willis
<b>Inspection Date:</b>	Monday, June 15, 2020	<b>Project Contact:</b>	Brian Clauto, Cory Chalmers
<b>Spread I: Franklin County</b>	STA 13539+00 – 13544+00 STA 13627+50 – 13658+80 STA 13676+00 – 13692+00	<b>Weather:</b>	Rainy

## FIELD INSPECTION PHOTO LOG

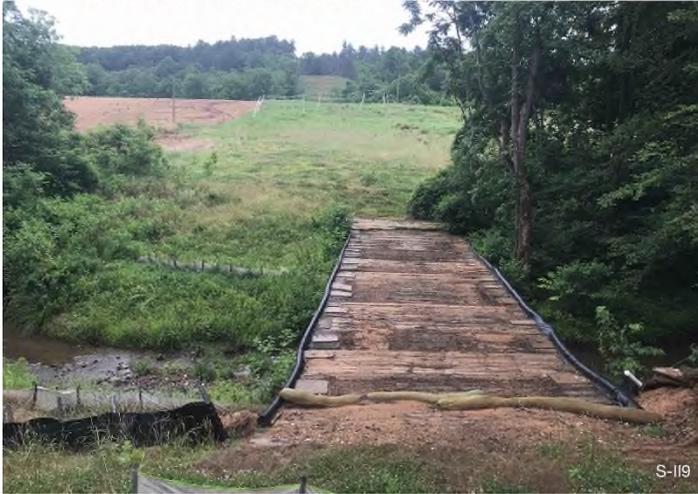
**Figure 1: Stream S-II9** – Controls in place and functioning properly.

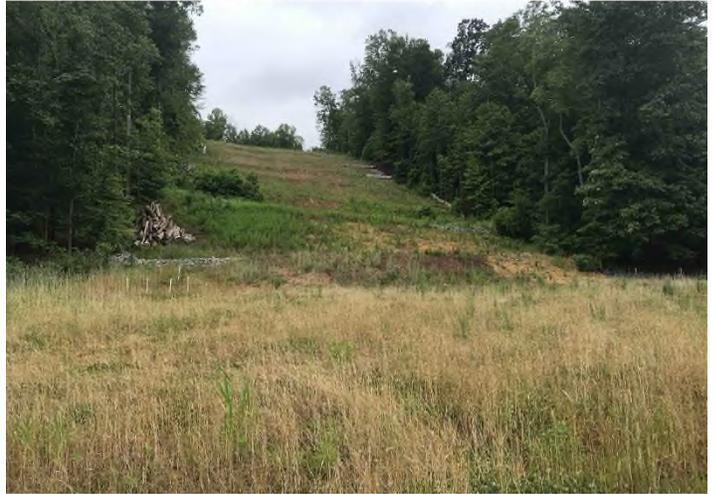
**Figure 2: STA 13632+00** – Controls in place and functioning properly.

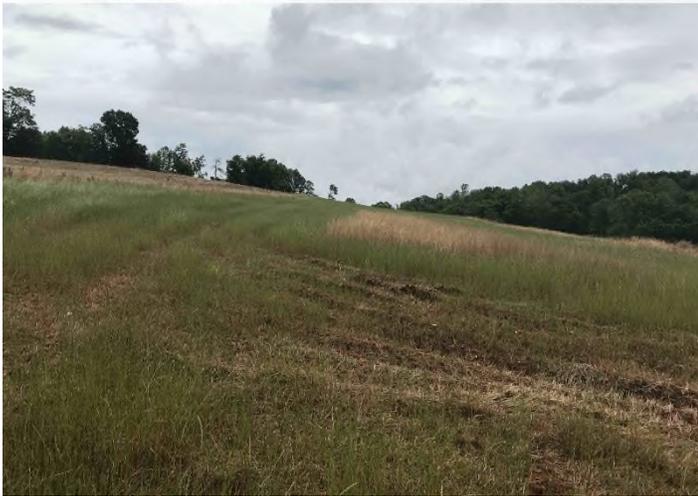
**Figure 3: STA 13645+00** – Controls in place and functioning properly.

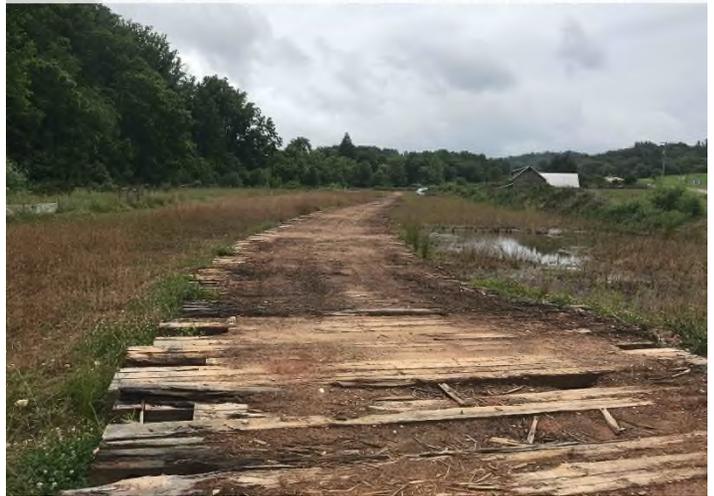
**Figure 4: STA 13687+00** – Controls in place and functioning properly.
