## FIELD INSPECTION REPORT

<b>Project Name:</b>	Mountain Valley Pipeline	<b>Inspector:</b>	Marshall Willis
<b>Inspection Date:</b>	Wednesday, June 17, 2020	<b>Project Contact:</b>	Brian Clauto, Cory Chalmers
<b>Spread I: Franklin County</b>	STA 13995+00 – 14000+00 MVP-FR-306.02 LY 032/033	<b>Weather:</b>	Rainy

## FIELD INSPECTION PHOTO LOG

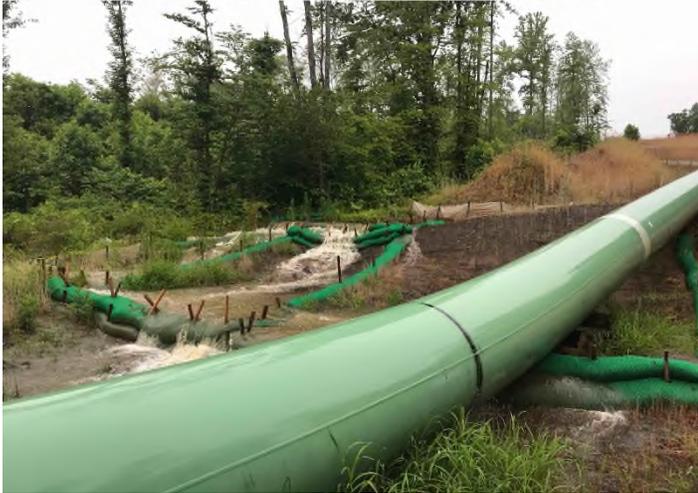
**Figure 1: STA 13998+50** – Offsite pond overflow onto ROW. Additional controls installed to slow and treat discharge from pond emergency spillway.

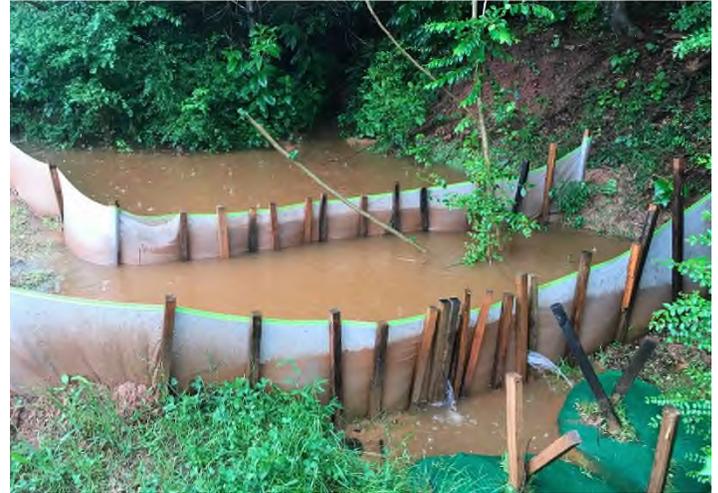
**Figure 2: STA 13997+00** – Sediment flowing onto ROW from offsite source. Additional controls installed to trap and treat stormwater prior to entering workspace.

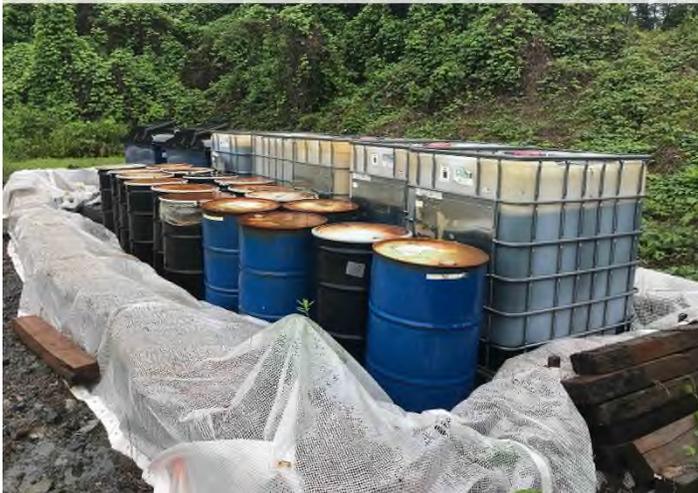
**Figure 3: Laydown Yard 032** – Controls in place and functioning properly.

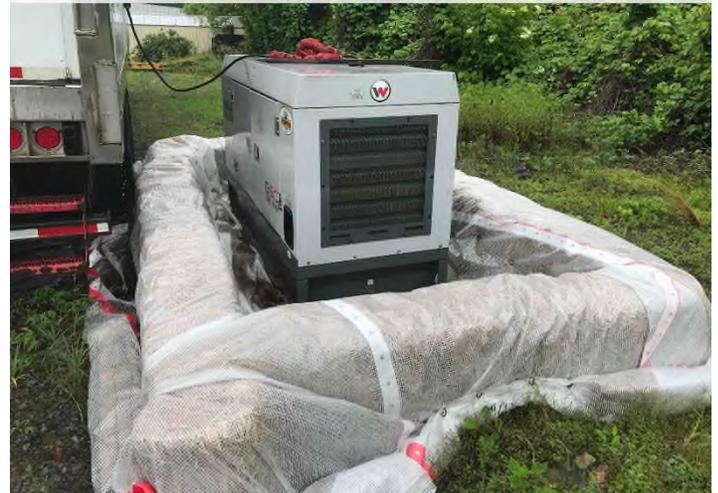
**Figure 4: Laydown Yard 032** – Controls in place and functioning properly.
