FIELD INSPECTION

Project Name:	Mountain Valley Pipeline	Inspector:	Marshall Willis
Inspection Date:	Thursday, June 20, 2019	Project Contact:	Brian Clauto
Spread I: Franklin County Pittsylvania County	STA 15826+77 – 15947+64 STA 14400+00 – 14411+04 MVP-FR-315	Weather (Wet/Dry/Rain):	Wet

FIELD INSPECTION PHOTO LOG

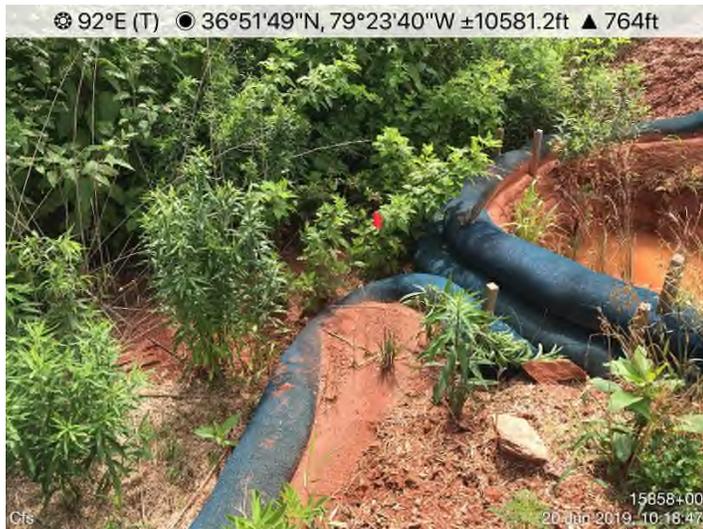
Fig. 1: STA 15858+00 – CFS maintenance needed.

Recommended Corrective Action: Maintain and install all controls per the approved plan and specs.

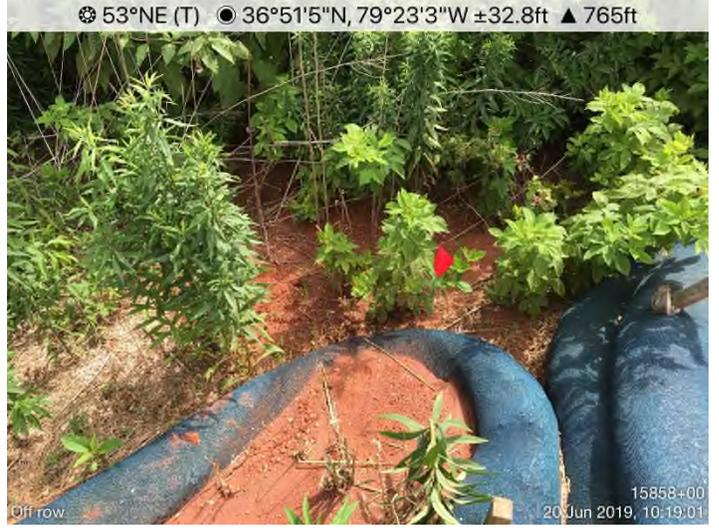
Fig. 2: STA 15858+00 – Sediment off ROW.

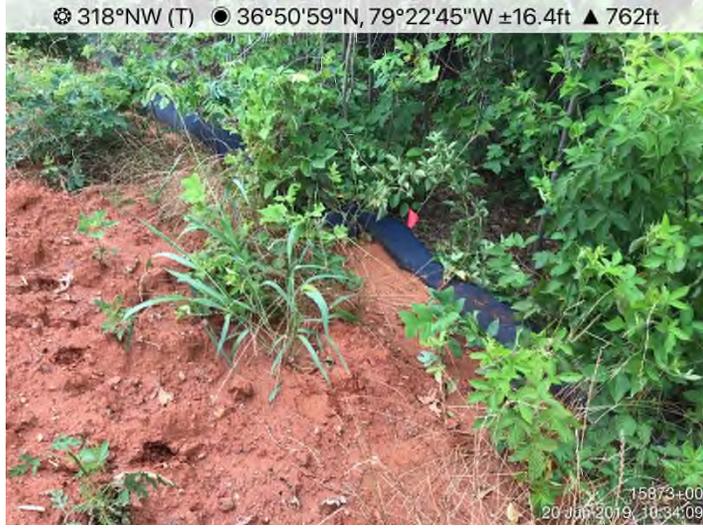
Fig. 3: STA 15873+00 – CFS maintenance needed.

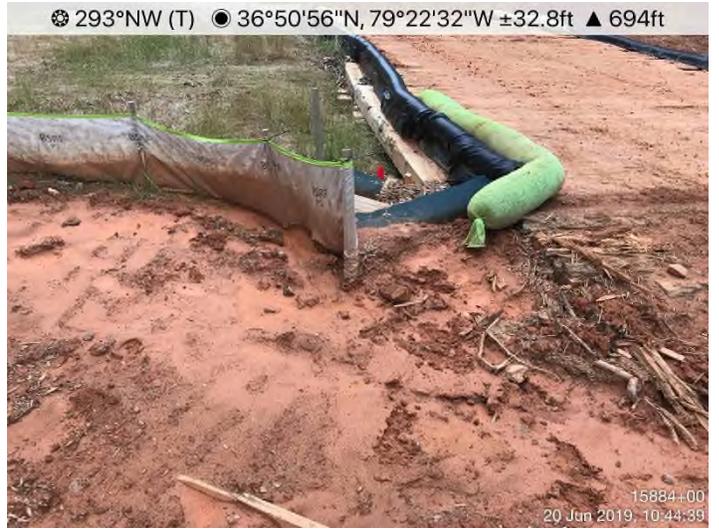
Fig. 4: STA 15884+00 – CFS maintenance needed.

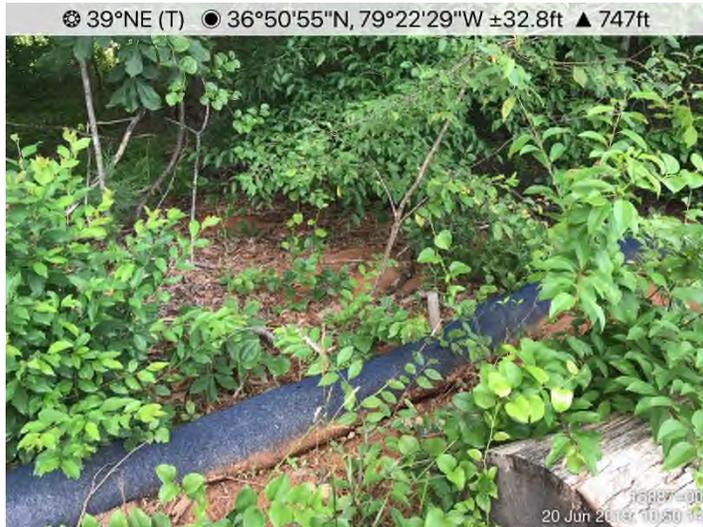
Fig. 5: STA 15887+00 – Sediment off ROW.

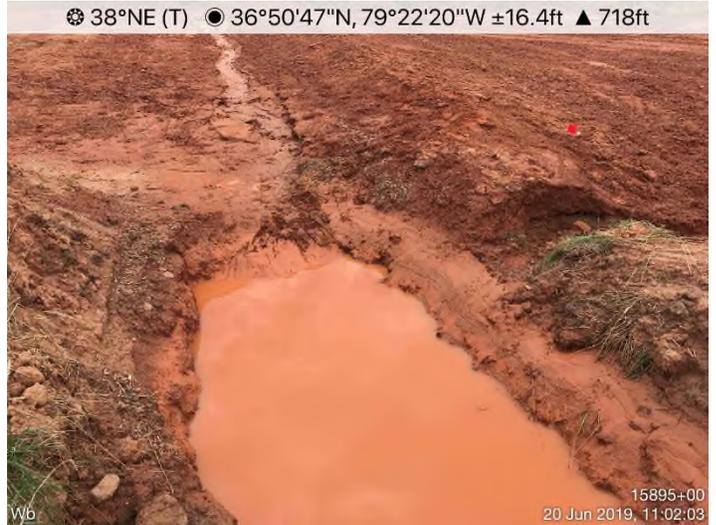
Fig. 6: STA 15895+00 – Waterbar maintenance needed.

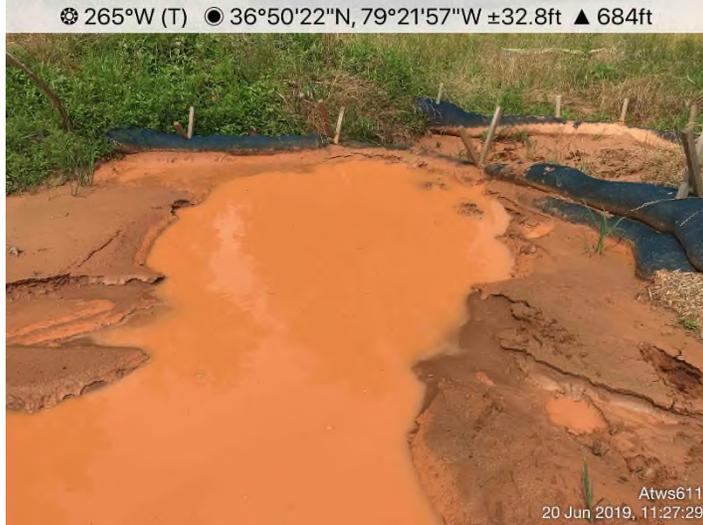
Fig. 7: ATWS 611 – CFS maintenance needed.

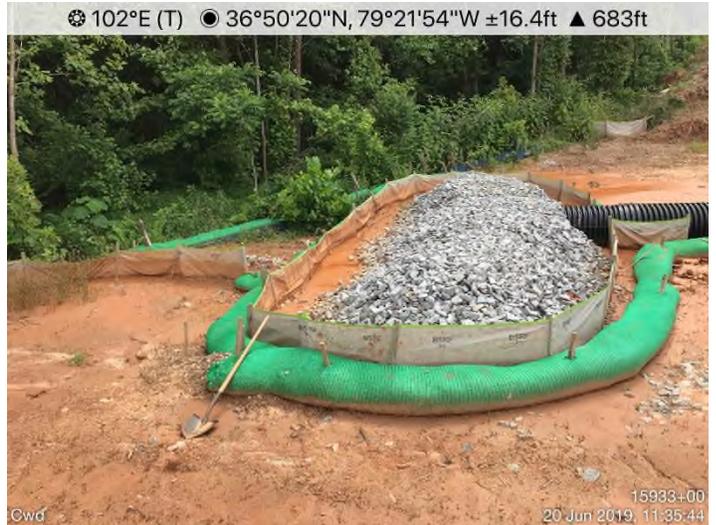
Fig. 8: STA 15933+00 – Sediment accumulation inside CWD outlet. Inadequate protection from onsite discharge.

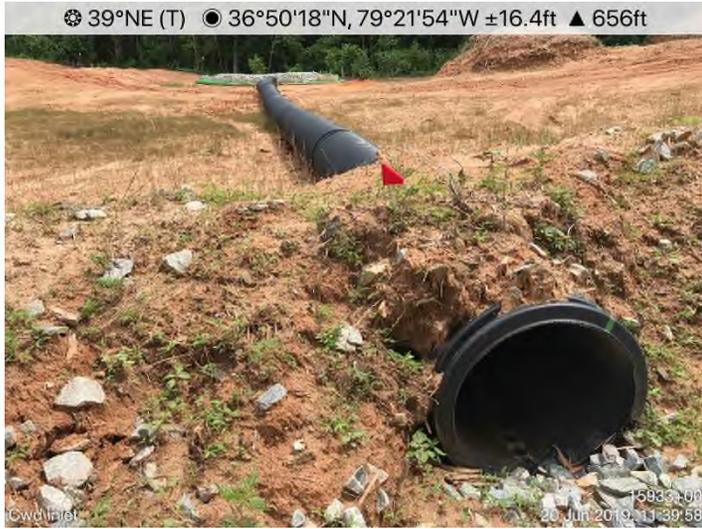
Fig. 9: STA 15933+00 – CWD inlet not functioning.

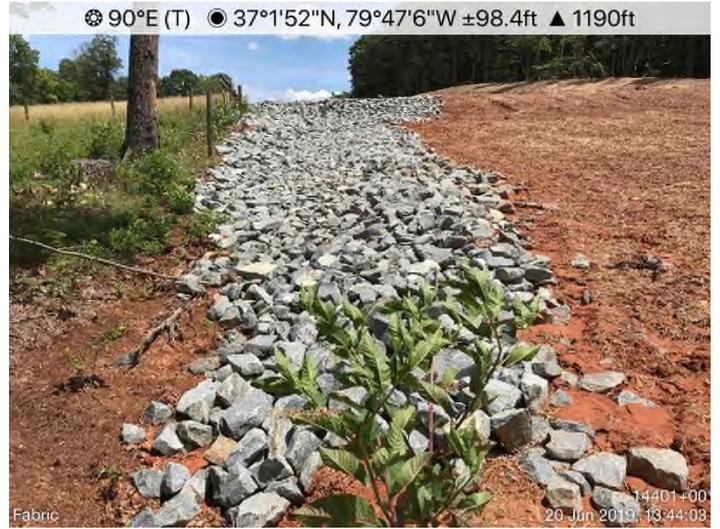
Fig. 10: STA 14401+00 – Riprap channel does not have fabric underlayment.
