FIELD INSPECTION

Project Name:	Mountain Valley Pipeline	Inspector:	Matthew Grant
Inspection Date:	Wednesday, June 26, 2019	Project Contact:	Brian Clauto
Spread: Franklin County AR32 MP269 MP265.5-266.5 Pittsylvania Co. MP 301 15419-159641	Spread I	Weather (Wet/Dry/Rain):	Dry

FIELD INSPECTION PHOTO LOG

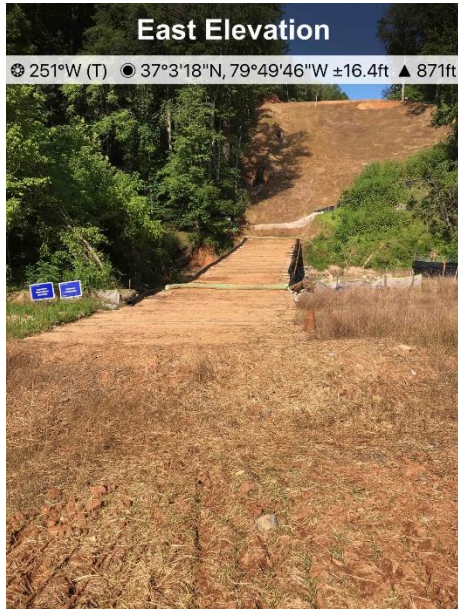
Fig. 1 ECD are in place at designated stream S-C19

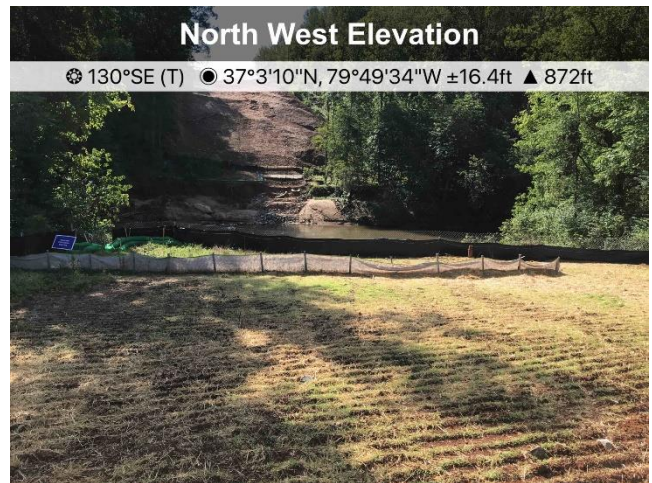
Fig. 2 At designated stream S-F11, bridge debris has been removed.

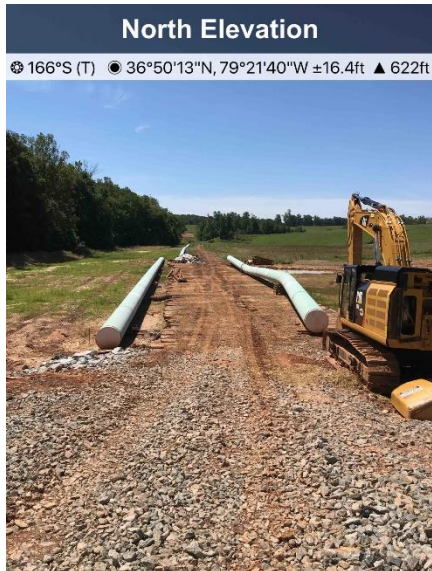
Fig. 3 Mat crossing material has been repaired at designated stream and wetland crossings W-H2, W-H3 and S-H5

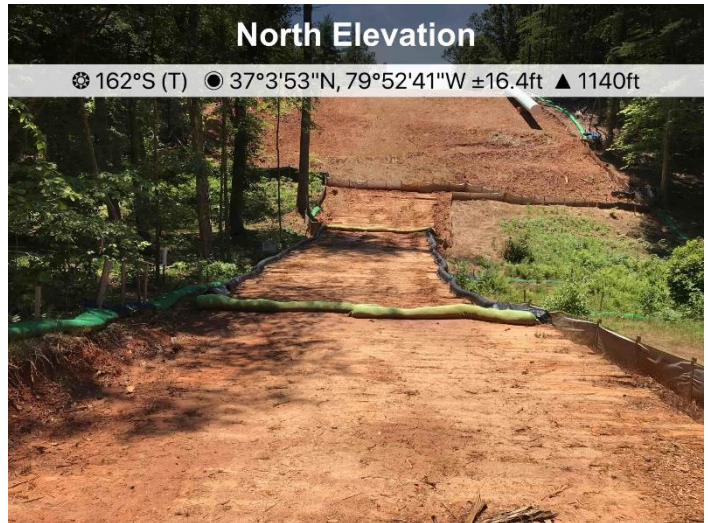
Fig. 4 ECD controls are in place at designated stream S-KL41
