FIELD INSPECTION

| Project Name: | Mountain Valley Pipeline | Inspector: | Marshall Willis |
| Inspection Date: | Friday, June 28, 2019 | Project Contact: | Brian Clauto |
| Spread I: Pittsylvania County | STA 15296+00 – 15370+62 STA 15647+03 – 15648+03 | Weather (Wet/Dry/Rain): | Dry |

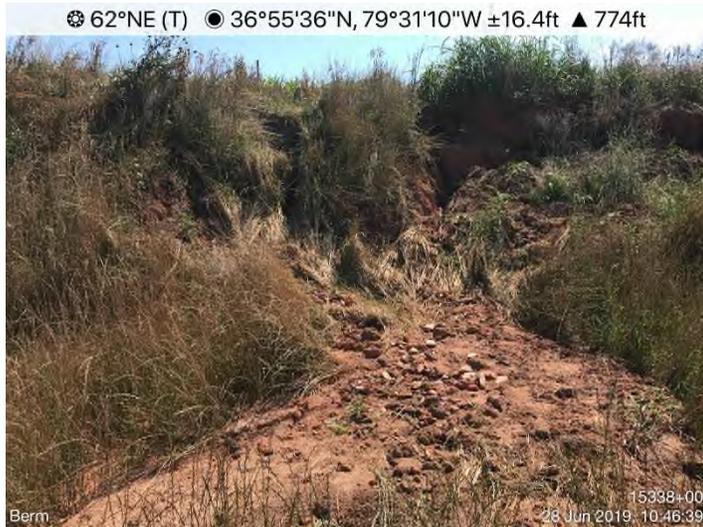
Fig. 5: STA 15338+00 – Perimeter berm failure at CWD drop inlet.

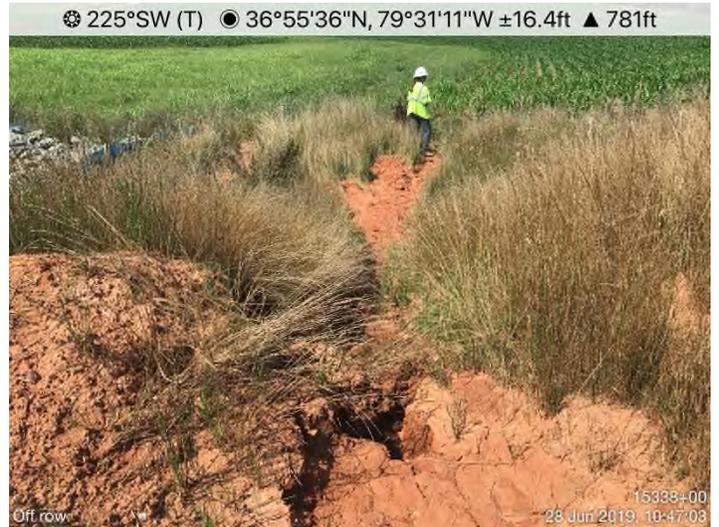
Fig. 6: STA 15338+00 – Sediment off ROW.

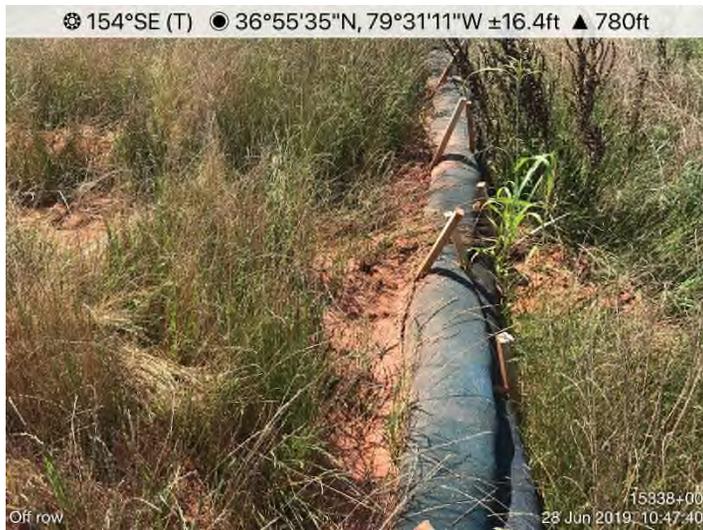
Fig. 7: STA 15338+00 – CFS maintenance needed.

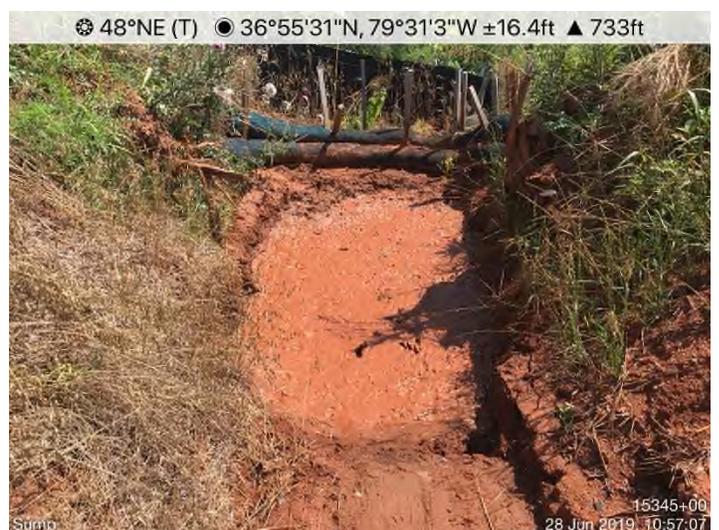
Fig. 8: STA 15345+00 – Sump maintenance needed.

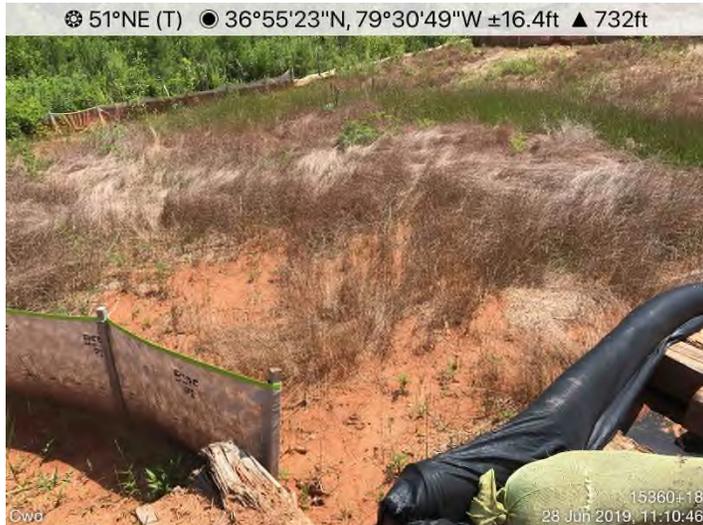
Fig. 9: **STA 15360+18** – Onsite sediment discharging into CWD swale.
