FIELD INSPECTION REPORT

| Project Name: | Mountain Valley Pipeline | Inspector: | Marshall Willis |
| Inspection Date: | Thursday, June 4, 2020 | Project Contact: | Brian Clauto, Cory Chalmers |
| Spread I: Franklin County | STA 13852+46 – 13958+31 MVP-FR-303.01/305 ATWS 1040/1041/518/519/697/1299 | Weather: | Dry |

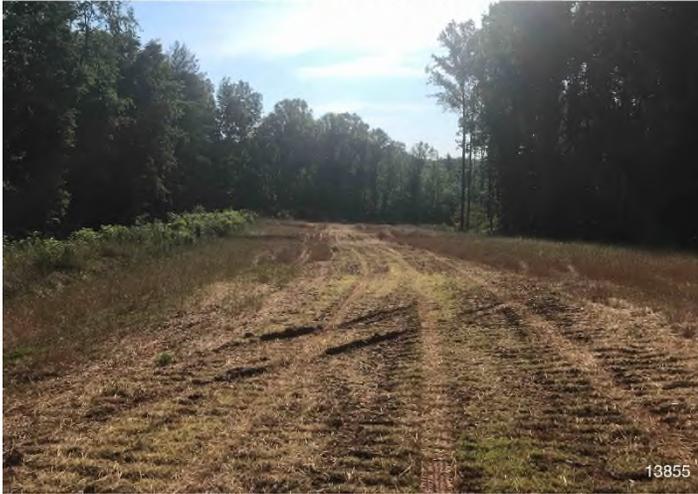
Figure 1: STA 13855+00 – Controls in place and functioning properly. Area stabilized.

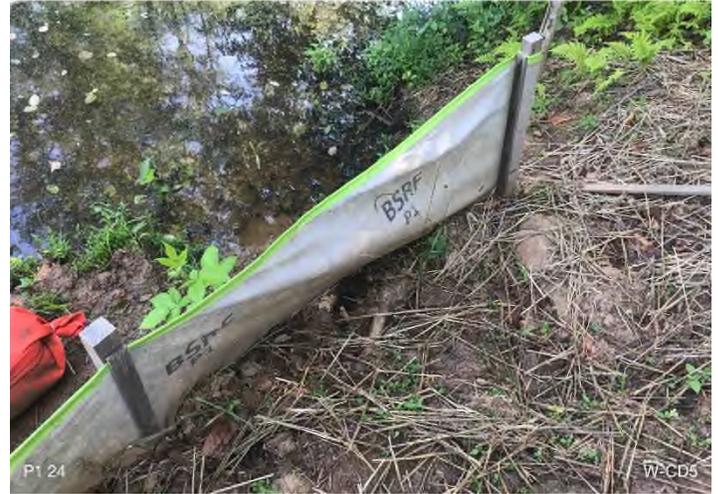
- STA 13890+00: P1 undermined above wetland W-CD5. Repair needed.

Figure 2: STA 13890+00 – P1 undermined above Wetland W-CD5. Repair needed.

Recommended Corrective Action: Maintain and install all controls per the approved PSS&S.

Deadline: Within 24-Hour of Notification

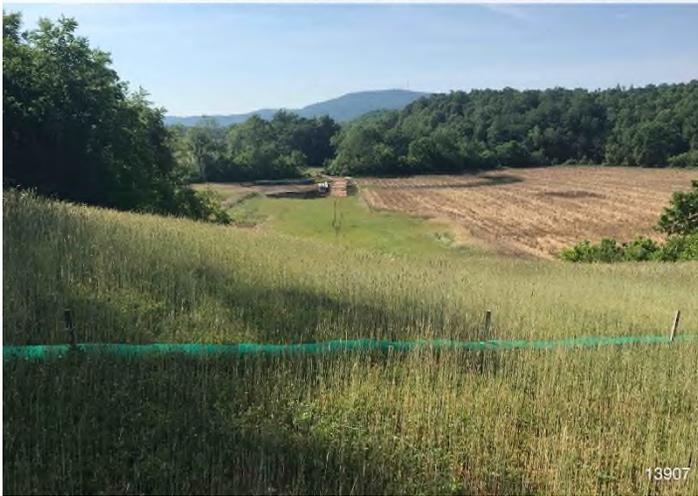
Figure 3: STA 13907+00 – Controls in place and functioning properly. Area stabilized.

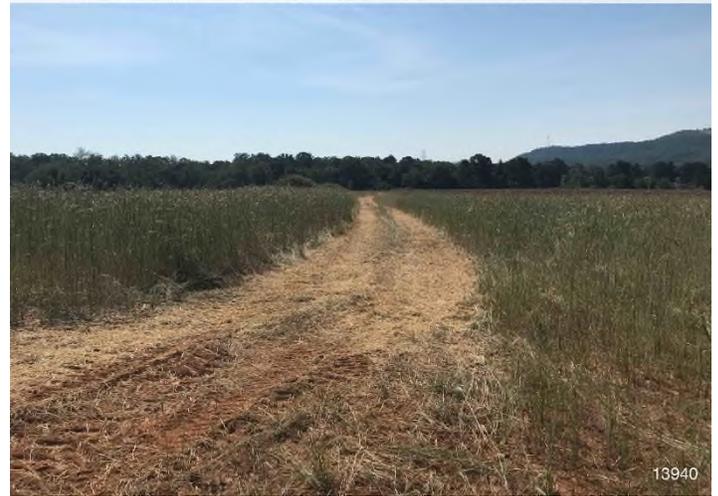
Figure 4: STA 13940+00 – Controls in place and functioning properly. Area stabilized.
