FIELD INSPECTION REPORT

Project Name:	Mountain Valley Pipeline	Inspector:	Marshall Willis
Inspection Date:	Wednesday, July 1, 2020	Project Contact:	Brian Clauto, Cory Chalmers
Spread I: Franklin County	STA 14062+00 – 14171+36 ATWS 1472/1473/1478/1479/1480	Weather:	Dry

FIELD INSPECTION PHOTO LOG

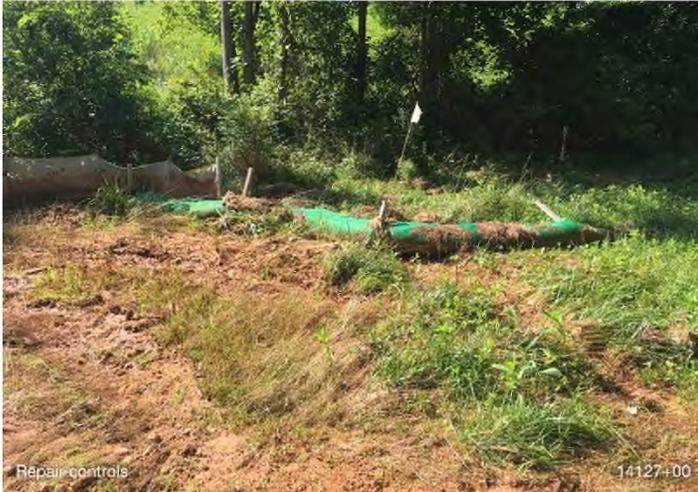
Figure 1: STA 14127+00 – Perimeter controls in need of repair.

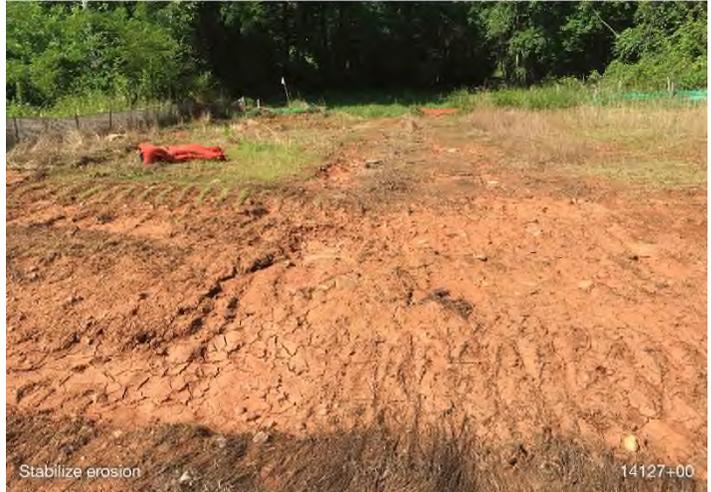
Figure 2: STA 14127+00 – Repair and stabilize erosion above damaged controls.

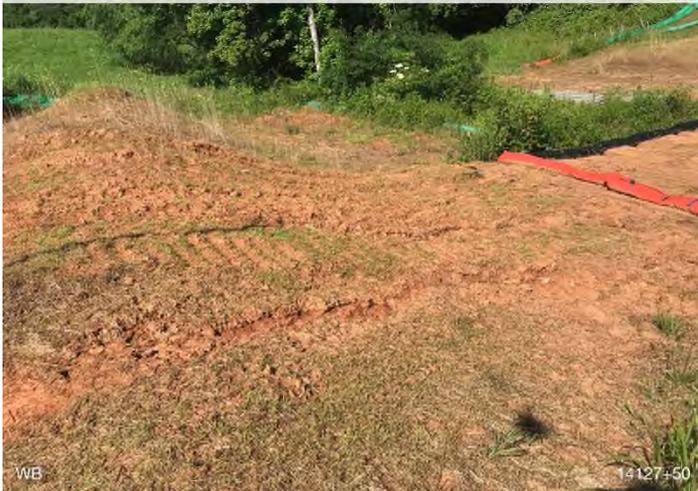
Figure 3: STA 14127+50 – Waterbar in need of repair. Discharge topping WB causing erosion. Rebuild WB to spec and repair/stabilize erosion.

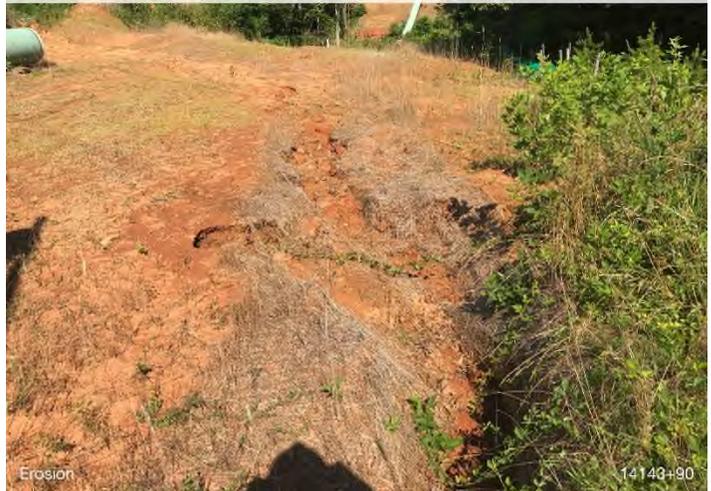
- STA 14143+90: Repair and stabilize erosion cause by onsite run on.

Figure 4: STA 14143+90 – Repair and stabilize erosion.

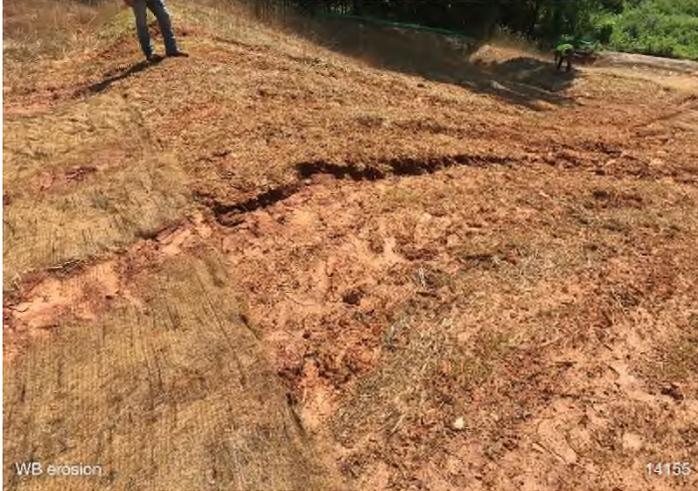
Figure 5: STA 14155+00 – Waterbar in need of repair. Discharge topping WB causing erosion. Rebuild WB to spec and repair/stabilize erosion.

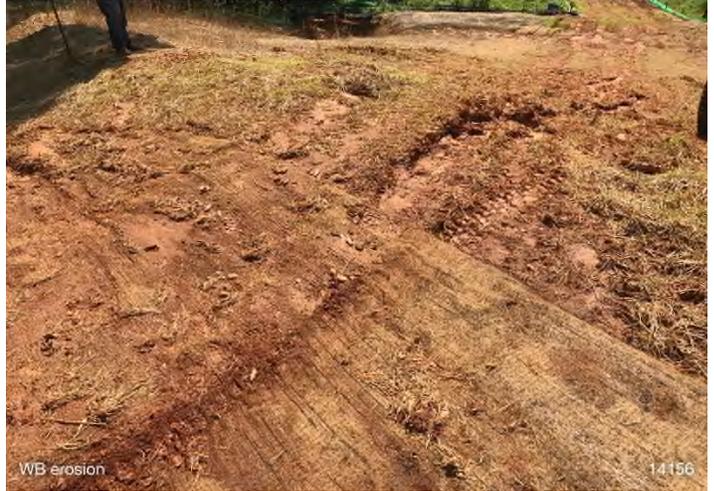
Figure 6: STA 14156+00 – Waterbar in need of repair. Discharge topping WB causing erosion. Rebuild WB to spec and repair/stabilize erosion.
